**Historical Land Use Investigation**  
1239 S. 11<sup>th</sup> St. AKA 1104 W. Madison St.  
Milwaukee, Wisconsin

File: 432-37

Department of City Development

April 4, 2014

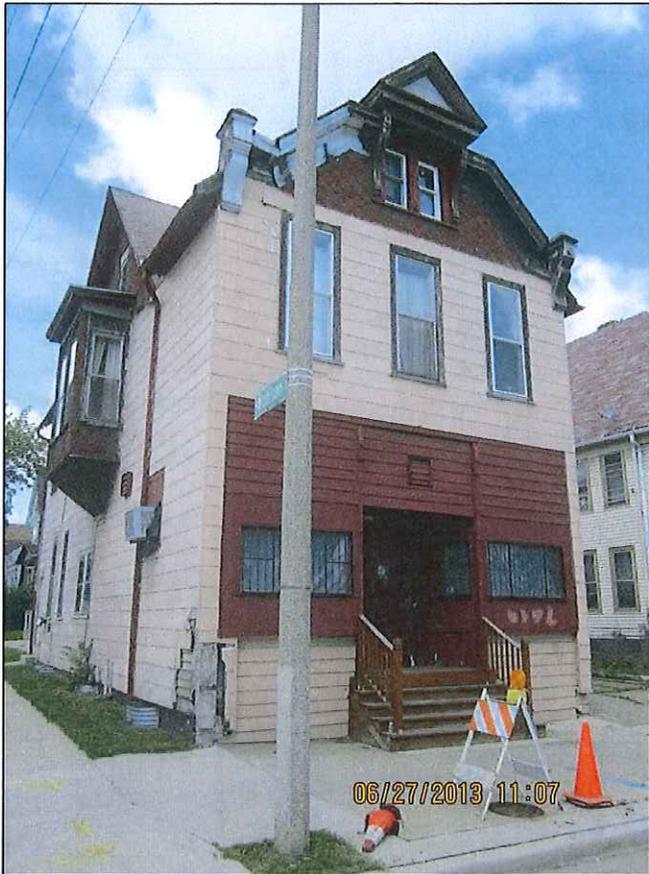
**View of project site exterior, looking northwest from S. 11<sup>th</sup> St. & W. Madison St.**

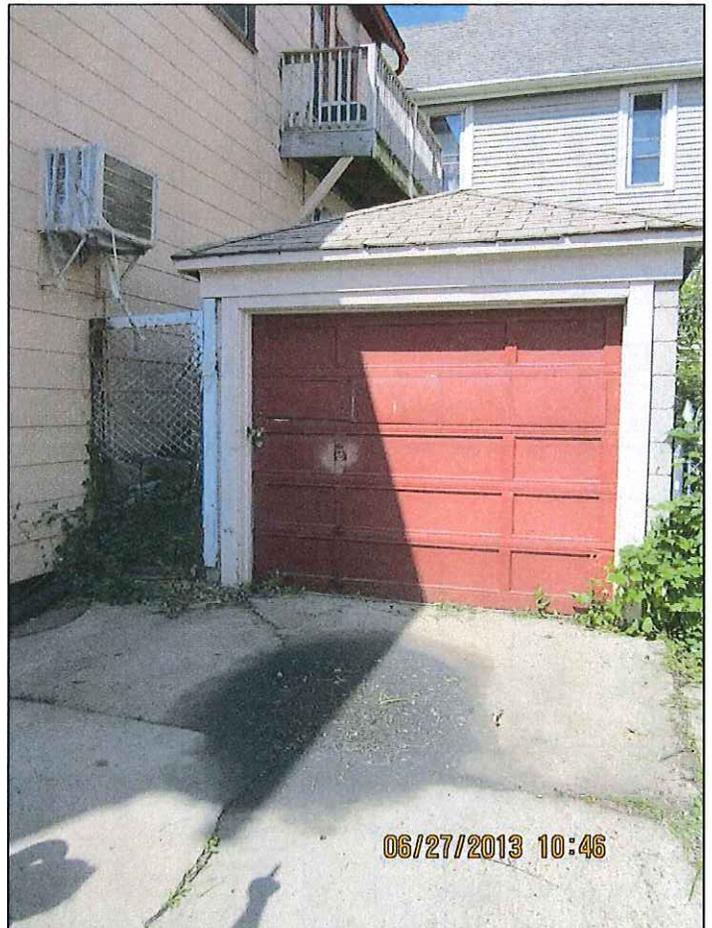
The exterior of the main structure and the detached garage was inspected. The garage was locked, so entry was not gained. A large oil stain was noted on the concrete driveway, which had some

**View of the garage on the project site, which is located directly north of the main structure, set back from S. 11<sup>th</sup> St. Entry was not gained to the garage during the inspection.**

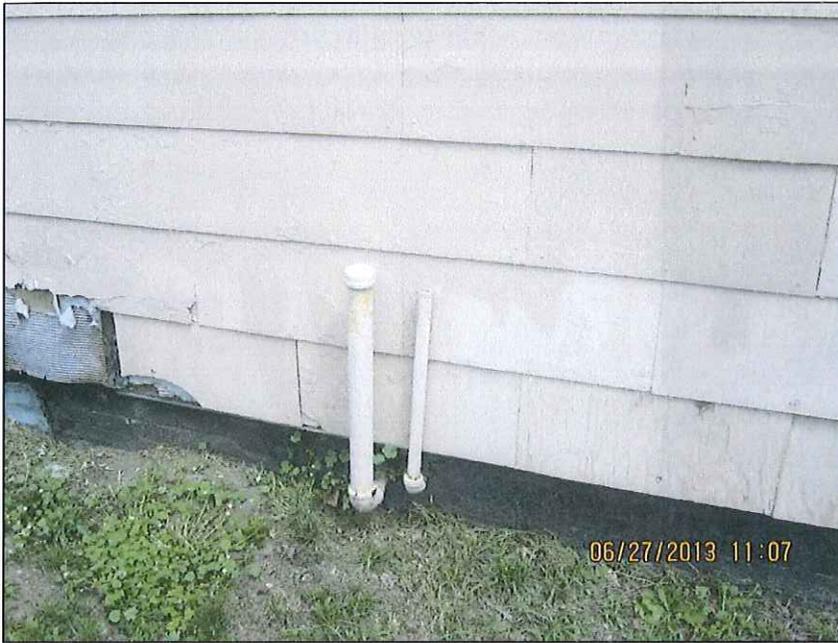
cracks and wear and tear. Oil tank fill and vent piping were observed along the southern wall of the main structure.

**Oil tank fill & vent pipes were observed along the main building's southern wall, along W. Madison St.**

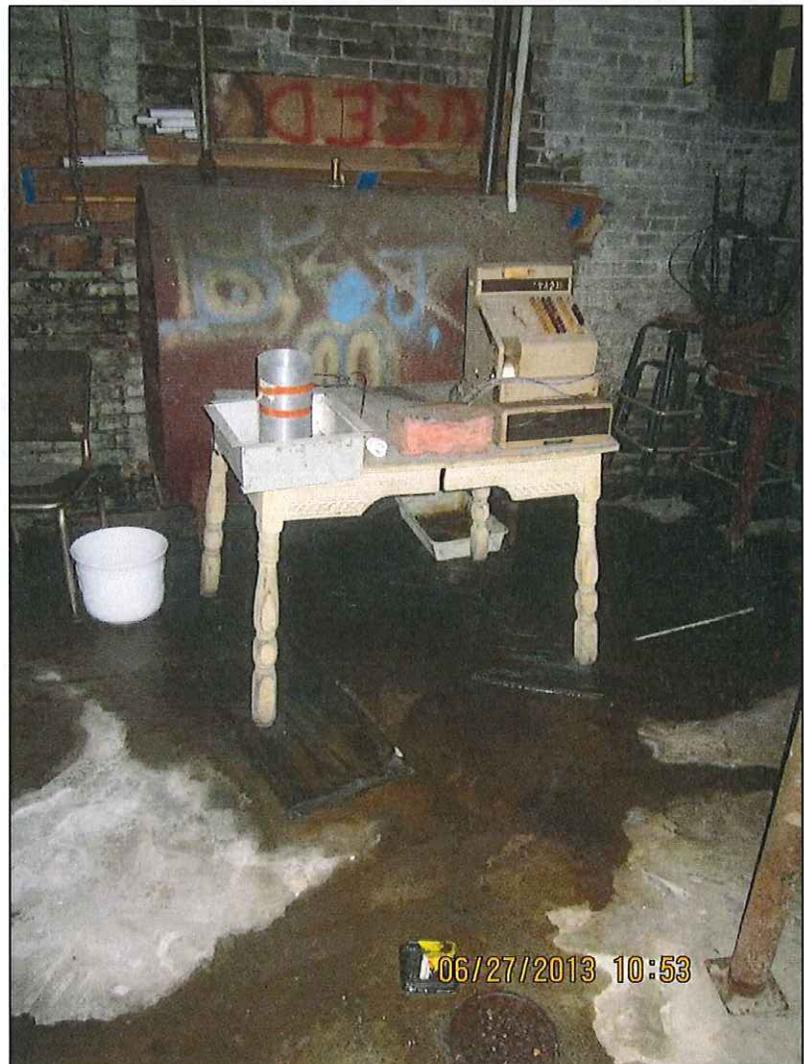
Inspection of the basement revealed the presence of one heating oil tank along the southern wall. The tank was tapped and sounded hollow/empty. The floor along the southern wall was wet, including the area underneath and surrounding the tank, and draining toward a nearby floor drain. Rainstorms had occurred in the days preceding the visit. It could not be discerned whether the fluid contained any oil. A second floor drain was also observed toward the southern end of the basement, where the floor was dry. A condensation line appeared to run from a large cooler to the drain. Also observed in the basement were numerous containers of what appeared to be household chemicals, such as paint and roof cement.

- The presence of a heating oil tank in the basement, which should be properly managed and disposed of, as well as potential oil staining on the ground near the tank and near a floor drain; and
- The potential for asbestos-containing material.

**One oil tank was observed at the project site, along the basement's southern wall. A floor drain was observed near the tank. The surrounding floor was wet.**

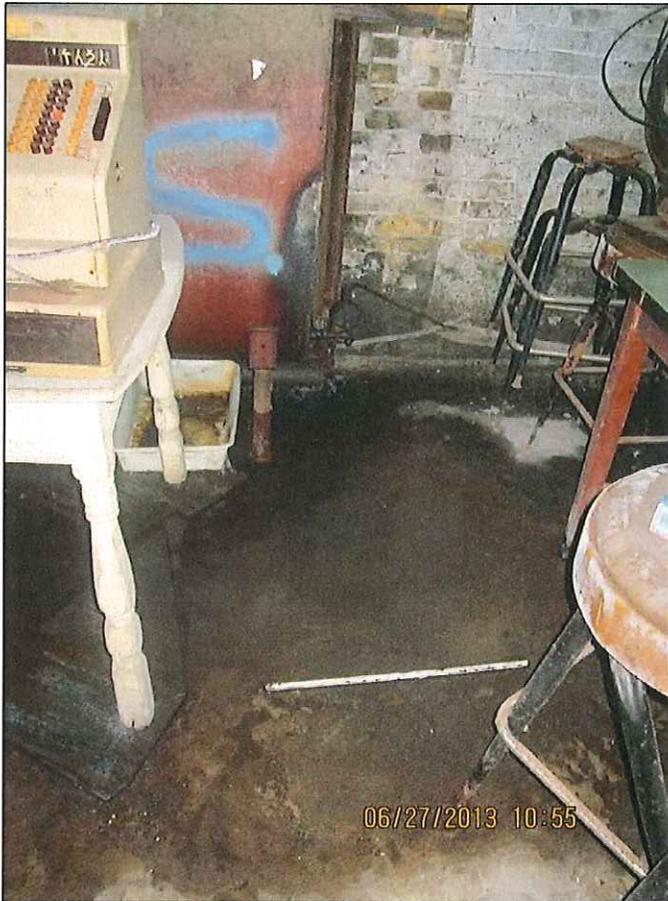
**Close-up view of the oil tank and surrounding floor space.**

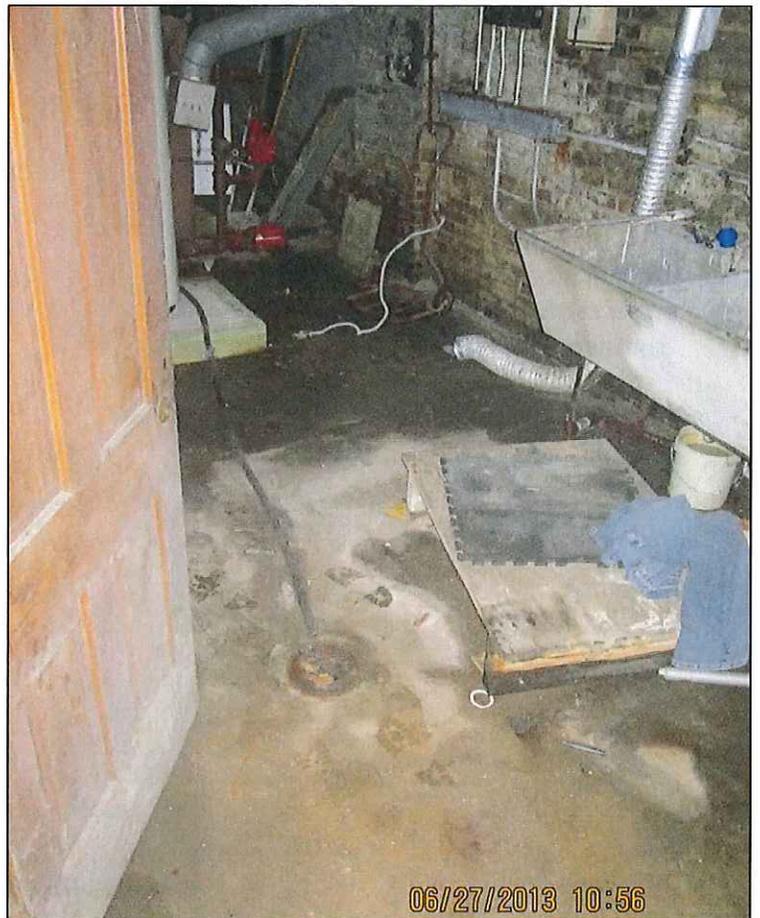
**A second floor drain was observed in the basement. The tube entering the drain appeared to be a condensation line extending from a cooler.**

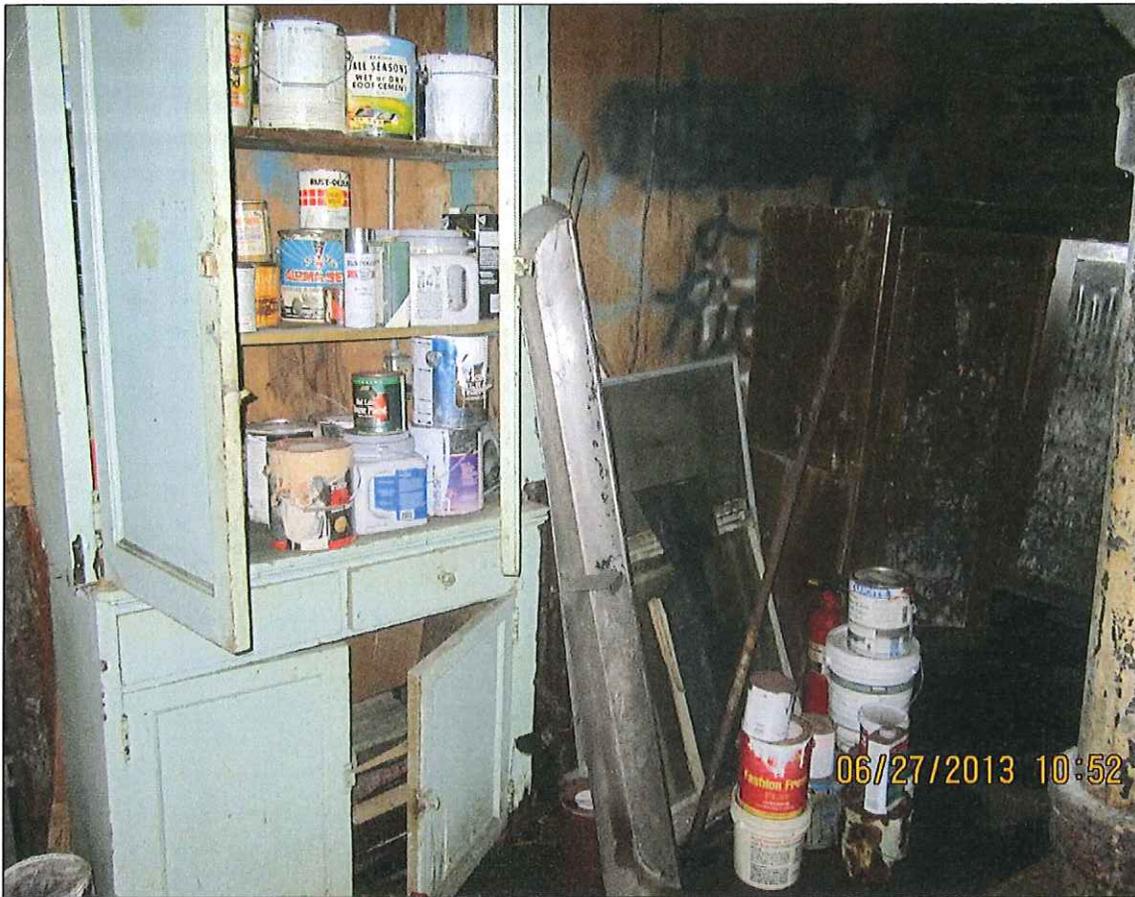
Paint and other household chemicals were observed stored in buckets in the basement.

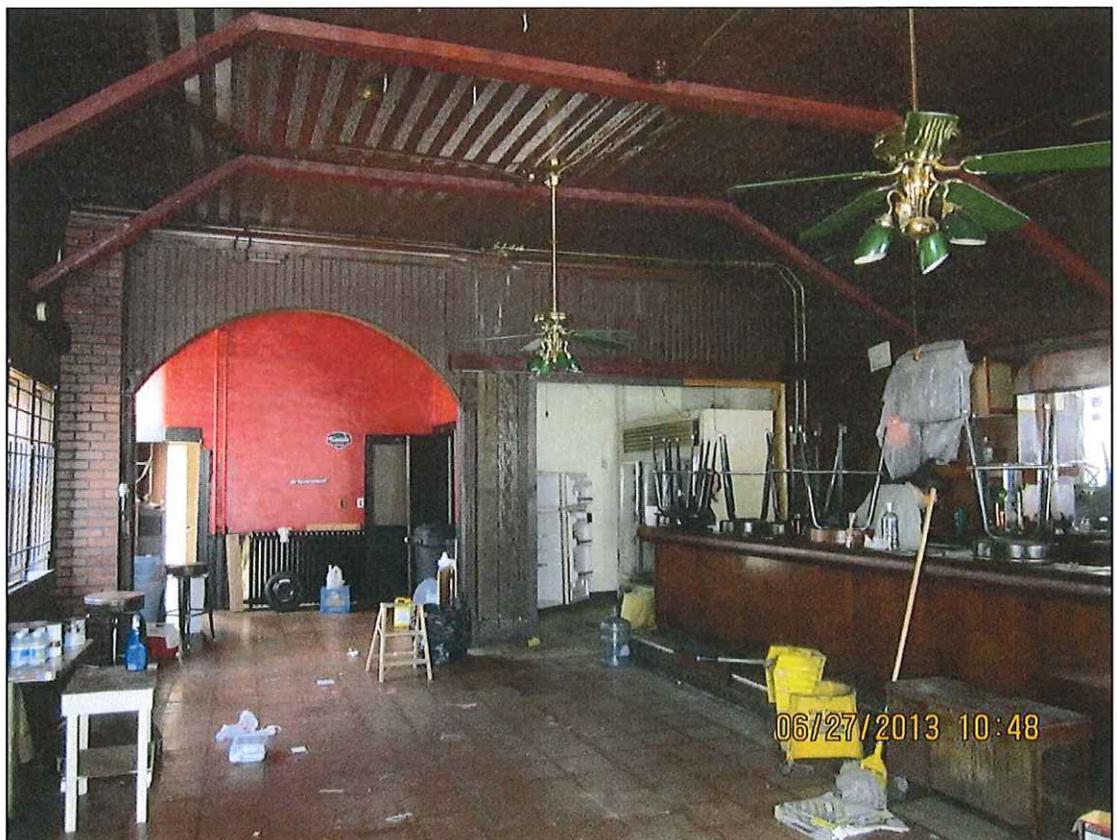
The ground floor tavern area was observed to be in good condition, with no environmental concerns noted.
