Historical Land Use Investigation
3020-26 West Fond du Lac Avenue
Milwaukee, Wisconsin

File: 309-15

Department of City Development

November 22, 2013

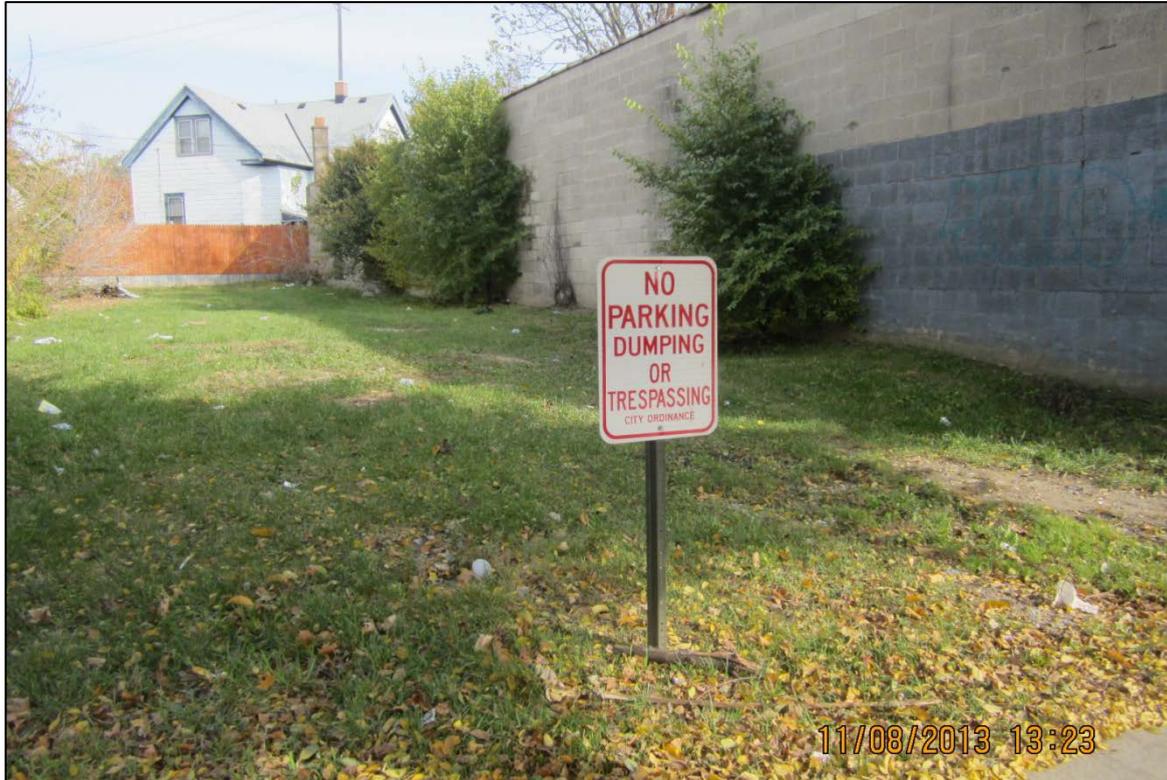
City Staff conducted a site inspection on November 8, 2013. The western portion of the project site (3026 W. Fond du Lac Ave.) was observed to be a vacant lot. The site was grassy, with a few patches of bare ground, gravel or concrete in the general area where Sanborn Maps indicate a home was previously located. The site was observed to have a small downward slope toward W. Fond du Lac Ave. No dumping was observed at the site, and scattered litter was minimal. A City sign ("no parking dumping or trespassing") was posted. No staining was observed in the area of the former above-ground storage tank (AST).

**View of the western portion of the project site, looking north from W. Fond du Lac Ave.
The structure on the right is 3020 W. Fond du Lac Ave.**

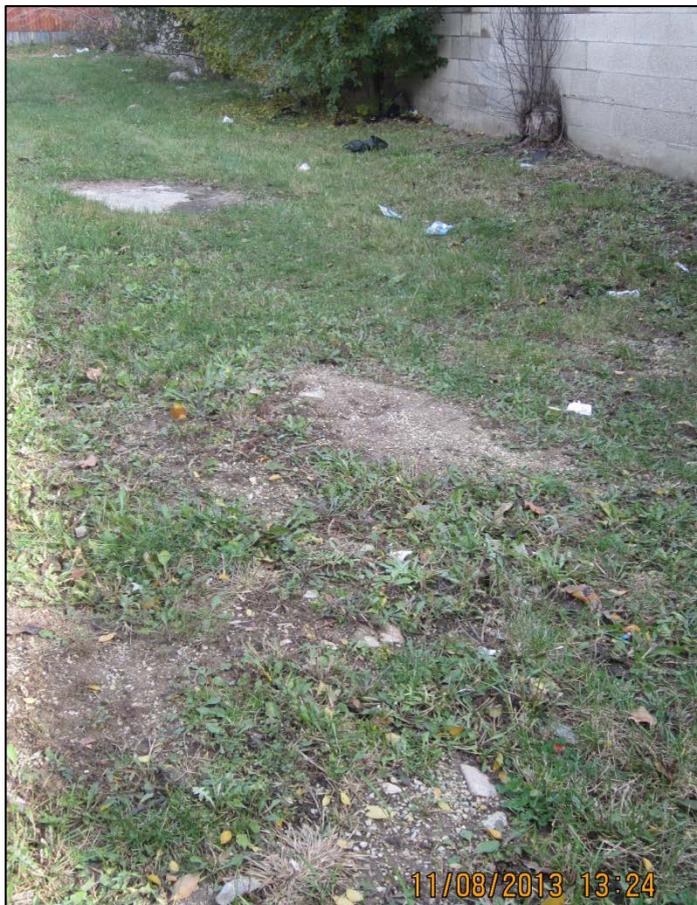
**Closer view of the
project site groundcover
conditions.**

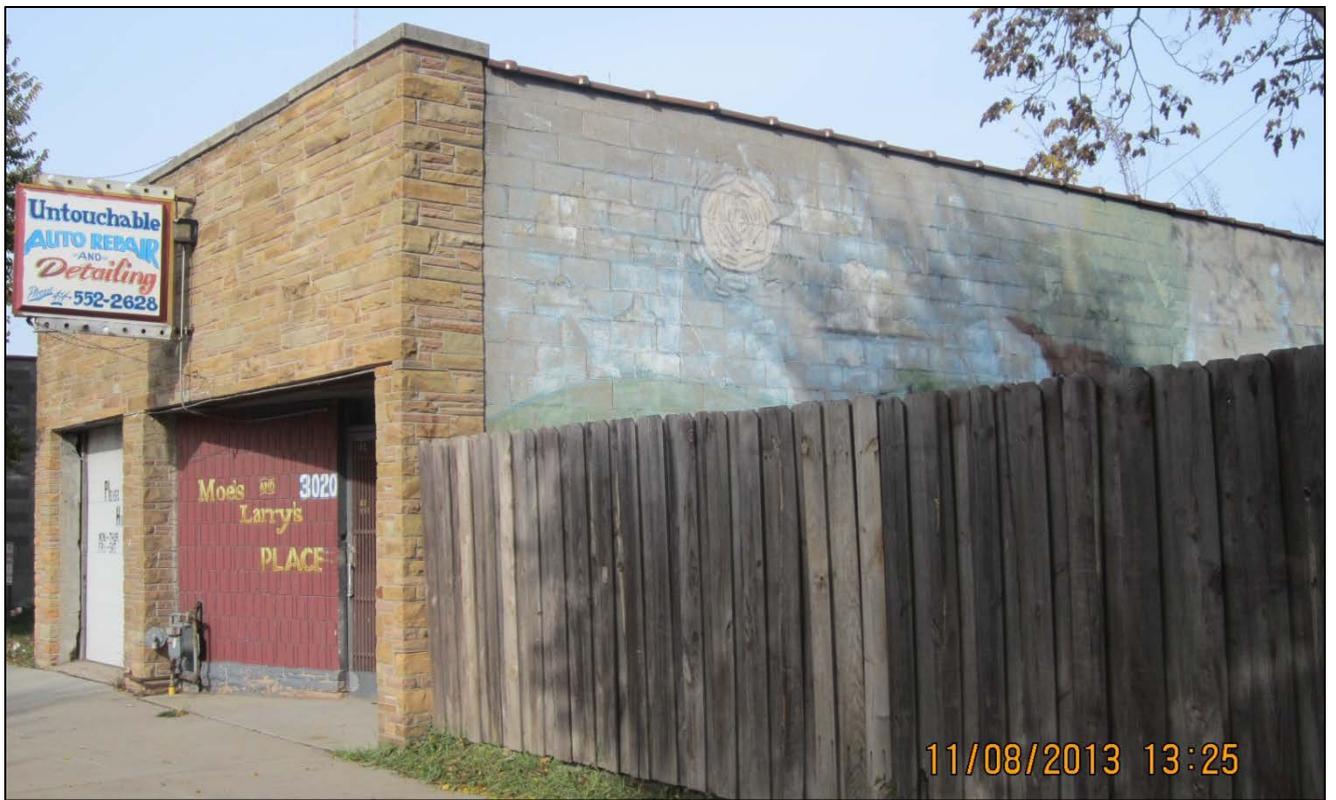
Exterior view of the eastern portion of the project site, looking northwest from W. Fond du Lac Ave.

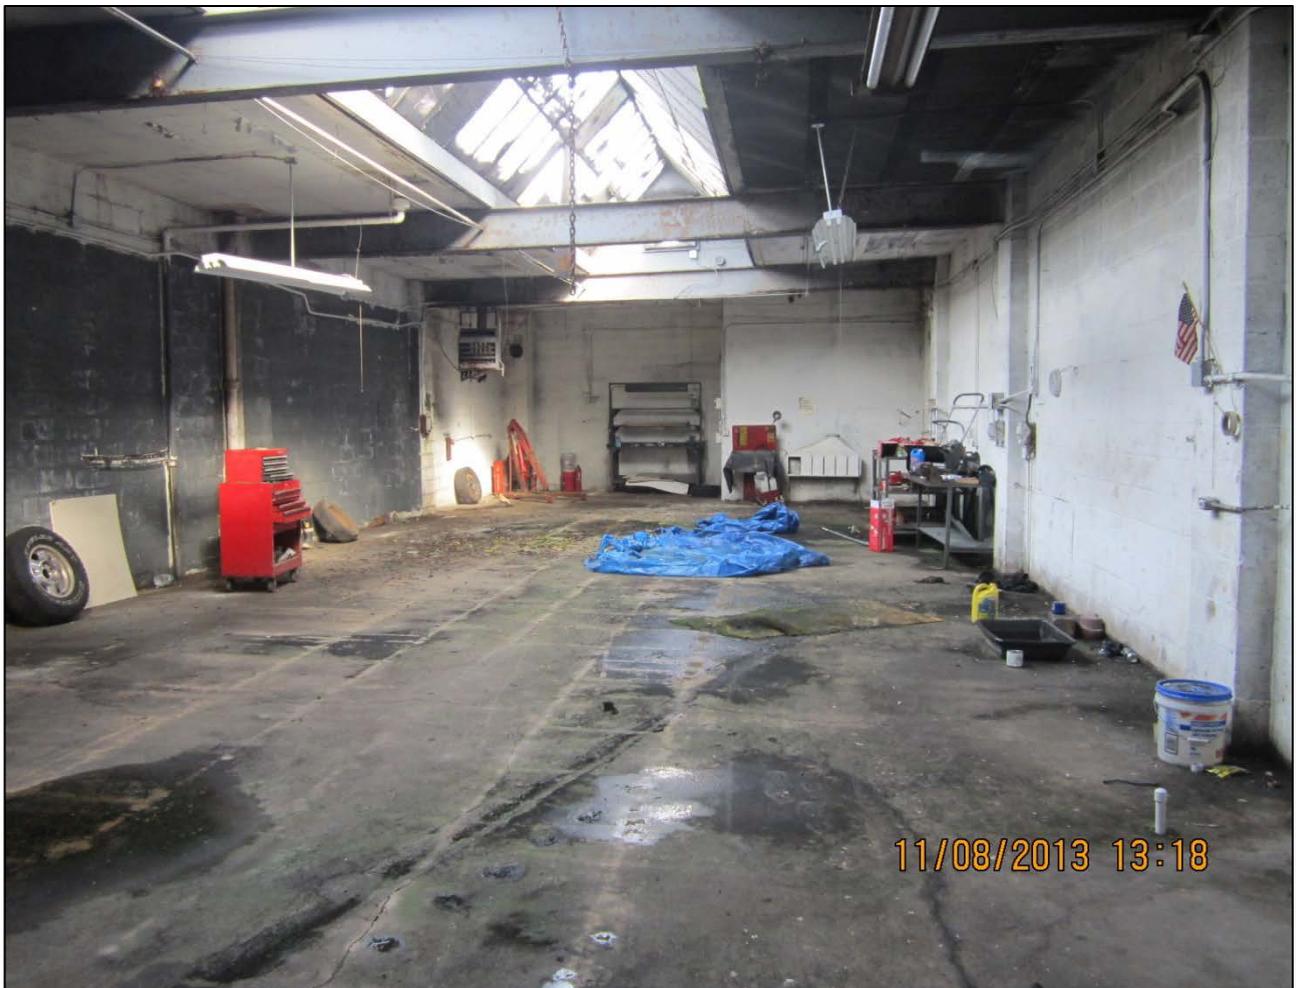
The front office area was observed to contain numerous discarded items, including tires, a lawn mower, electronic items, and other goods. The garage area was observed to an open room with a large skylight and concrete floor. The floor appeared to be stained and wet in some areas. Roof leaks were observed during the site inspection. Five gallon buckets as well as various smaller bottles of chemicals were observed in the garage area. A metal parts cleaning station was observed, which could indicate the presence of solvents. The attached storage container appeared

Interior view of the eastern portion of the project site, looking north. The floor appeared wet and stained in some areas. The ceiling was leaking in several spots during the inspection.

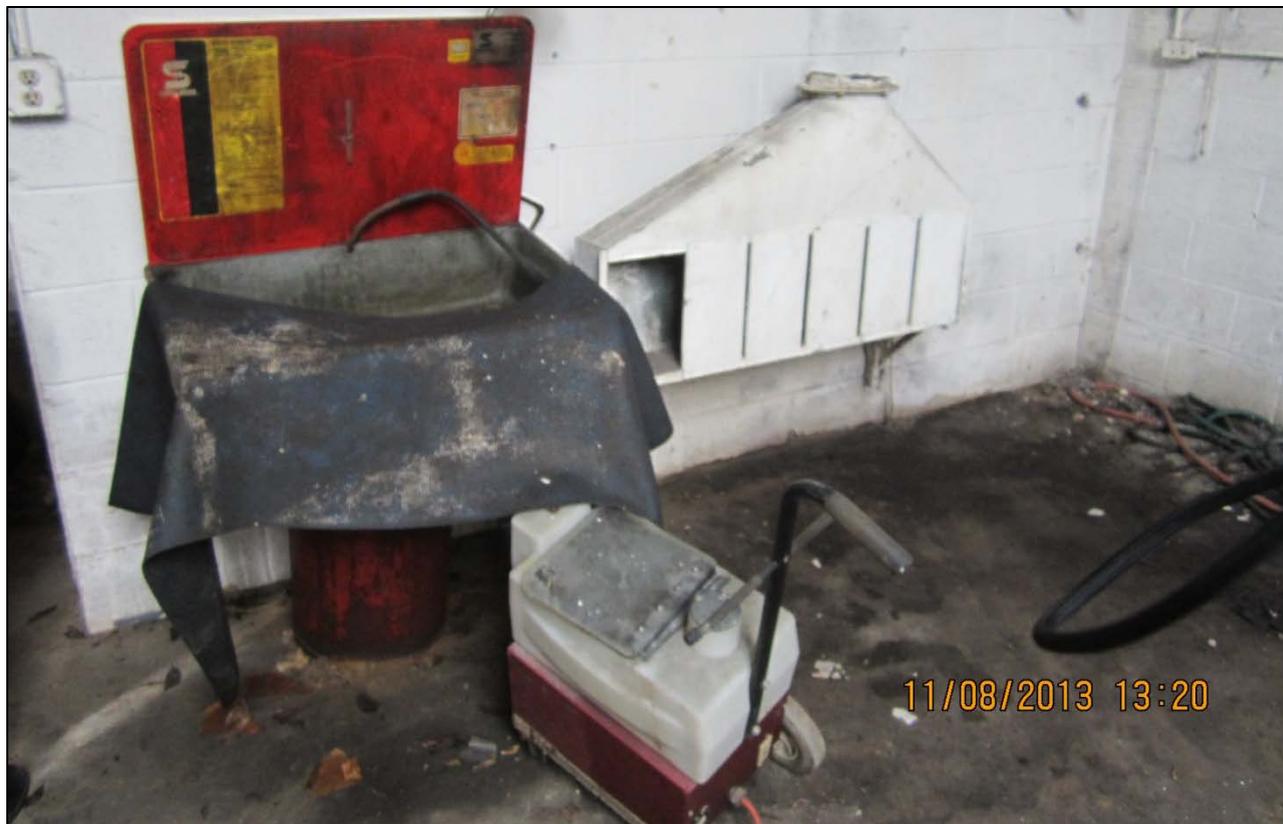
A metal cleaning station was observed. The storage container appeared to be empty, but this was not verified.

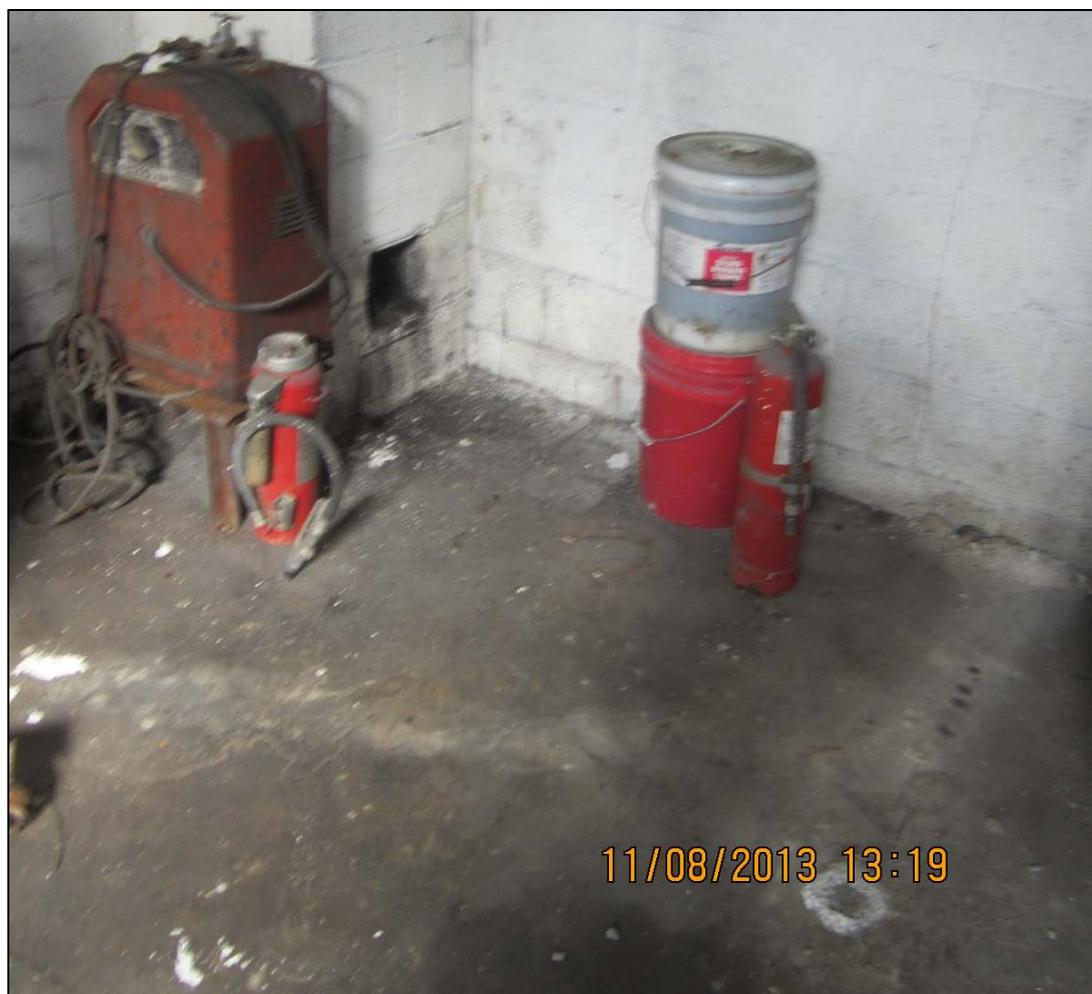
Five gallon buckets as well as smaller bottles of chemicals were observed.

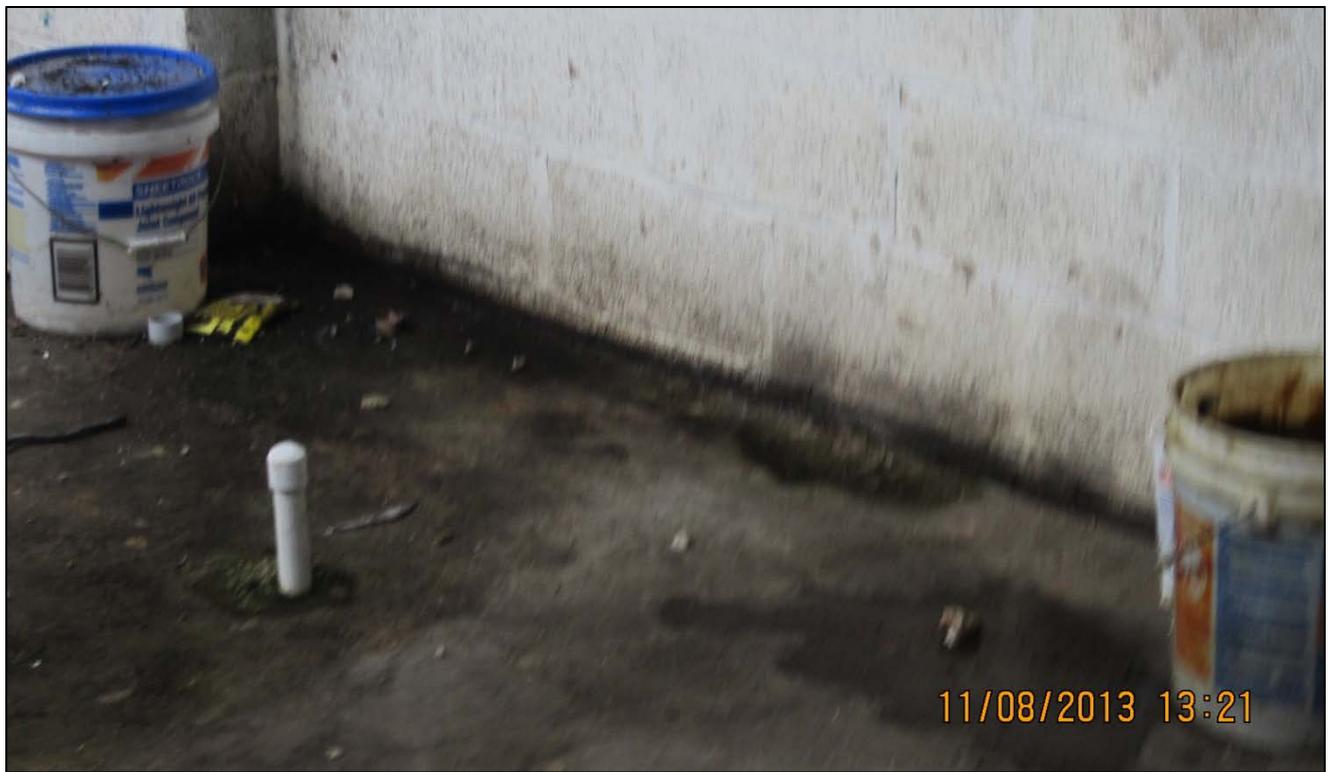
to be empty, but this could not be confirmed. A temporary monitoring well, believed to be associated with Phase II investigations, was observed inside the structure, near the east wall.

A temporary monitoring well was observed near the east wall of the building.

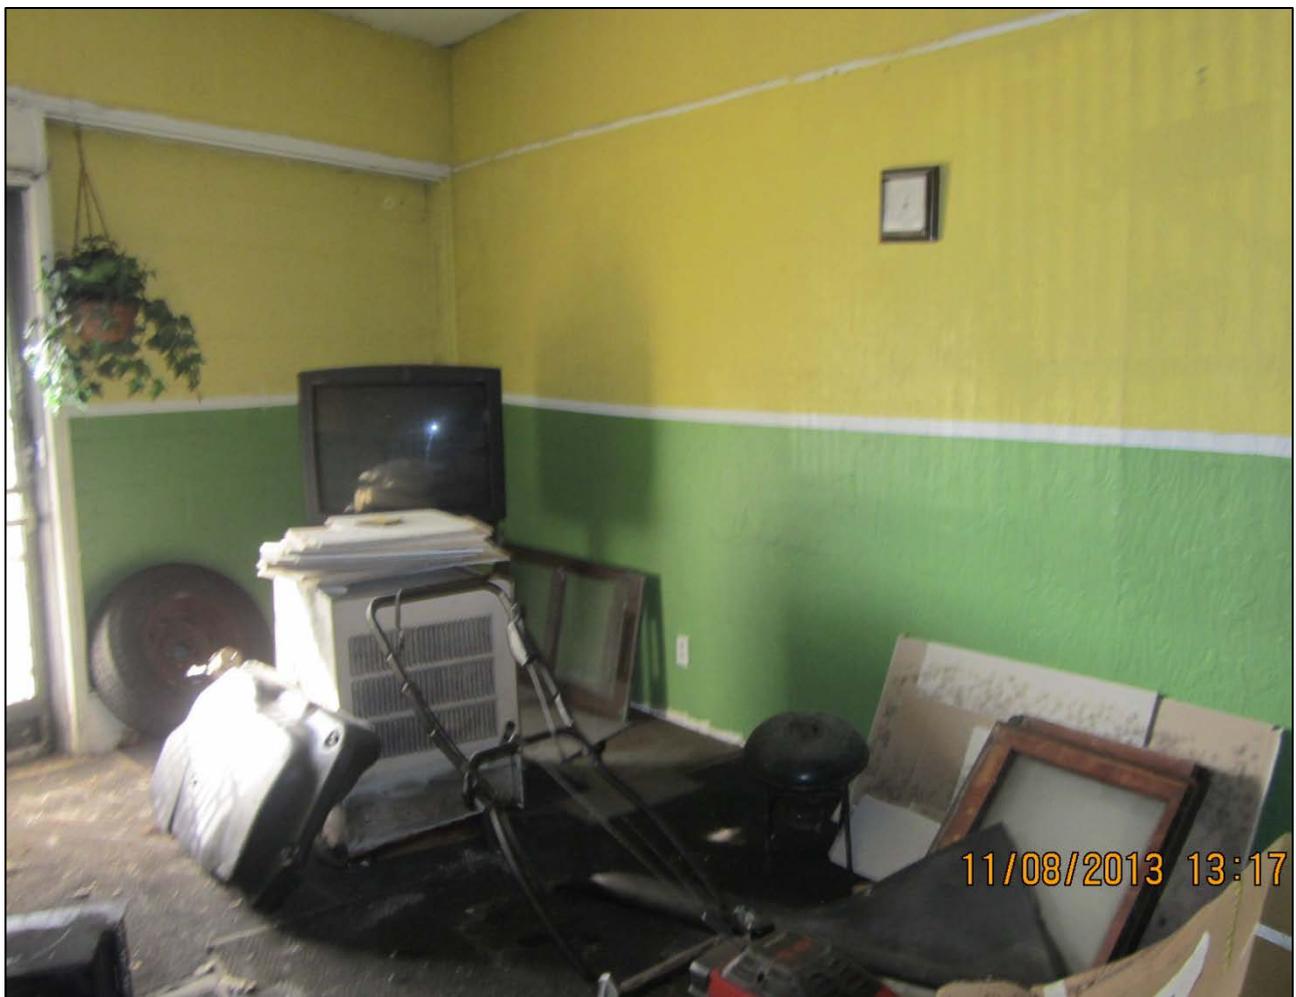
Interior view of the front office area. Tires, electronic waste, and other items were observed.
