Historical Land Use Investigation
4828 West Lisbon Avenue
Milwaukee, Wisconsin

File: 328-22

Department of City Development

November 11, 2013

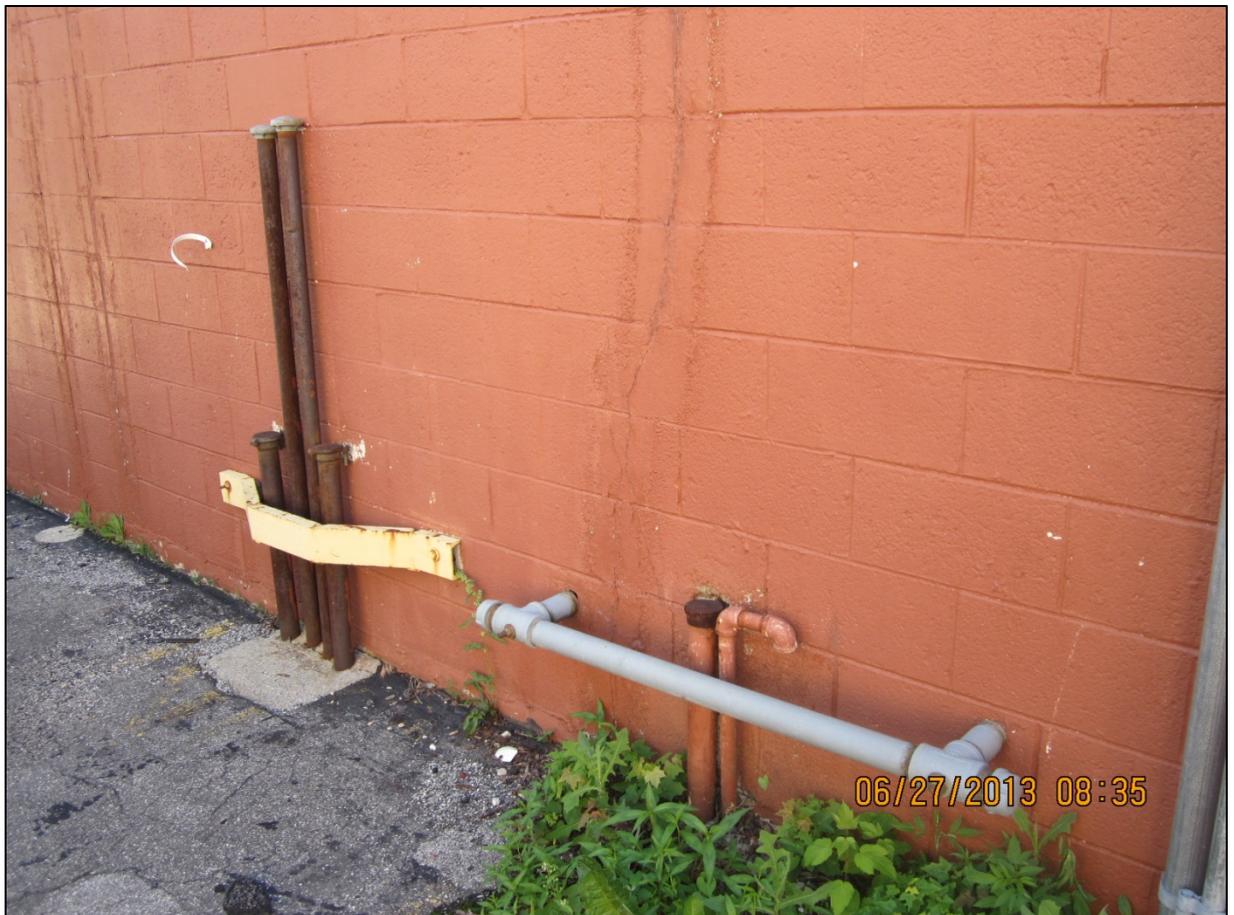
An inspection of the exterior & interior of the project site was conducted on June 27, 2013. The undeveloped space on the western third of the site was observed to be partially paved, in worn condition, and partially dirt/grass. Three sets of fill and vent pipes were observed along the western wall of the building. Two pipe covers were locked shut, while another pipe was filled with debris.

Oil tank fill and vent pipes were observed along the western wall of the building.

- DNS records indicate the presence of three oil tanks on the site, including one 1,000-gallon UST and two 275-gallon ASTs, which should be properly maintained or removed and which could potentially be leaking. During the site inspection, two ASTs were observed along the west wall of the basement and three sets of fill and vent pipes were observed along the west exterior wall. No further information on the UST was found during this investigation.

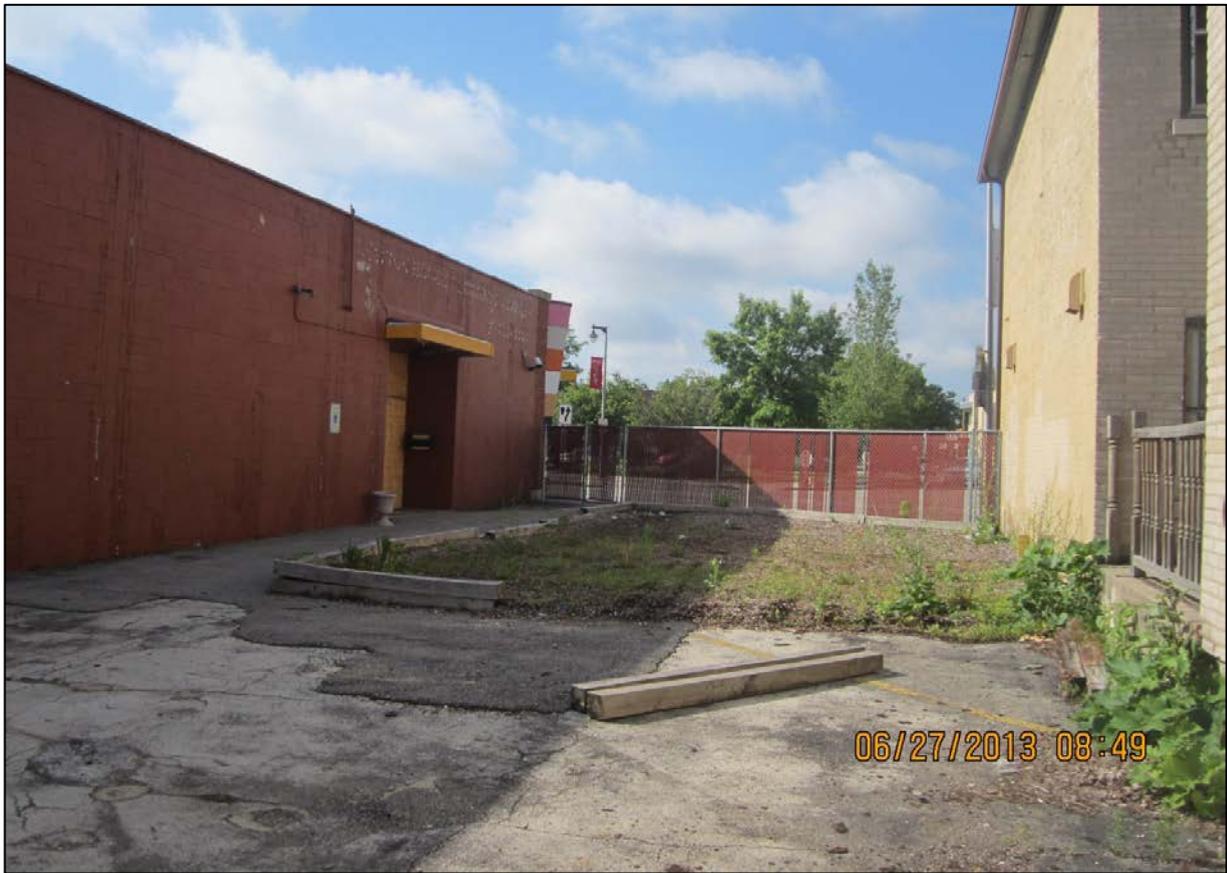
View looking south (toward W. Lisbon Ave.) of the undeveloped, partially-paved western portion of the project site.

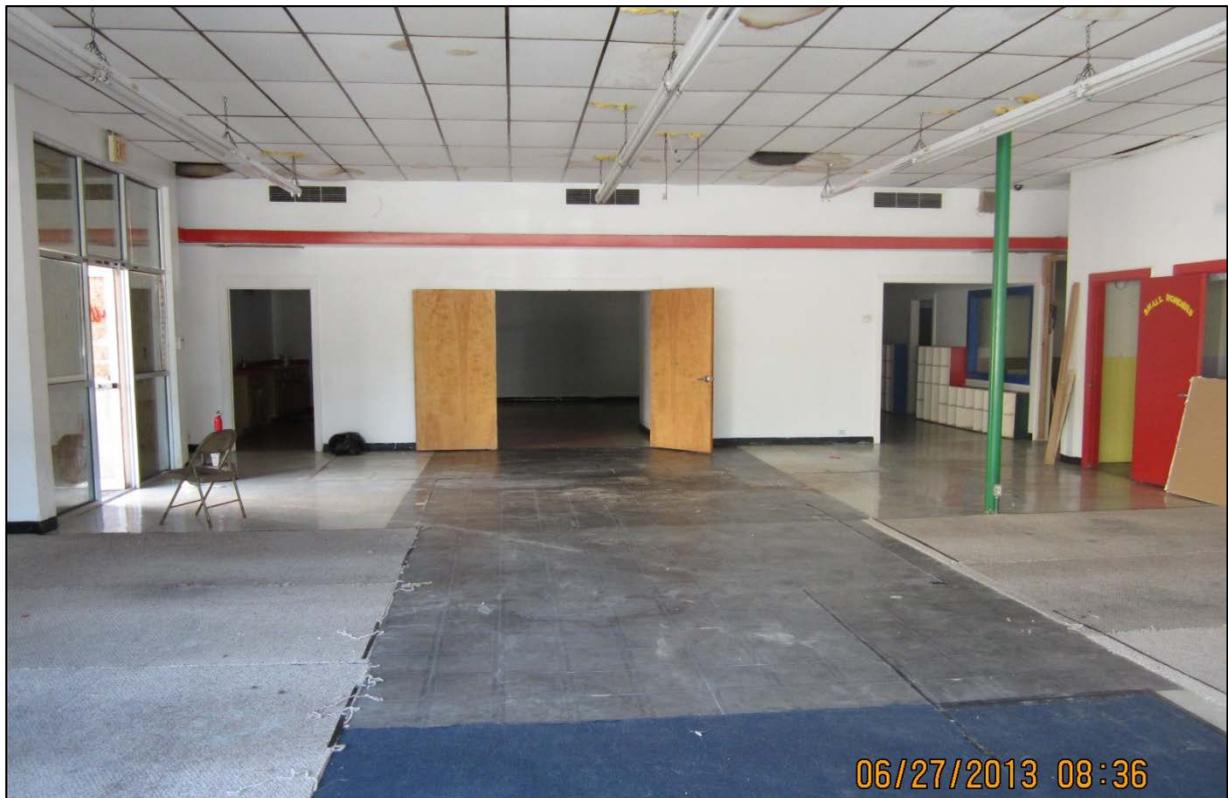
The interior of the structure was observed to have been used most recently as a day care. The interior smelled damp/moldy. Staining appeared on some of the ceiling tiles in the front rooms.

View of the building interior (front room, west end of building).

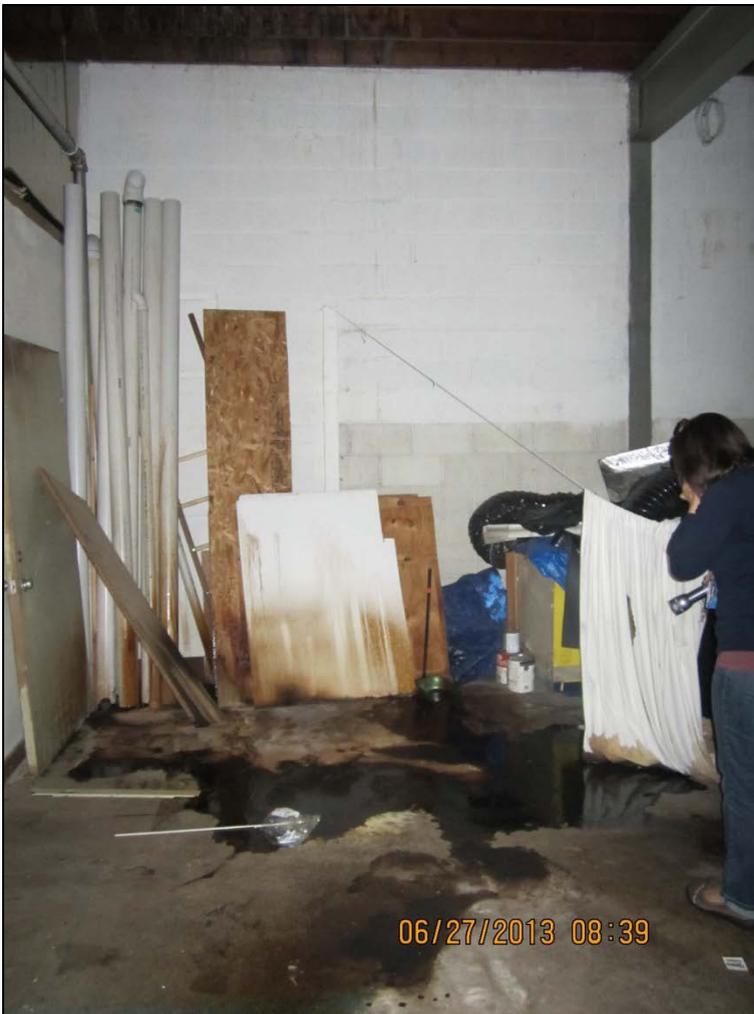
View of the storage/work area in the rear portion of the building. A brown liquid substance was observed on the floor, present at various spots throughout the western side of this area.

- Pools of a brown substance of unconfirmed origin were observed in the ground floor work/storage area. These appeared to be associated with a dripping roof sealing material, and should be cleaned up.

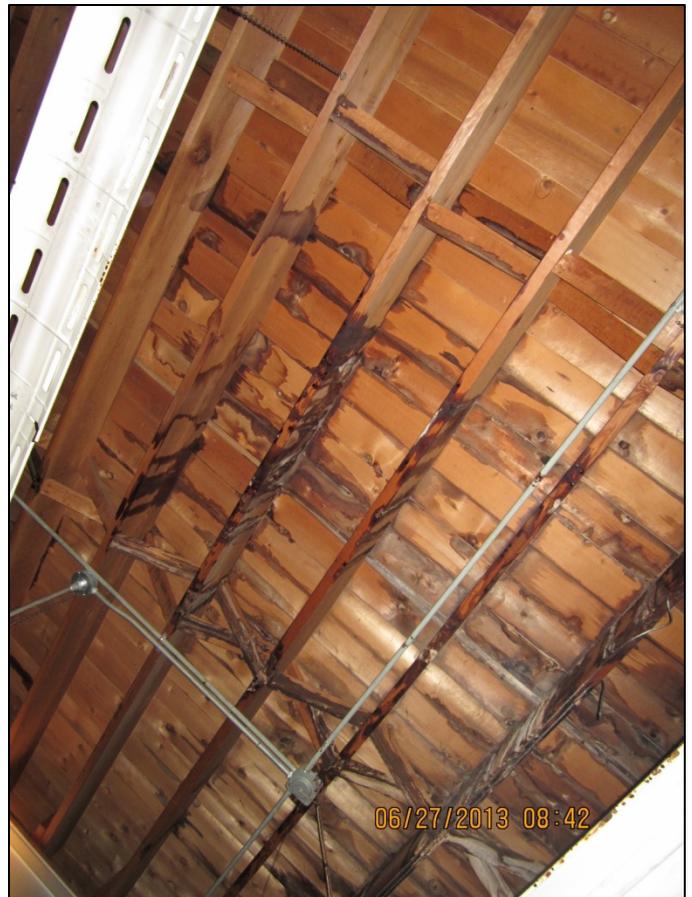
The rear portion of the building was observed to be work/storage space. A brown liquid substance was observed pooled in various spots on the floor. The exposed rafters appeared to have brown staining in areas above the spills, suggesting that a roof sealing material was dripping into the building. The work/storage space was observed to have various abandoned small containers of up to five gallons, some of which had visible labels for building products such as paint. A conveyer belt system extending into the basement was noted in the work/storage space. The basement is accessible from the work/storage space, but was found to have standing water and could not be safely inspected.

View of the ceiling in the storage/work area. Based on the locations and appearance of the brown liquid on the floor and the ceiling above, it appeared that a roofing substance had been dripping down onto the floor, producing the pools of brown liquid; however, this could not be confirmed during this inspection.

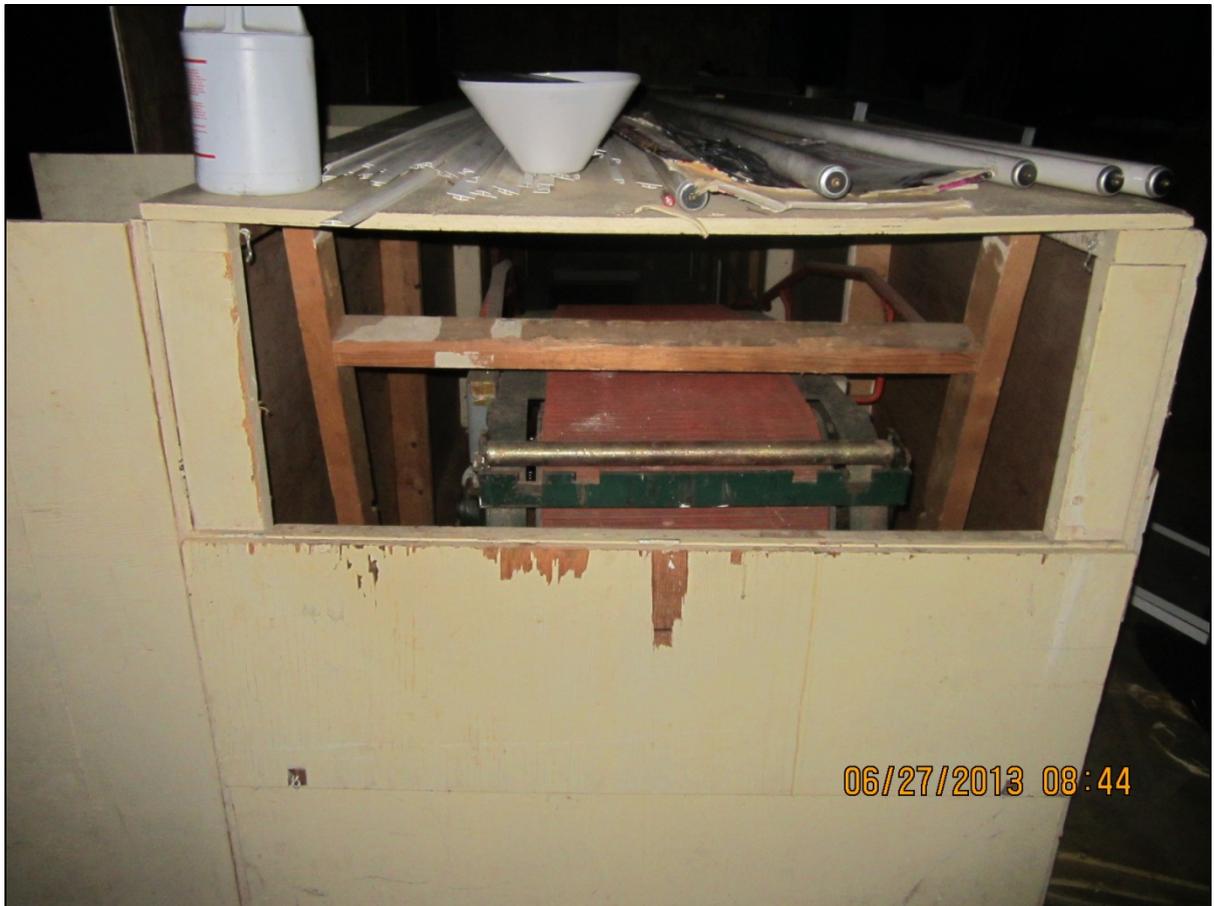
A large conveyor was observed in the storage/work area, extending down into the basement.

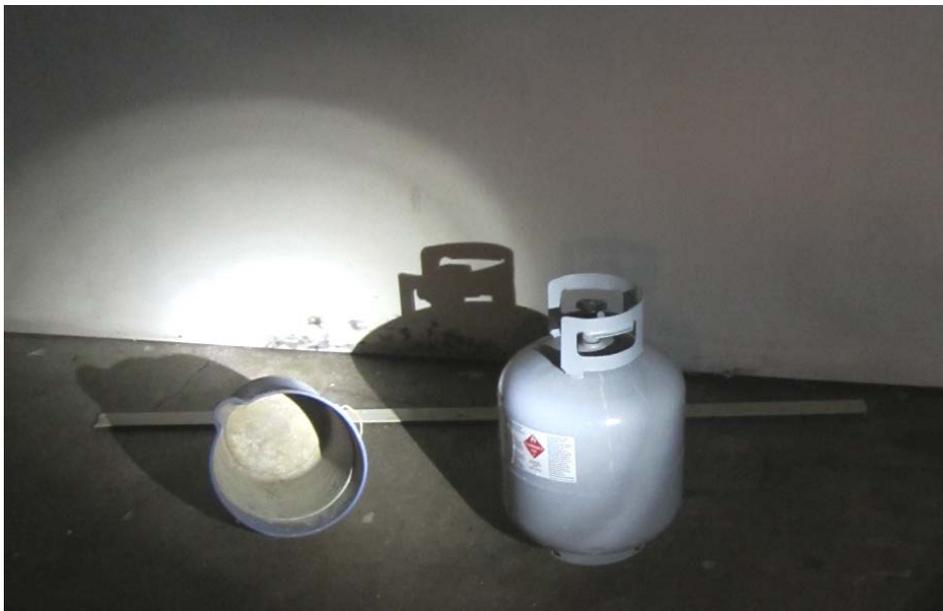
An abandoned cylinder observed in the storage/work area.

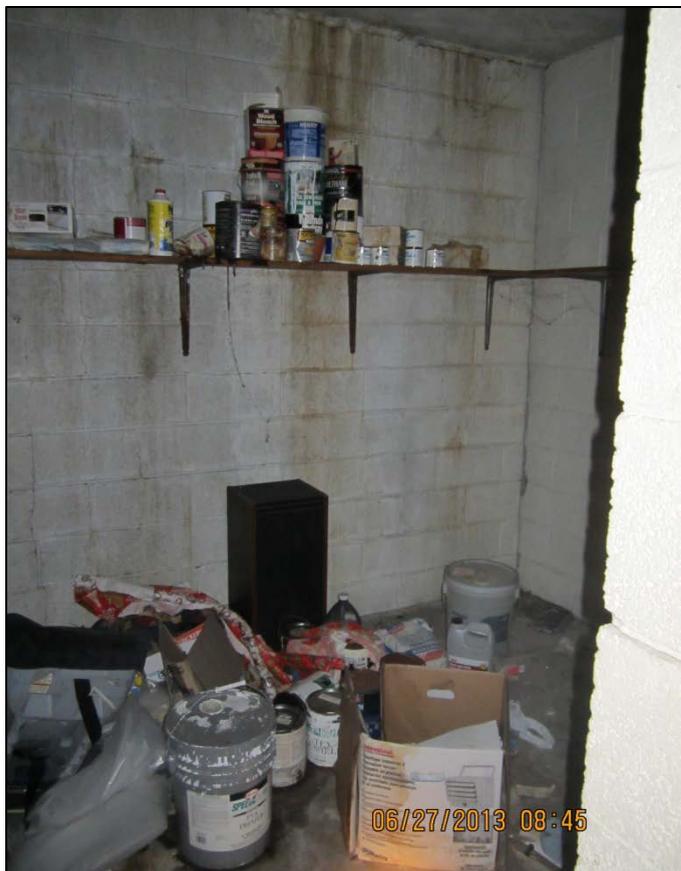
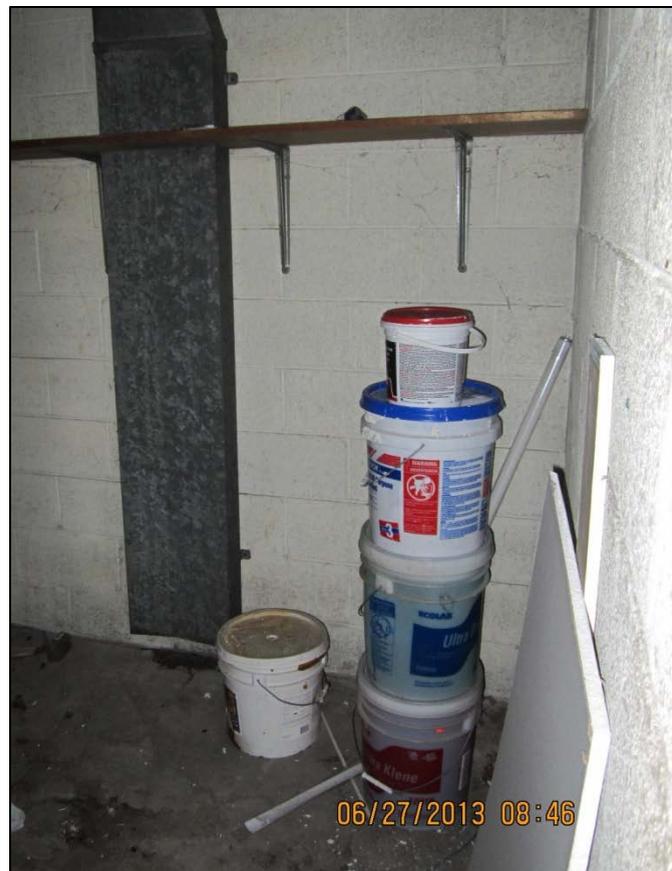
- Staining was observed on the basement floor.
- Numerous household-scale containers of potentially-hazardous materials which require proper disposal, such as paint, were observed on site. Historic records indicate prior use for several decades as a Paint & Wallpaper store, with on-site storage of paints and thinners.

Containers of up to five gallons were observed in the work/storage area.

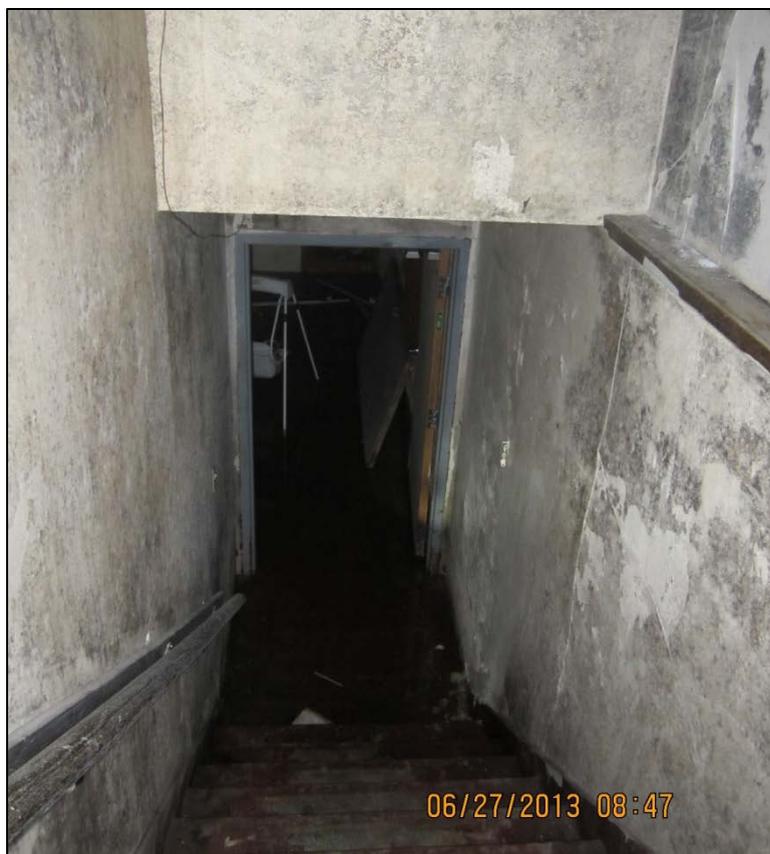
View down the basement stairs. The basement was found to have standing water, so could not be safely inspected during the initial site inspection.

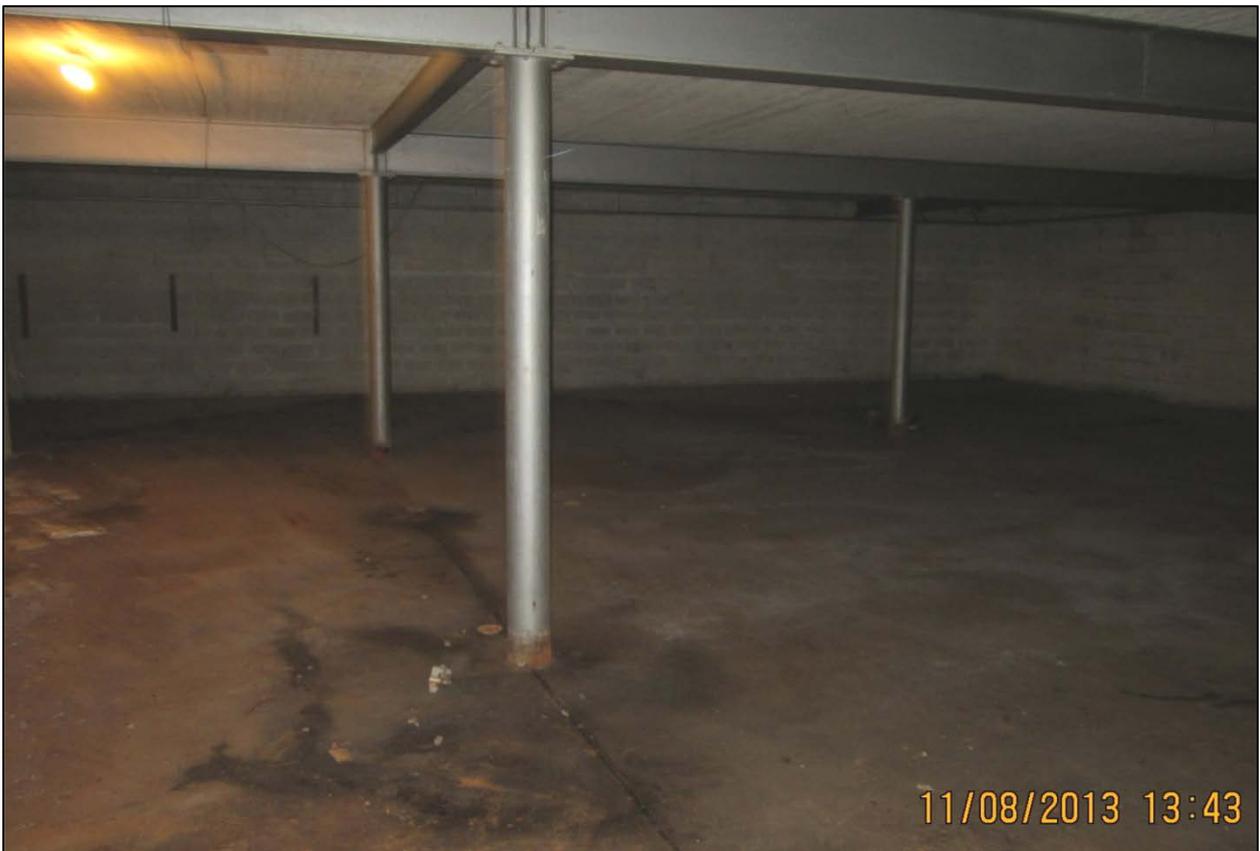
On a return visit on November 11, 2013, the basement was found to be dry. The basement was observed to have floor staining, particularly in a rear utility area where the floor was covered in some areas by a dark substance. Two furnaces with some rusting were observed in this area. Two tanks/cylinders with unknown contents, but which sounded empty when tapped, were observed to be suspended from the ceiling above the furnaces. Two above-ground storage tanks were also

The basement was observed to be dry during a follow-up site inspection. Staining was observed on the floor.

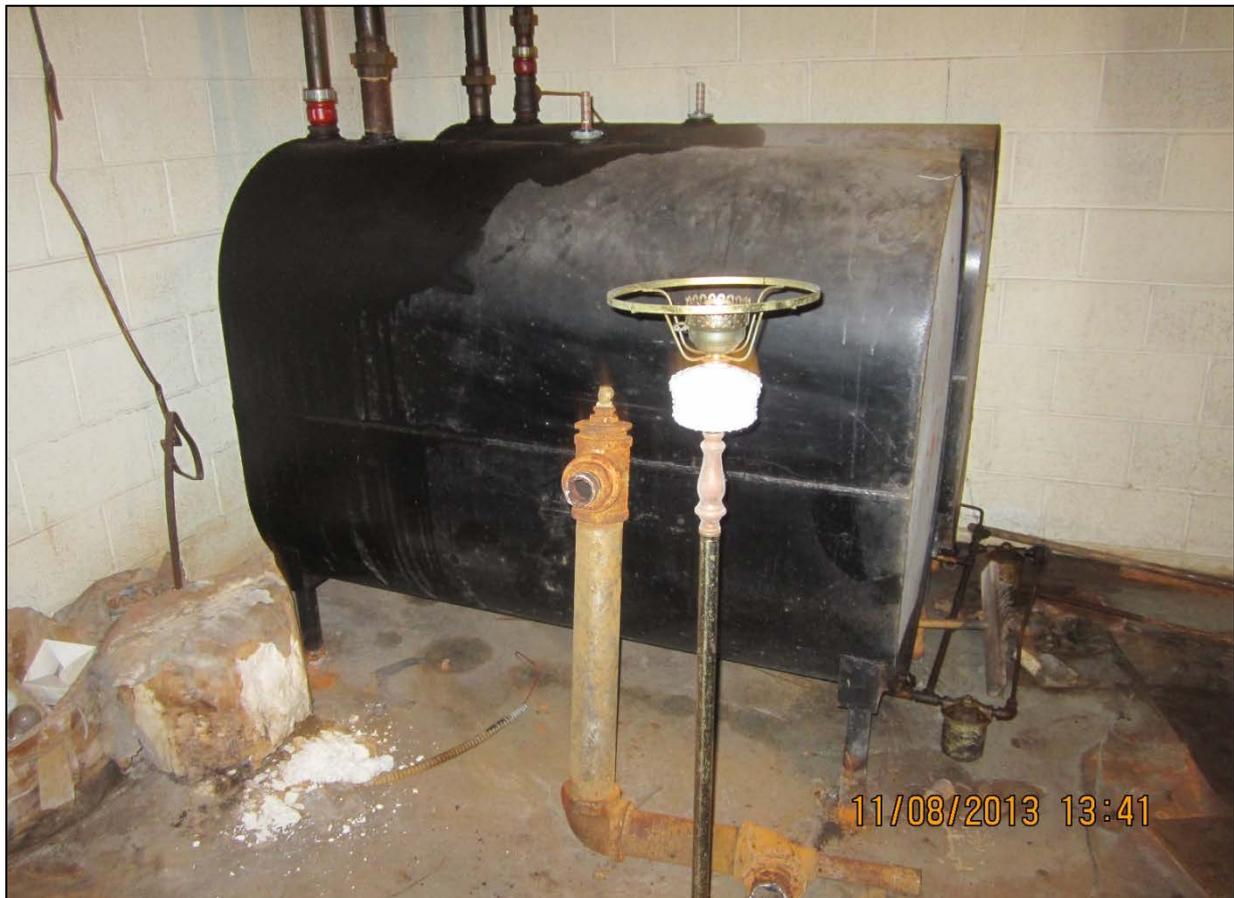
observed in this area. These tanks also sounded empty when tapped, but this could not be verified. These tanks and their piping appeared to align with the location of oil fill/vent pipes that had been observed along the exterior western wall of the building. The concrete floor in the utility area generally appeared to be in decent condition, with no significant cracking observed.

Two storage tanks were observed in the basement. The tanks sounded empty, but this was not verified. The floor in this area was damp and stained.

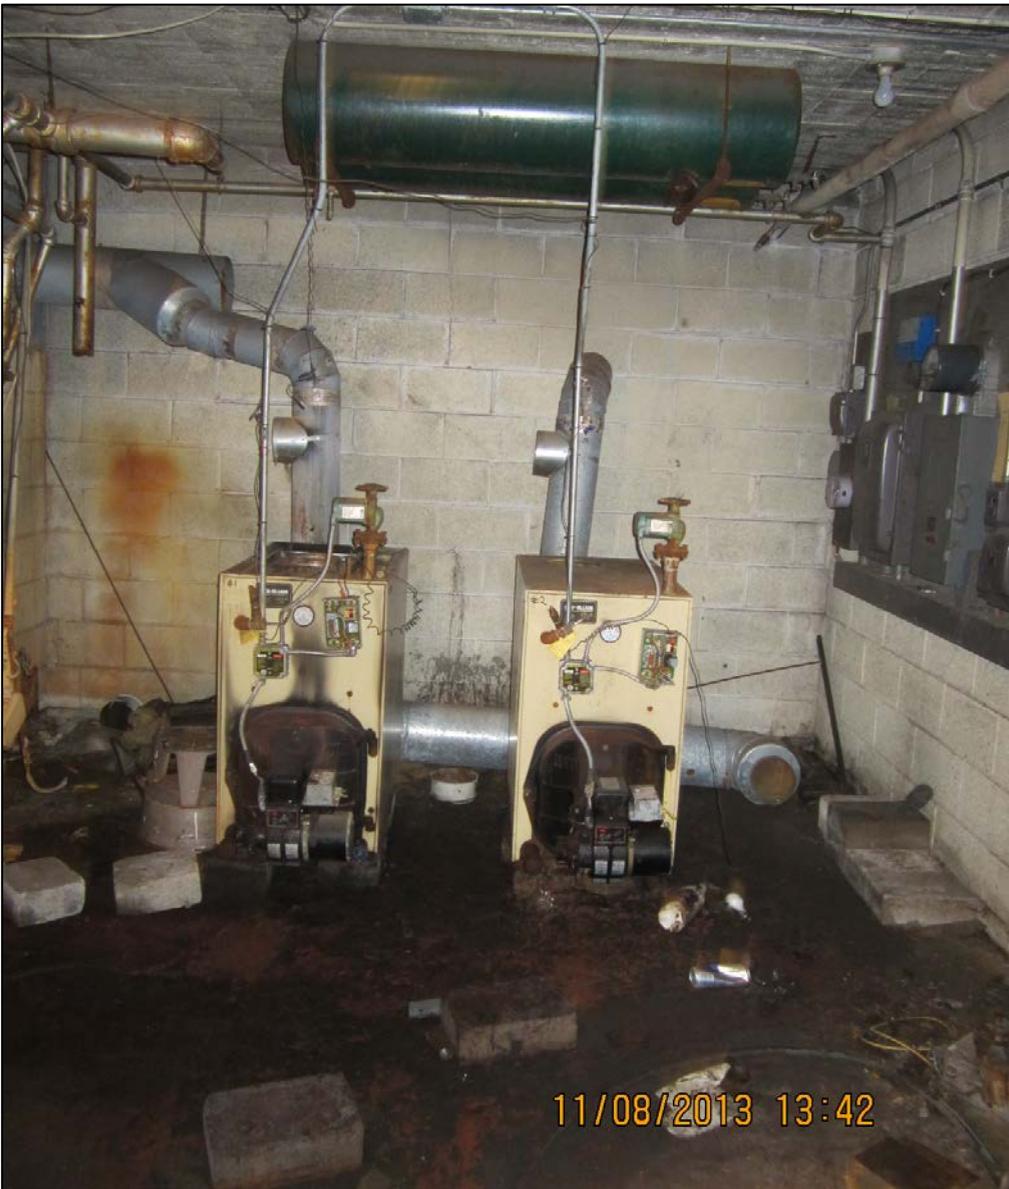
View of the basement utility space near where the storage tanks were observed. Staining was observed on the floor. Two tanks with unknown contents were observed suspended from the ceiling.

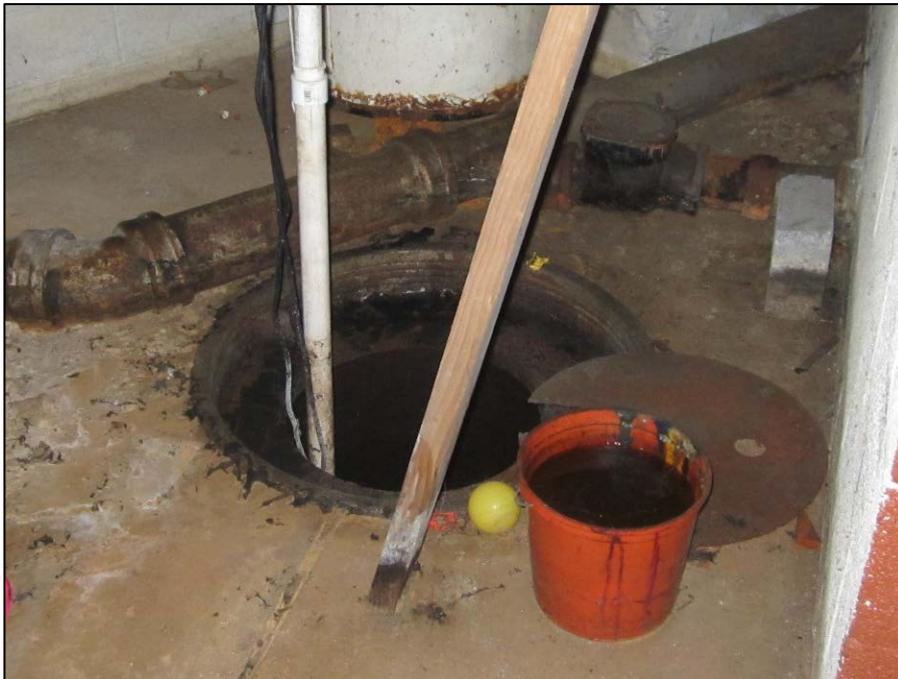
A sump pump was also observed in the basement, and an open bucket with dark liquid was found nearby. In addition to utility and open spaces, a basement restroom area was observed. Storage from the prior day care use (i.e. toys; baby swings; etc) was scattered around the basement.

A sump pump and a bucket of dark liquid were observed.
