Historical Land Use Investigation
5128-30 West Center Street
Milwaukee, Wisconsin

File: 306-04

January 8, 2013

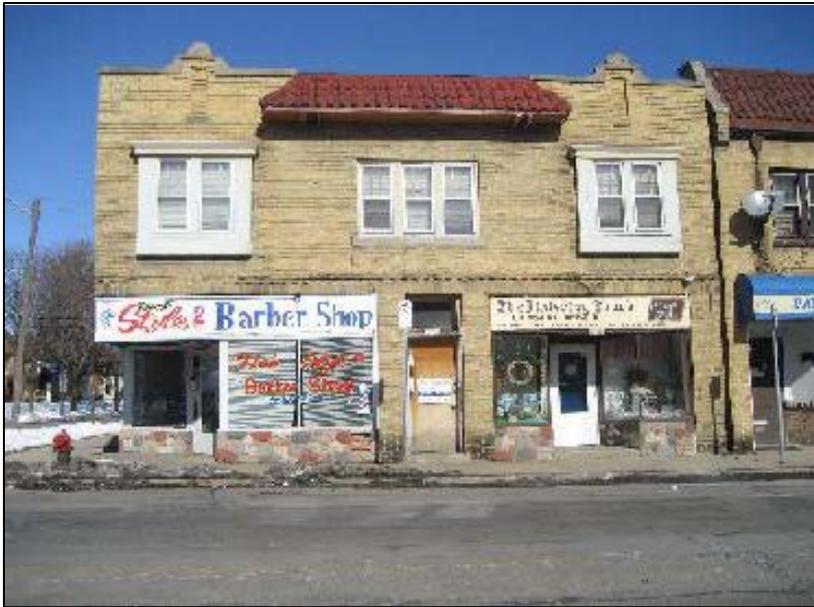
View of project site facing north from W. Center St.

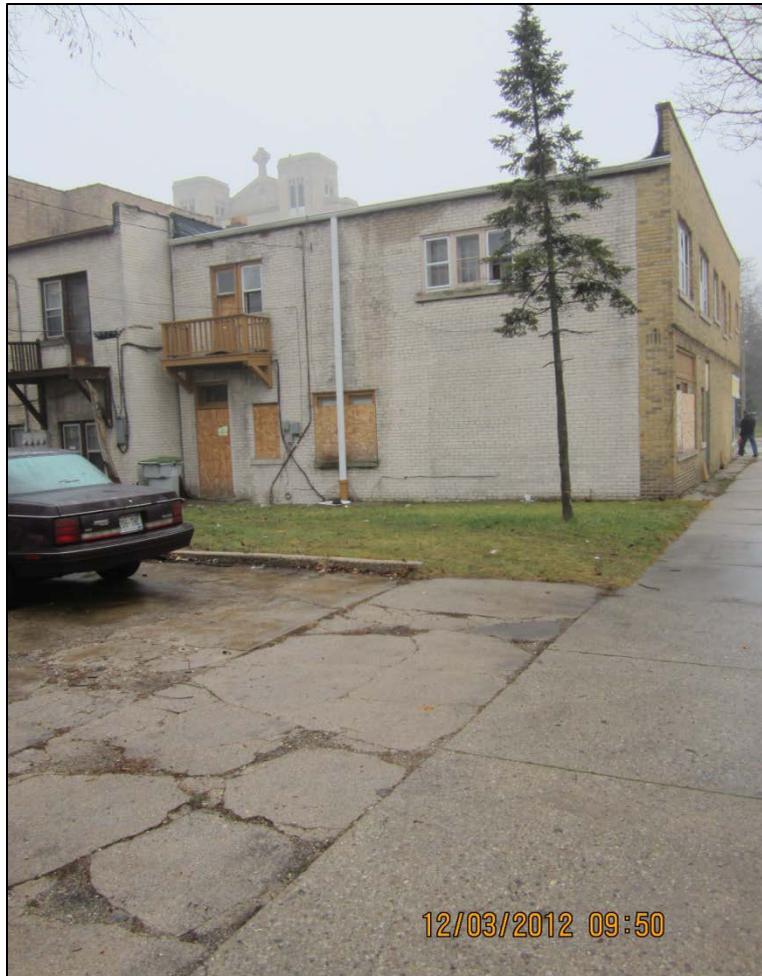
A concrete slab at the rear of the parcel was being used for parking.

**View of project site rear, facing south from N. 52nd St.
The paved parking area previously contained a garage.**

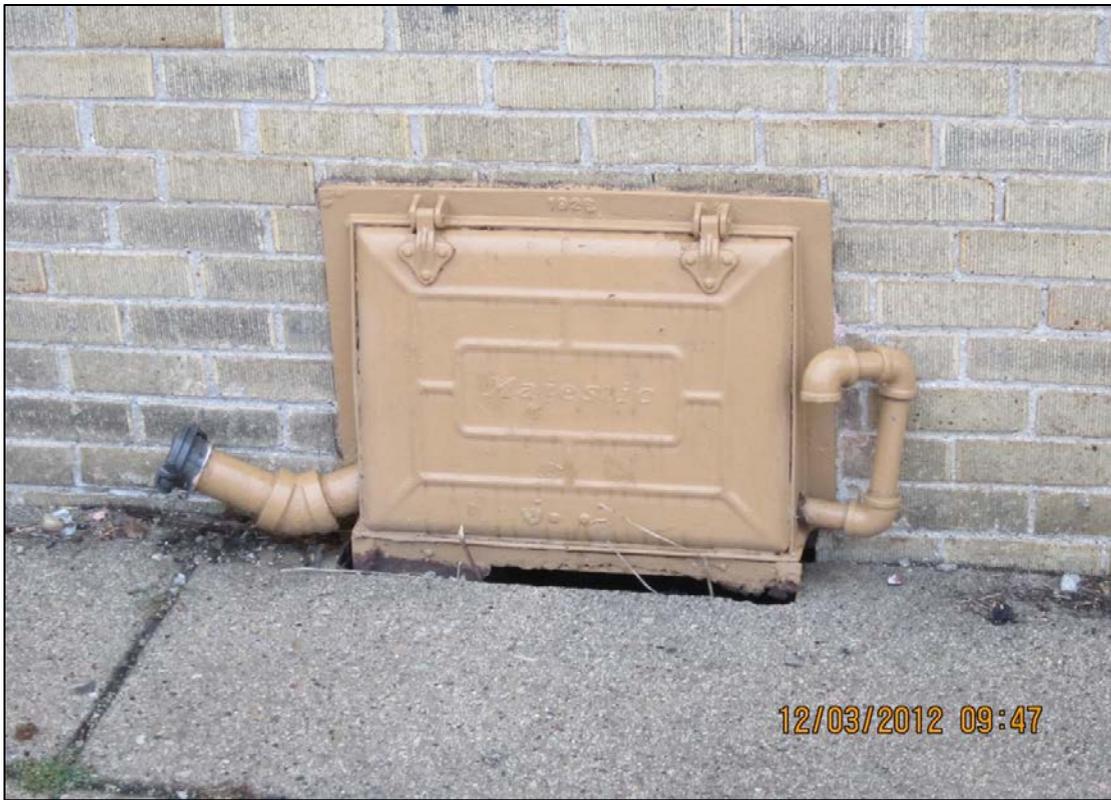
On December 3, 2012, City staff conducted an inspection of the project site. A photographic log of the project site is included as **Attachment A**. The two-story building at the site was boarded, but broken windows were observed at the 5130 W. Center St. storefront and at the rear basement. Vent and fill pipes associated with a fuel oil tank were noted, on the west side of the building along N. 52nd St.

Two oil fill locations were observed on the west building wall, along the N. 52nd St. sidewalk.

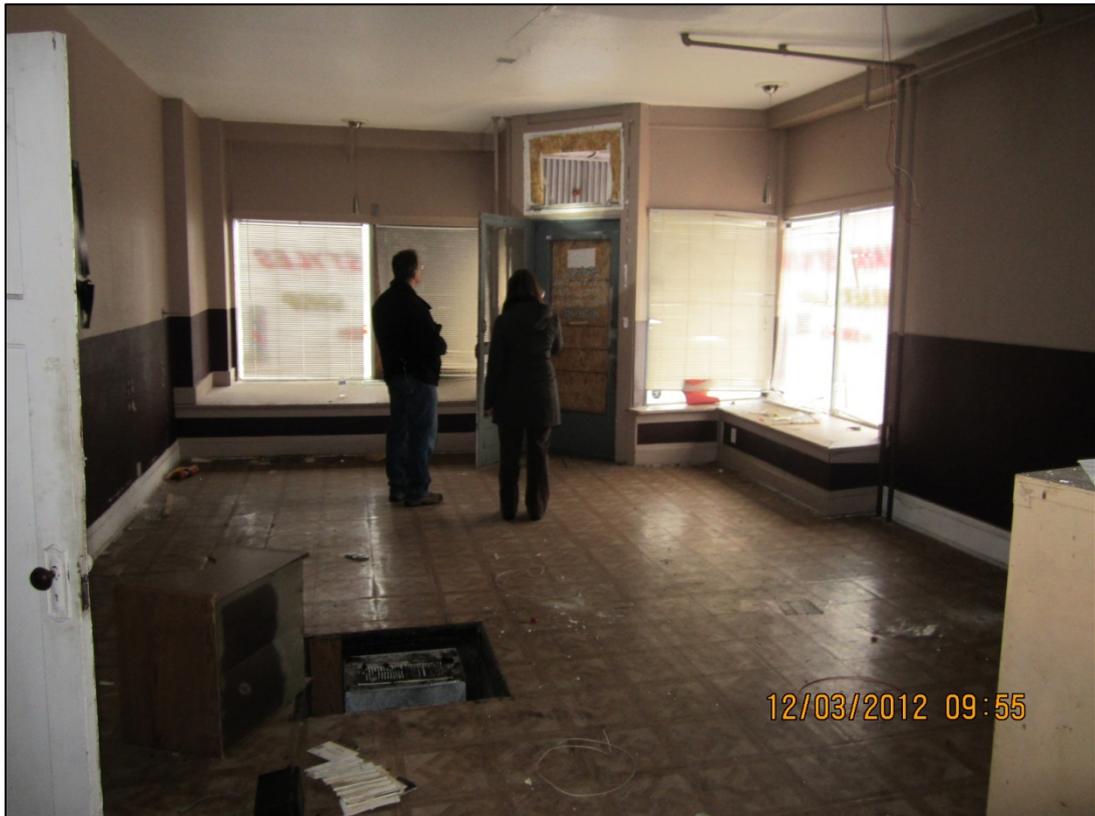
Interior view of the 5130 W. Center St. storefront, last occupied by a barber shop.

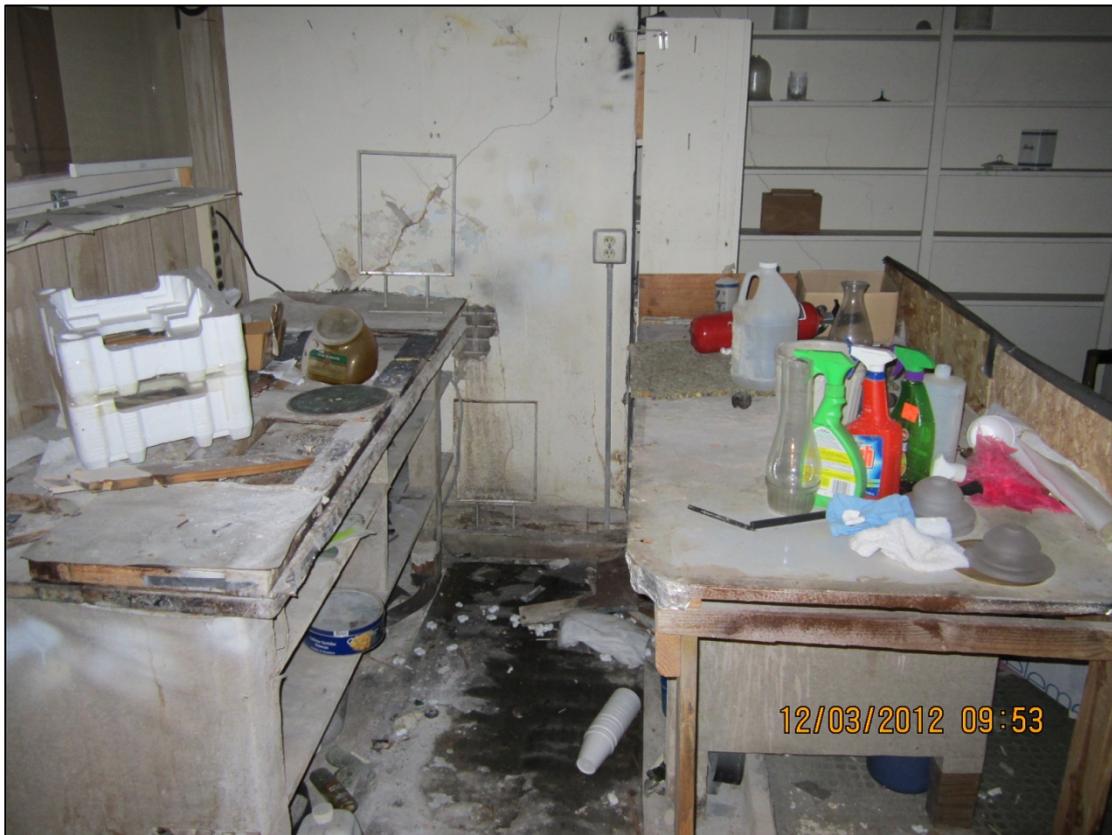
Interior view of the 5128 W. Center St. storefront, last occupied by a glass/crystal repair shop. Small bottles of various chemicals were observed.

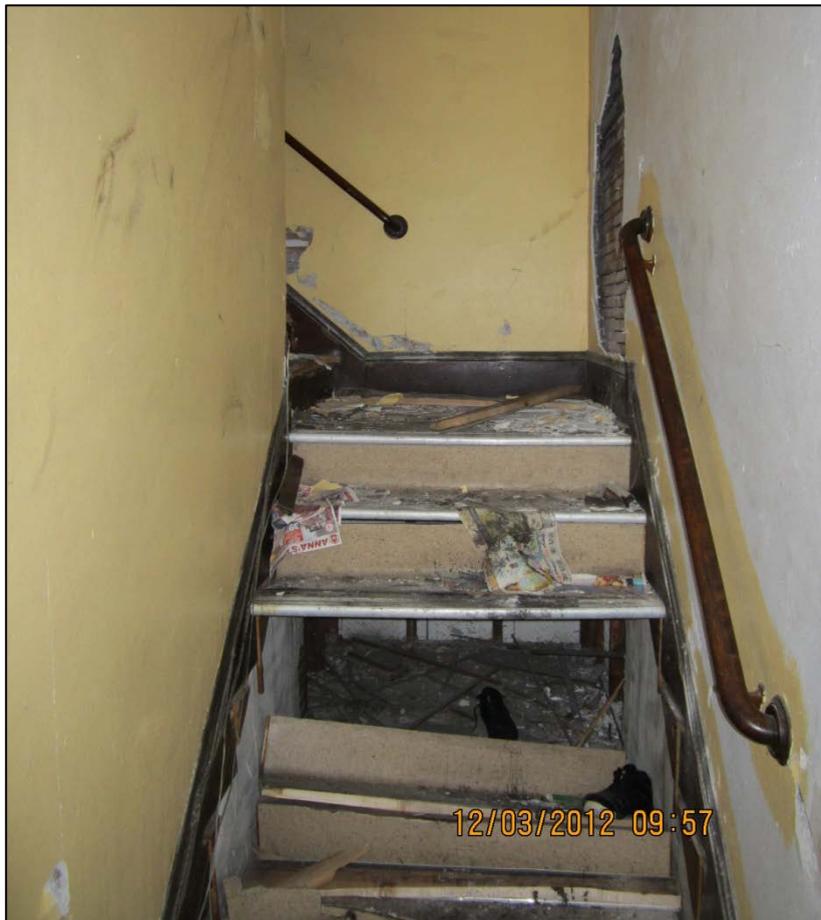
The staircase was in poor condition, prohibiting inspection of the second story.

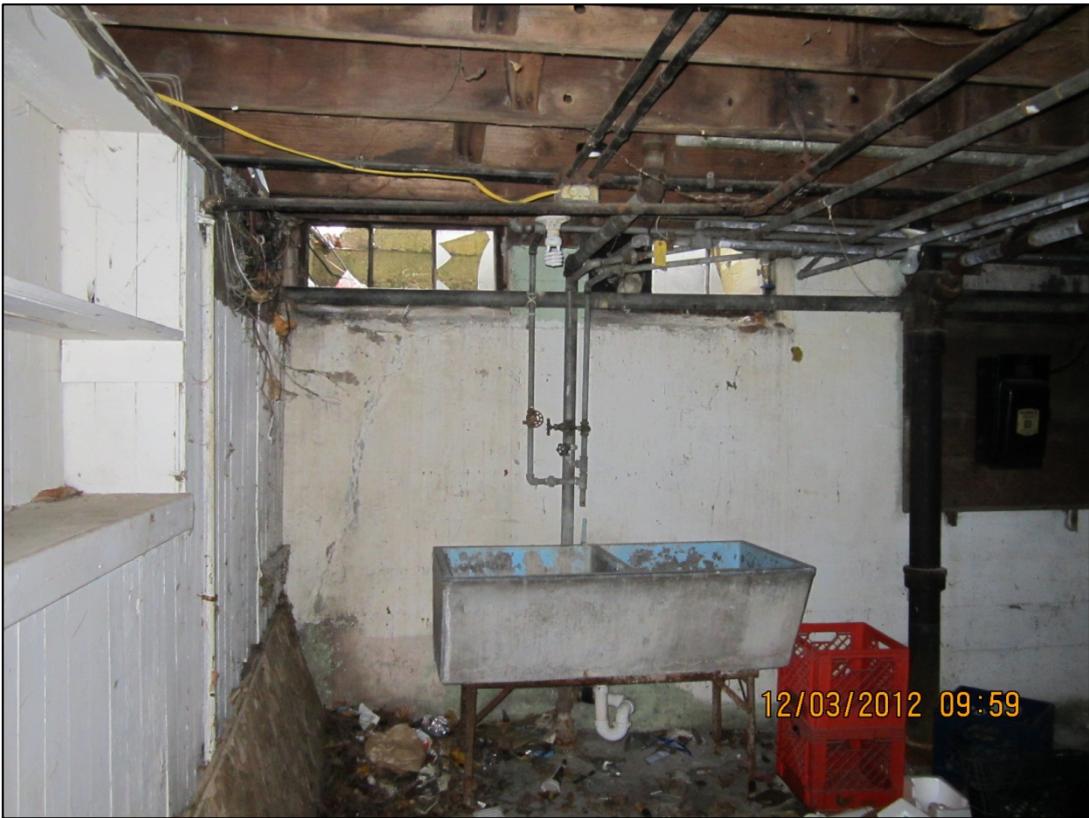
View of the basement's southern wall. Broken windows were observed.

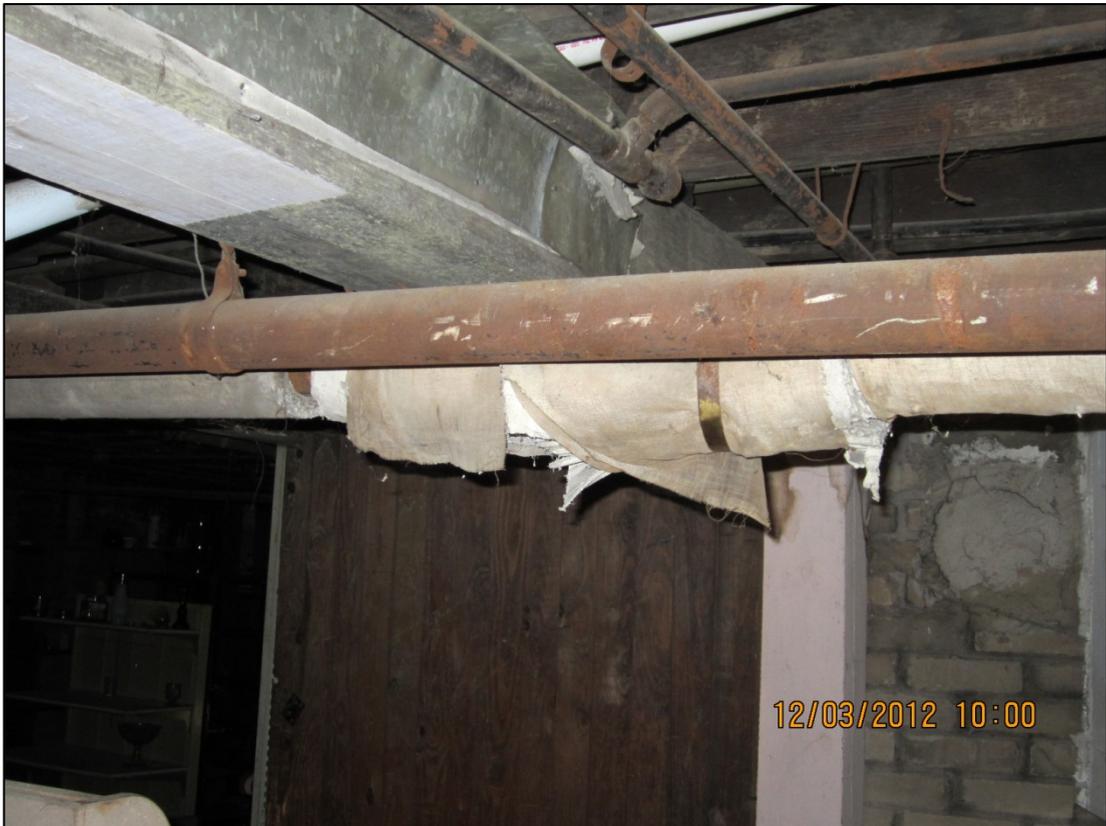
In the basement, two oil tanks were found. The floor surrounding the tanks was littered and what appeared to be ash was observed, but no significant staining was observed. Piping was observed that appeared to contain asbestos.

Piping in basement may contain asbestos.

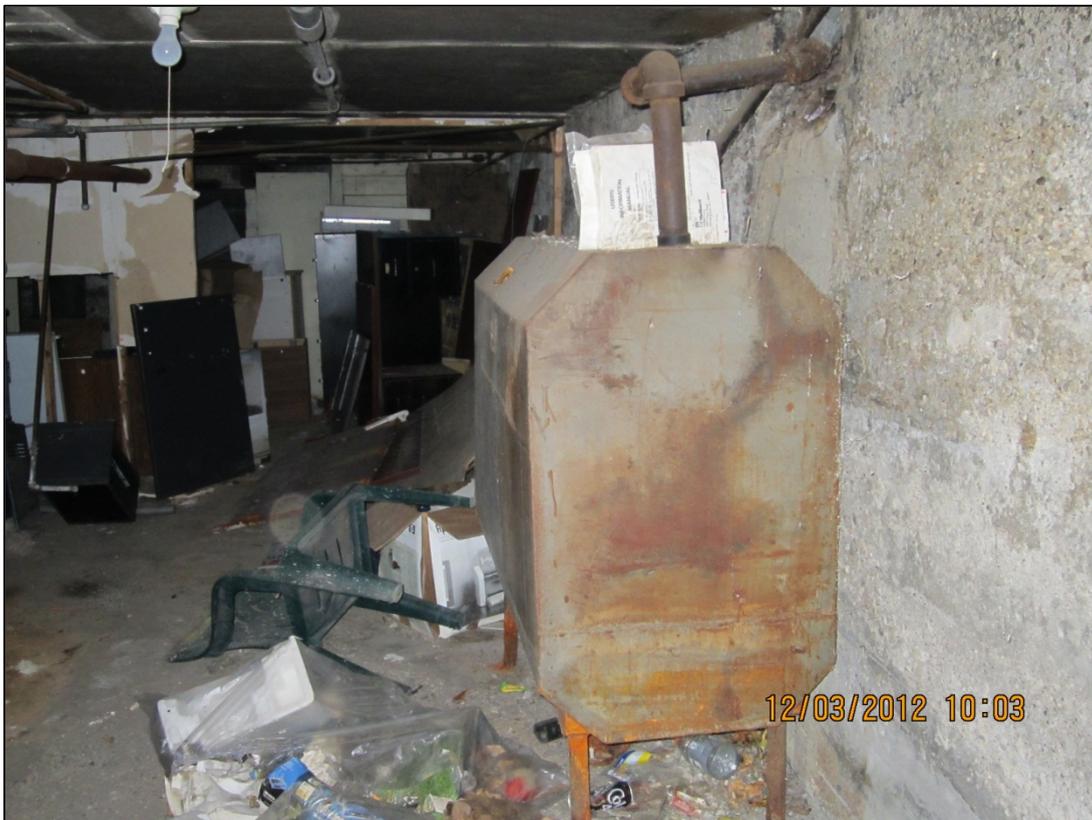
One of two oil tanks observed. Tanks were in alignment with the fill locations along N. 52nd St.

- The fuel oil tanks should be removed and properly disposed.

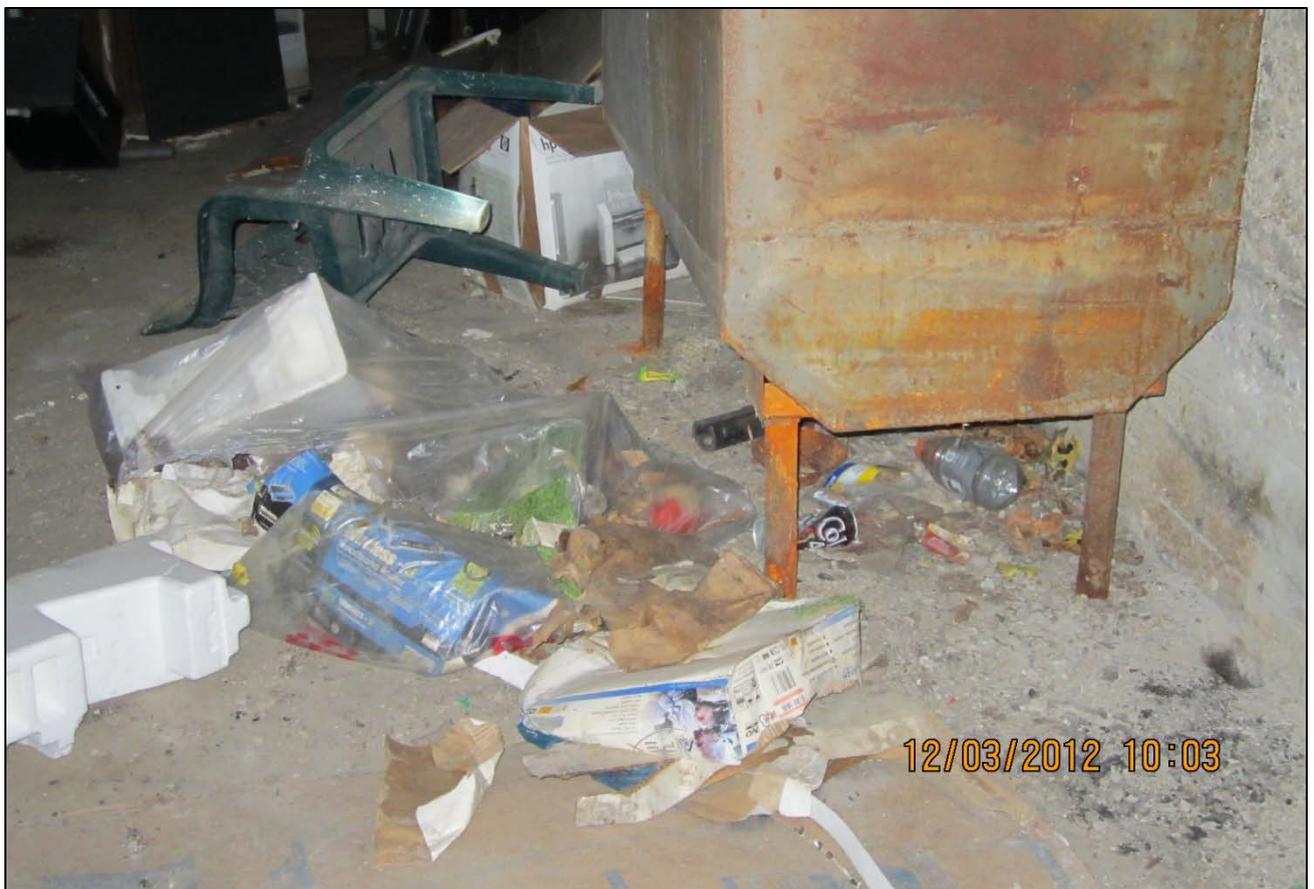
Visible staining was not noted on the floor. Ash was present in this floor area.

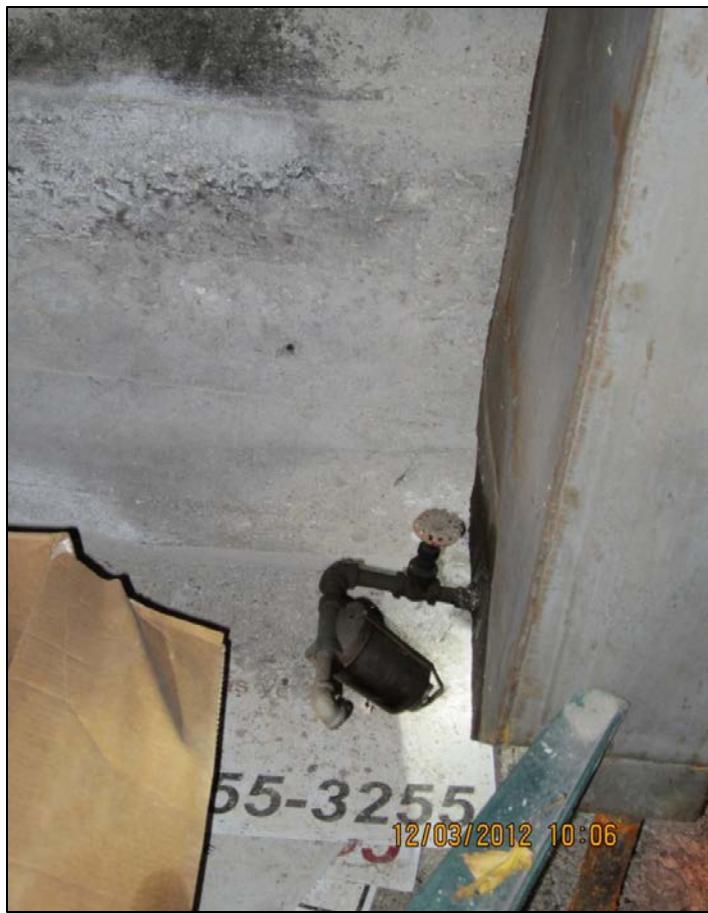
Second oil tank observed at the project site.

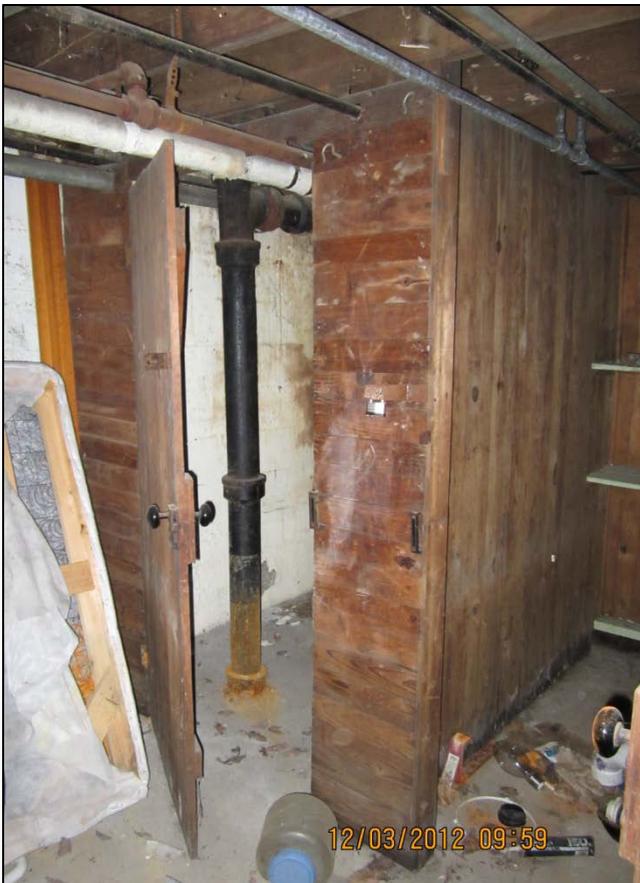
View of piping; connection & use undetermined.

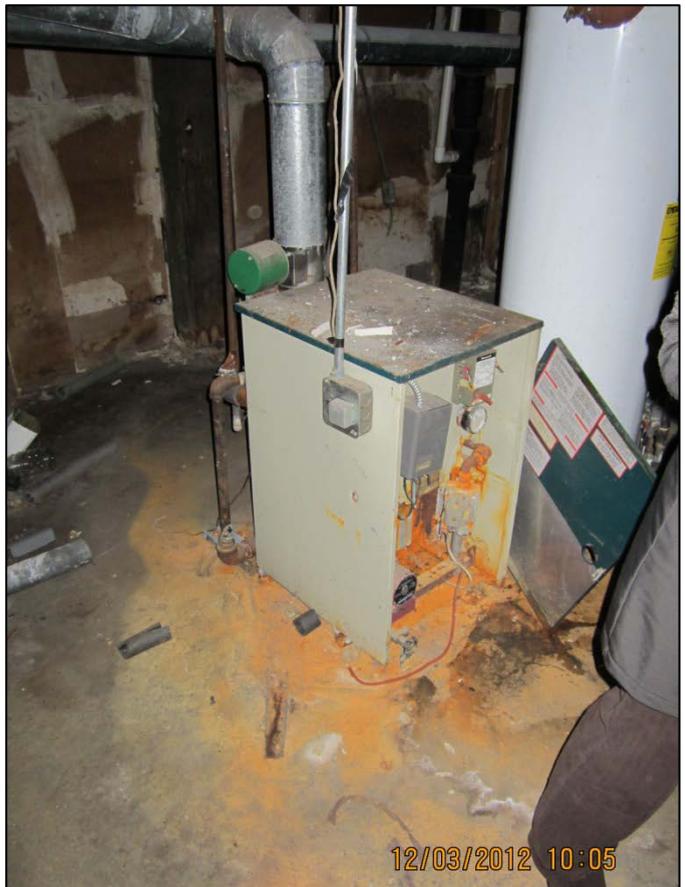
View of basement conditions.
