**Historical Land Use Investigation**  
5725 West Burleigh Street  
Milwaukee, Wisconsin

File: 306-25

**Department of City Development**

September 18, 2015

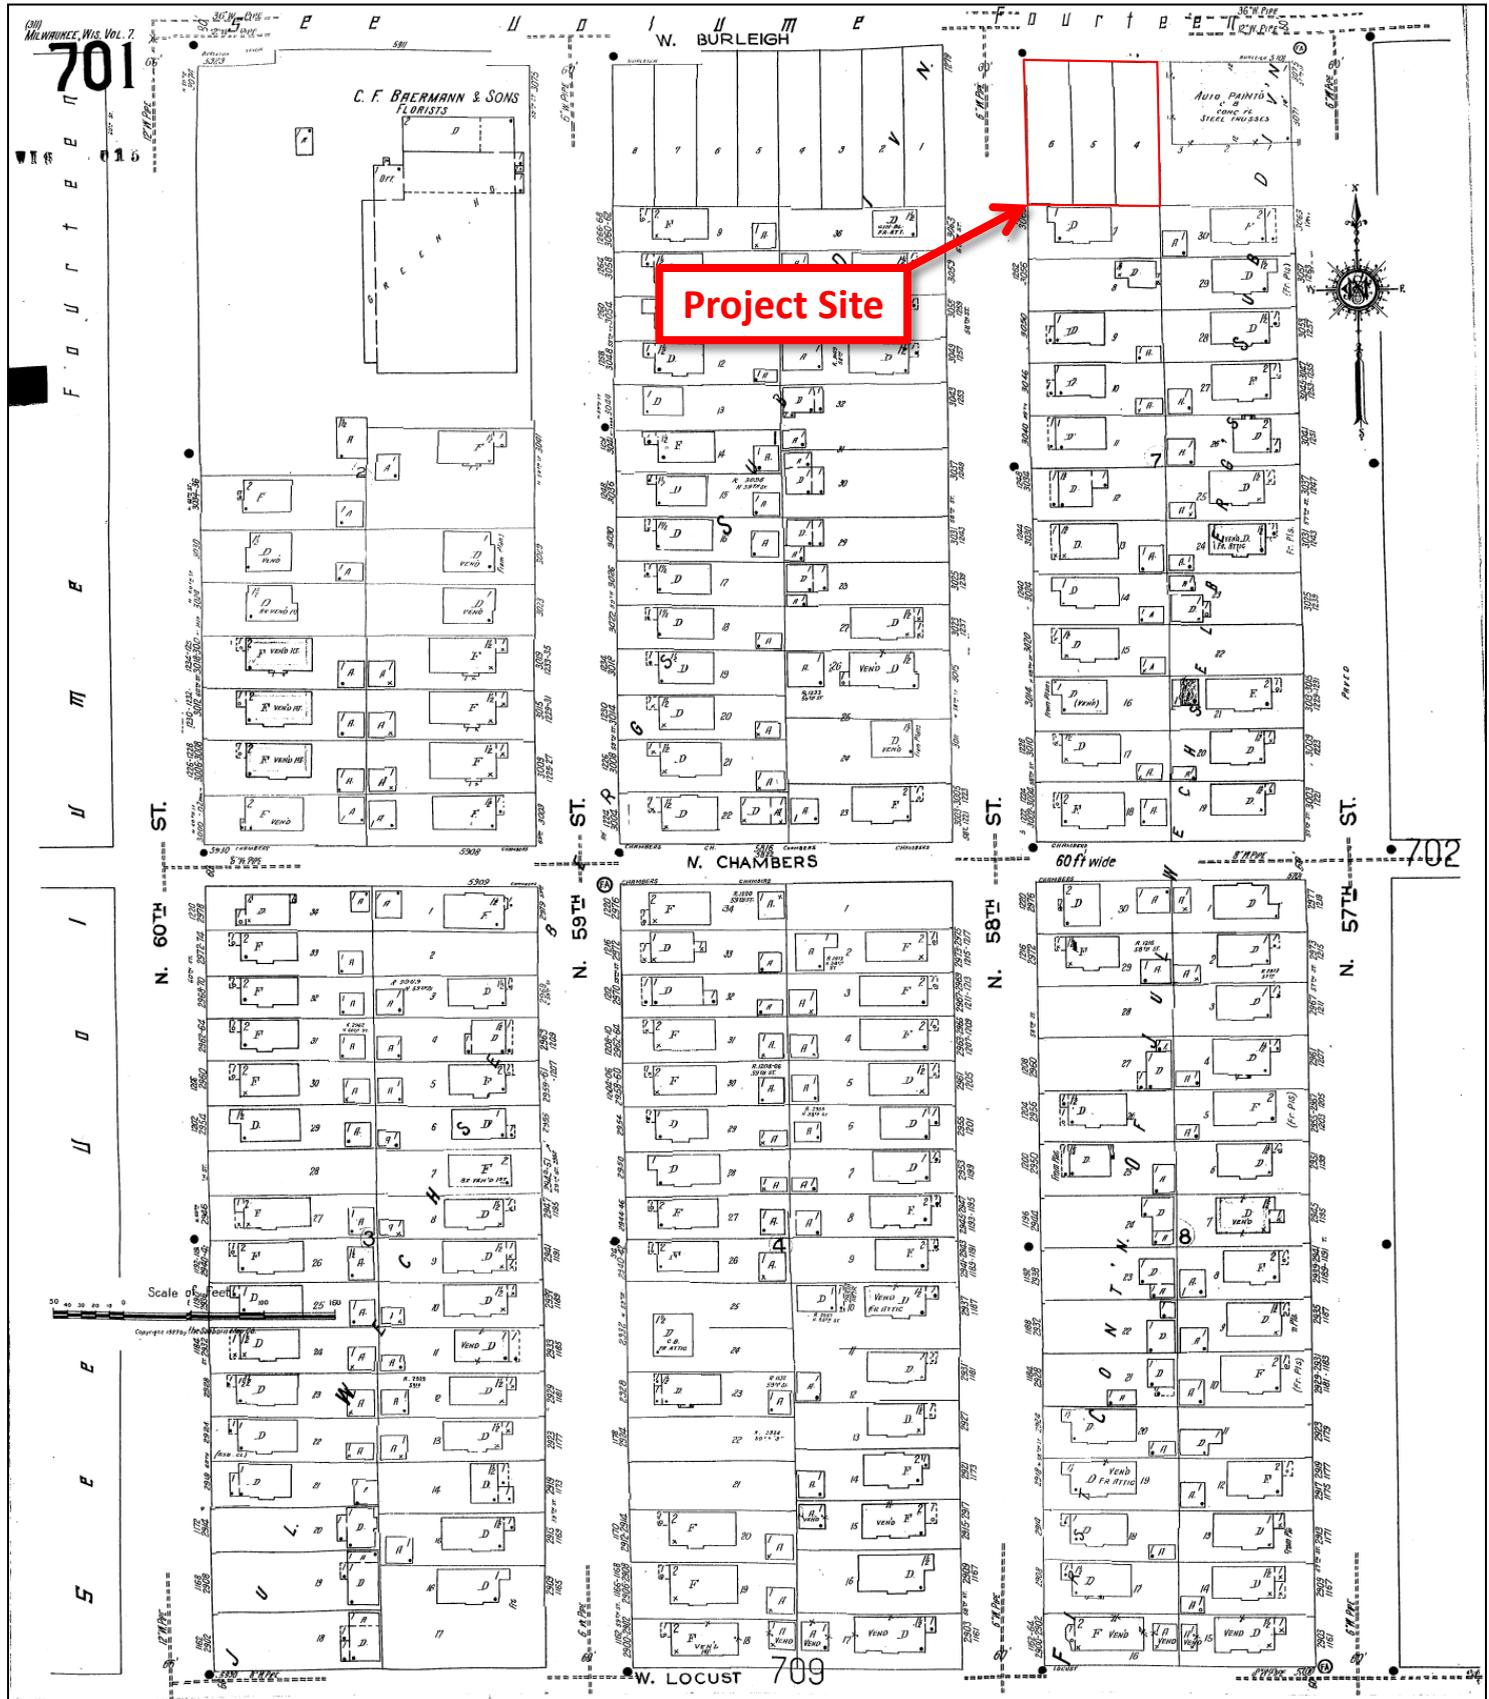
**FIGURE 5**  
**1951 Sanborn Fire Insurance Map**  
**5725 W. Burleigh Street, Milwaukee, WI**

1. A 1910 (*with updates through 1937*) Sanborn Fire Insurance Map shows the project site undeveloped. The map shows other undeveloped parcels and residential buildings surrounding the project site (**Figure 4**).
2. A 1910 (*with updates through 1951*) Sanborn Fire Insurance Map shows the project site with the same general features as the 1910 map. The map shows an automobile painting business and other residential buildings surrounding the project site (**Figure 5**).
3. A 1969 Sanborn Fire Insurance Map shows the project site occupied by a two-story building occupied by a sign factory and a dwelling, two adjoining one-story additions, and a one-story structure made of iron. The map shows an automobile painting business and other residential buildings surrounding the project site (**Figure 6**).

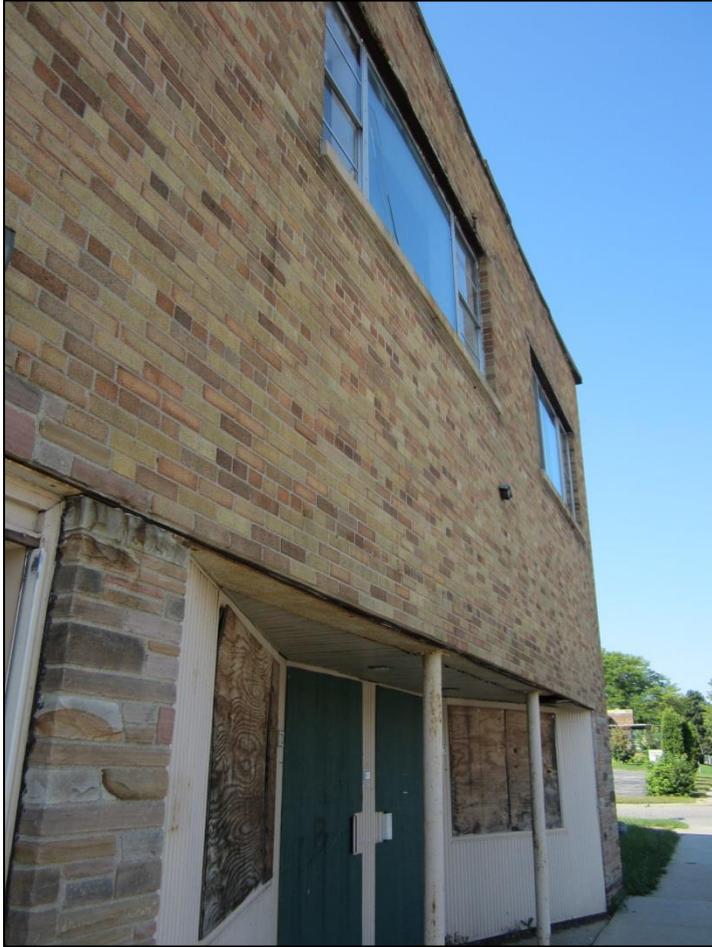
Front view of project site facing south (09/16/2015)

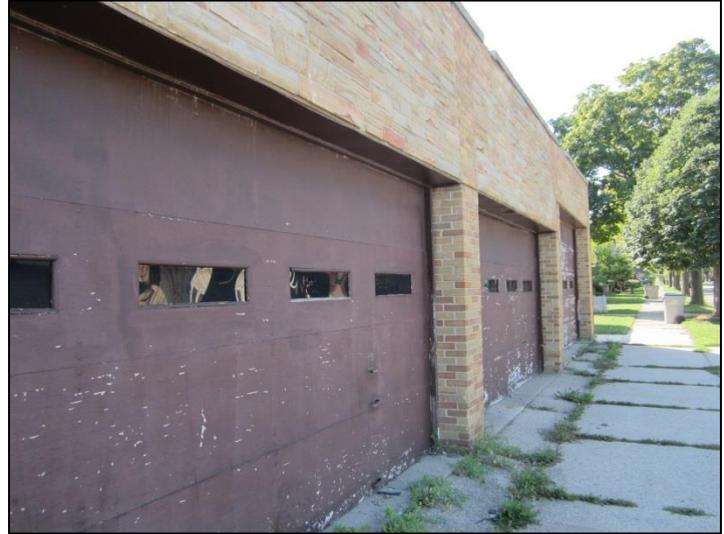
Side view of project site facing southeast (09/16/2015)

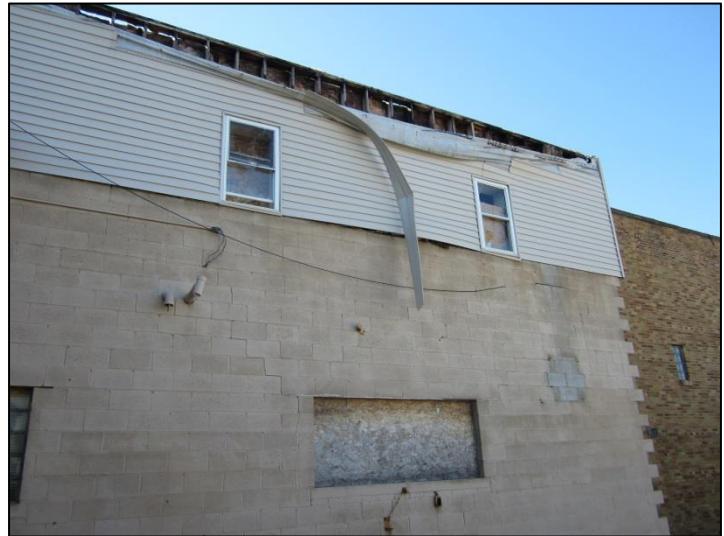
Side view of project site facing west (09/16/2015)

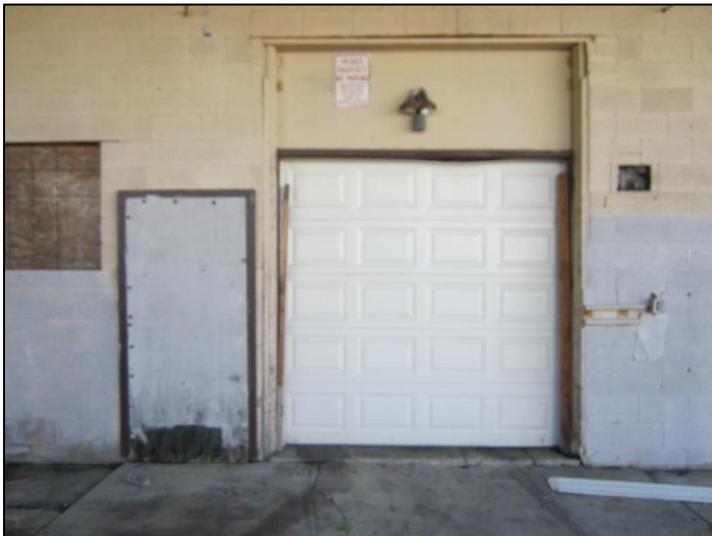
Side view of project site facing west (09/16/2015)

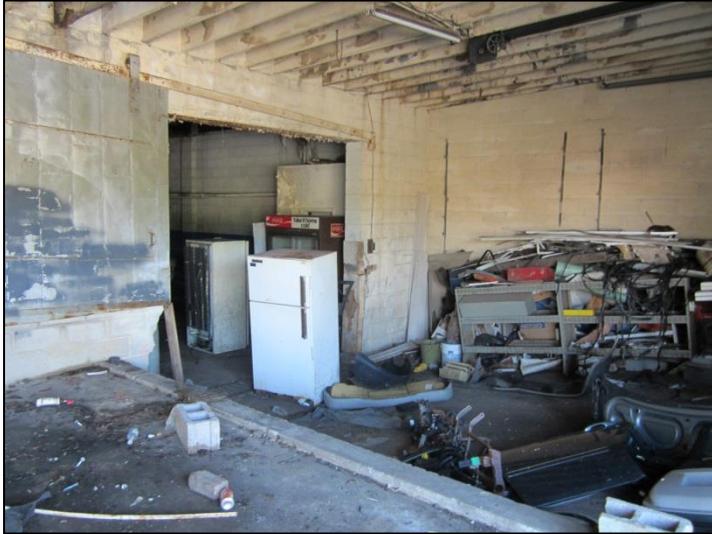
First-floor view of project site (09/16/2015)

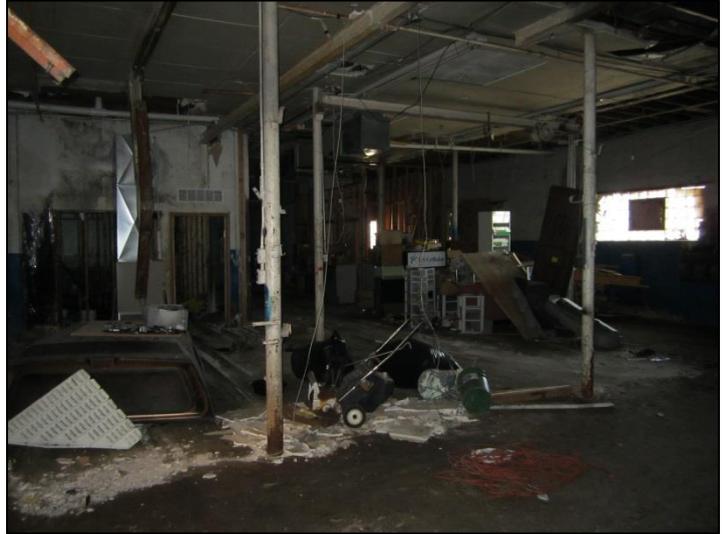
First-floor view of project site (09/16/2015)

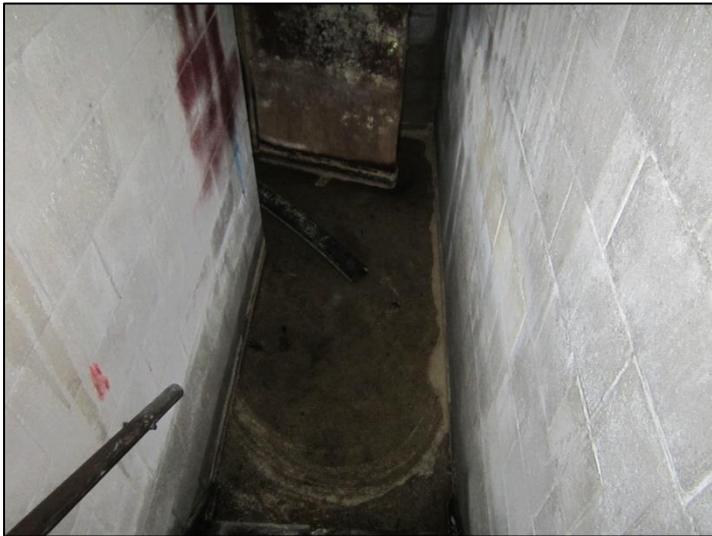
Basement view of project site (09/16/2015)

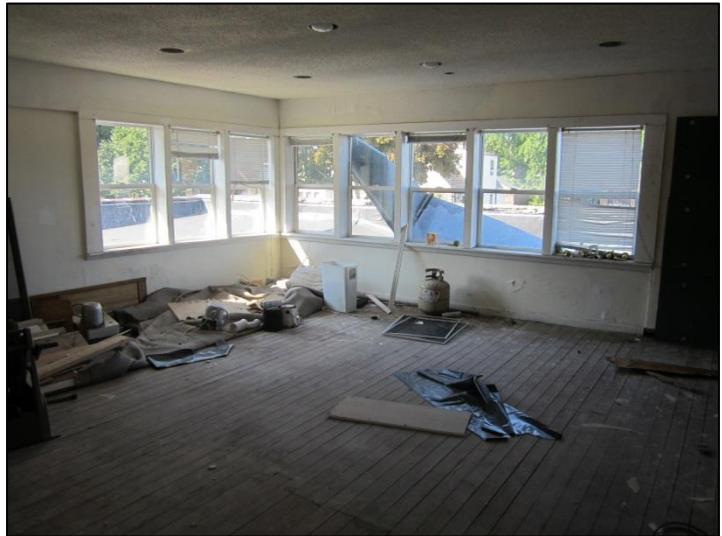
Second-floor view of project site (09/16/2015)
