Mr. Anthony Fahres
City of Milwaukee Water Engineering M029
3850 N. 35th Street, Room 235
Milwaukee, WI 53216

Sample Identification - **(2) Segments of Failed 16" Diameter Cast Iron Water Pipe**

Project Number: P20-0162

Objective: We were requested to perform chemical analysis, mechanical testing and microstructural evaluation of the failed pipe sections. We were further requested to comment on any material conditions that may have contributed to the failure of the pipe.

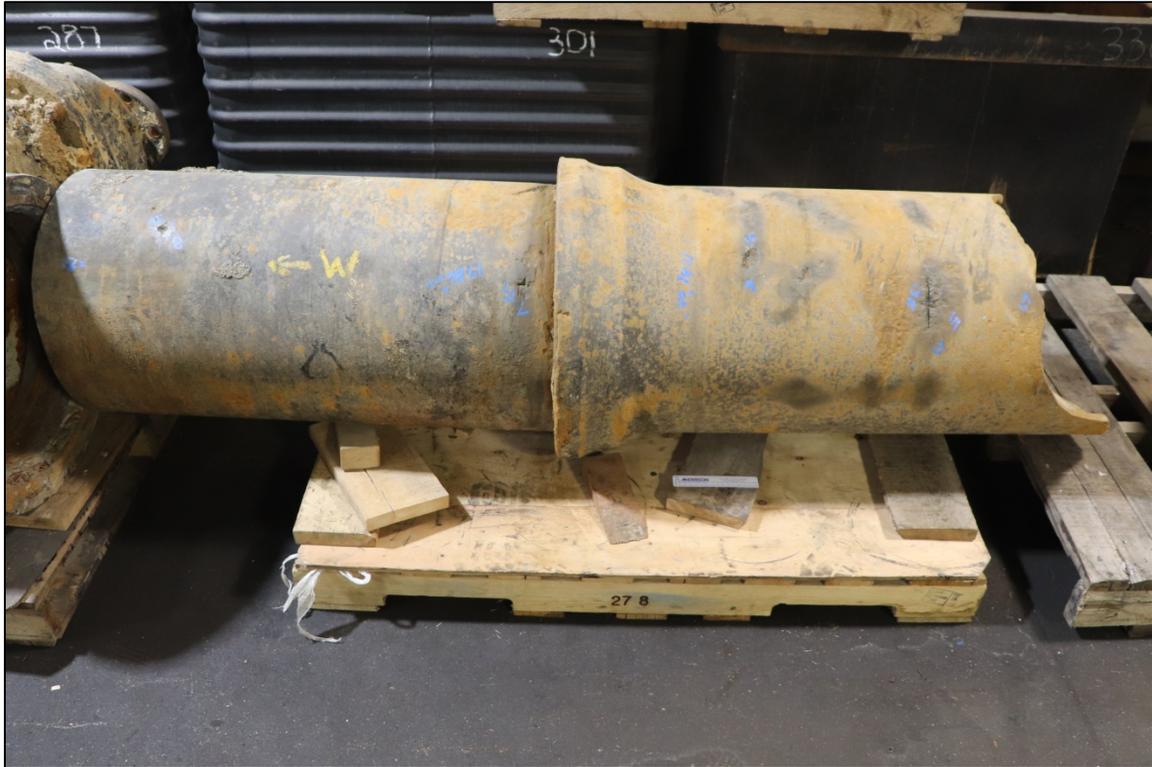
City of Milwaukee Water Engineering M029
Failed 16" Diameter Cast Iron Water Pipe: Pipe #1
Image #1

Two segments of the failed water pipe were submitted. The pipe #1 segment exhibited an irregular transverse fracture of the pipe at one end with a saw cut at the opposite end (see Image #1). The pipe #2 segment exhibited an irregular transverse fracture on one end along with a longitudinal fracture splitting the pipe lengthwise and a T-joint fitting at the opposite end (see Images #2 and #3).

Pipe #1 is shown as it was received for evaluation. The fractured end is to the right; the cut end to the left.

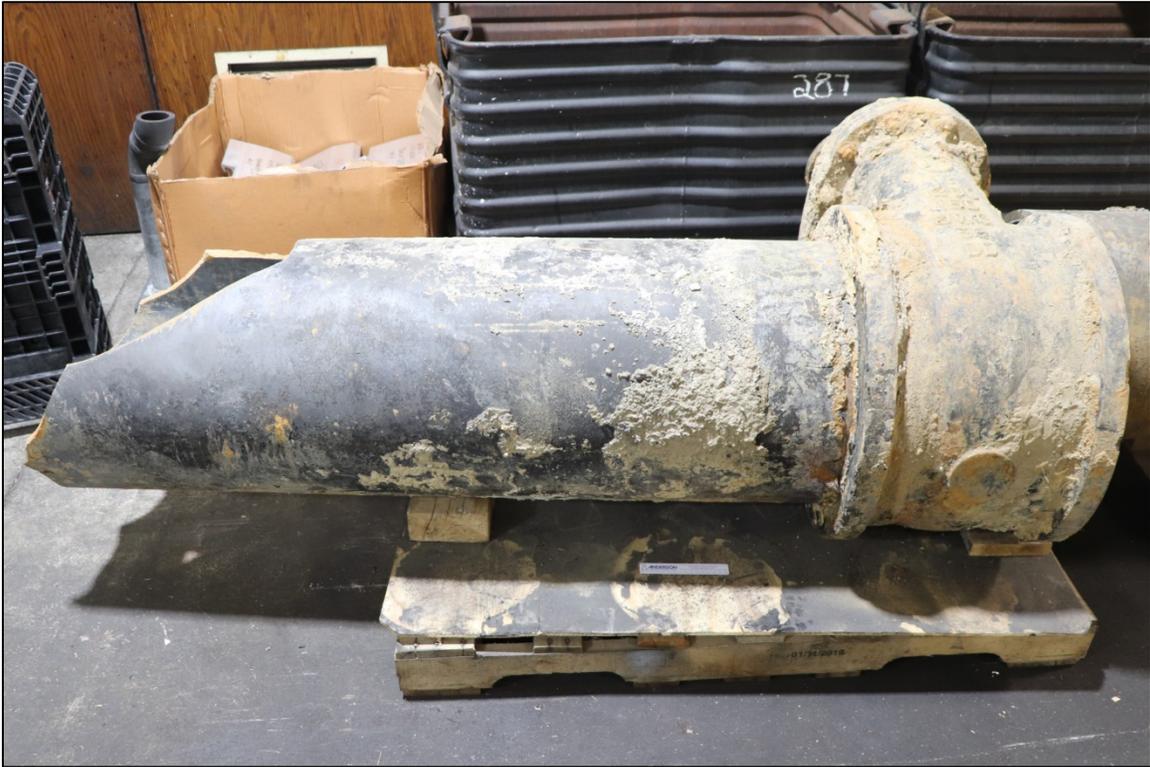
City of Milwaukee Water Engineering M029
Failed 16" Diameter Cast Iron Water Pipe: Pipe #2
Image #2

Pipe #2 is shown as it was received for evaluation. The fractured end is to the left.

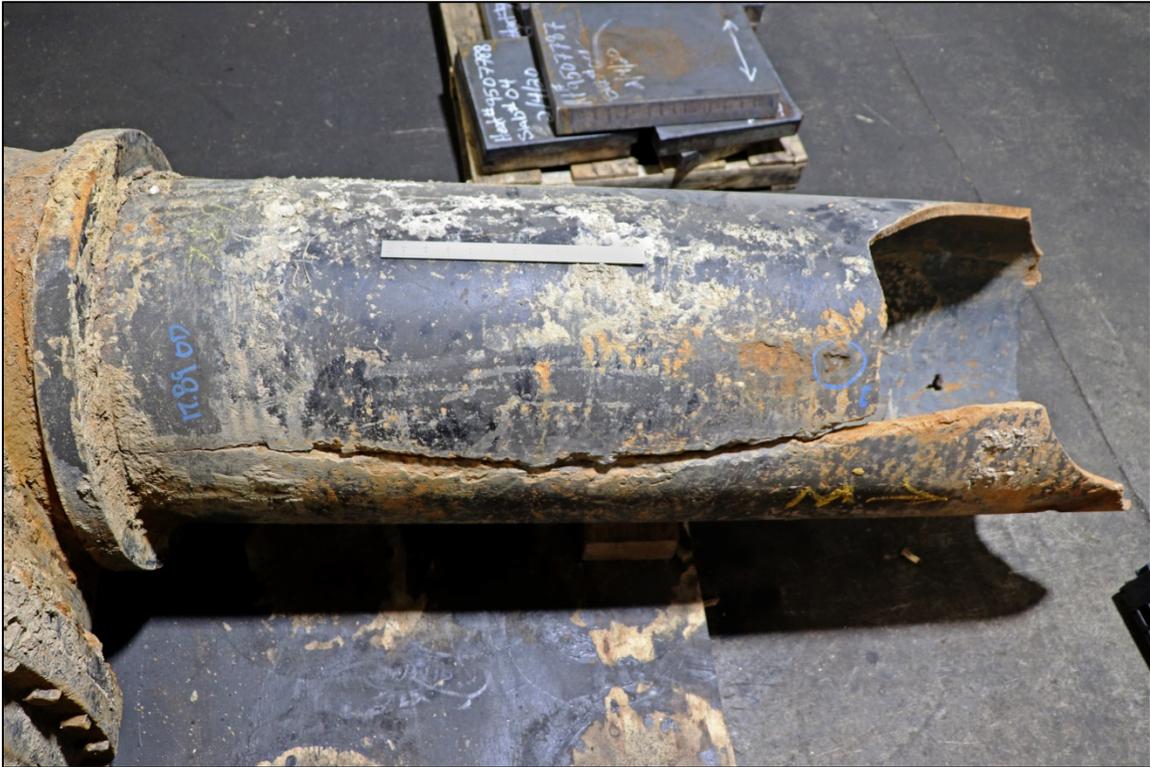
City of Milwaukee Water Engineering M029
Failed 16" Diameter Cast Iron Water Pipe: Pipe #2
Image #3

Although the pipe microstructure is especially susceptible to fracture from impact, longitudinal cracks in water pipes are typically the result of high water pressure or compressive stress from the top (surface) or side. Surface compressive stress often causes longitudinal cracking on both sides of a pipe. Either side compressive stress or

water pressure may have contributed to the failure of the pipe whose fracture resistance was compromised by the poor microstructure and the corrosive attack.

The longitudinal fracture is shown in the as-received pipe #2.

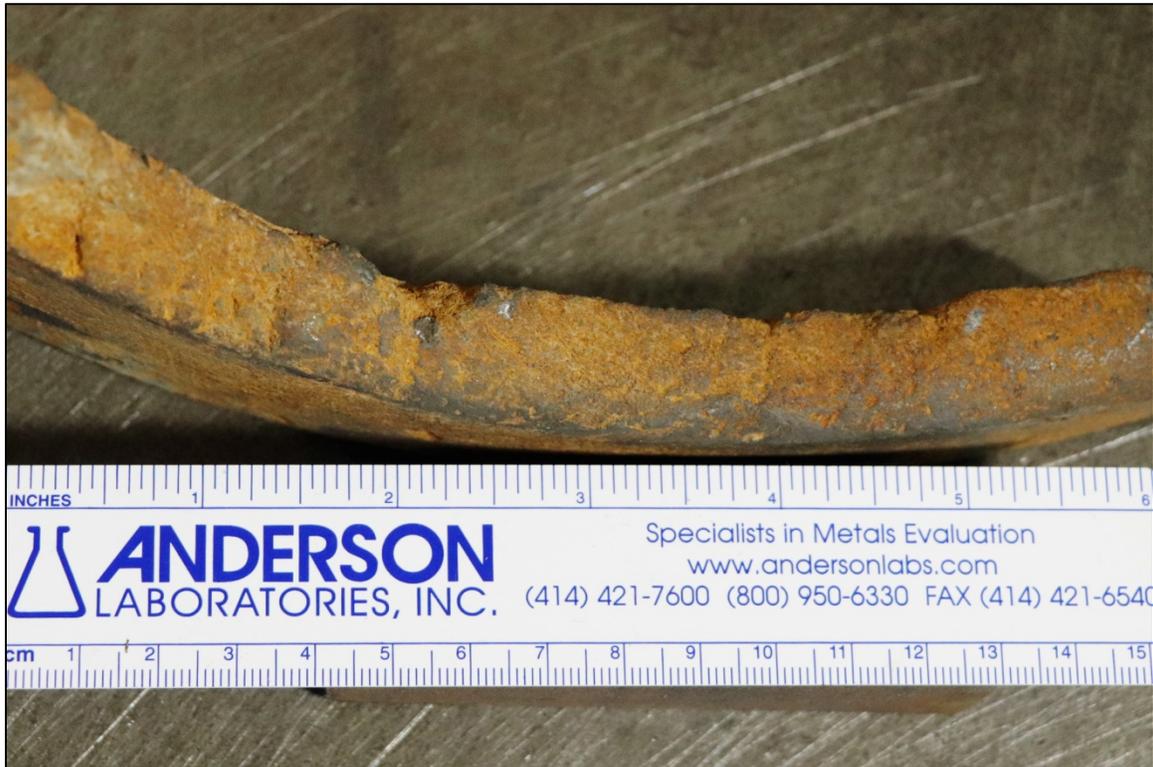
City of Milwaukee Water Engineering M029
Failed 16" Diameter Cast Iron Water Pipe: Pipe #2
Image #4

The transverse fracture surfaces on both ends as well as along the longitudinal fracture exhibited post-fracture rust-type corrosive attack, adherent soil, and various amount of mechanical damage (see Image #4). This post-fracture damage to the fracture surfaces prevented determination of the fracture origin(s), fracture mode, and the direction of fracture propagation.

The image shows the condition of the fracture faces found on both pipe segments. Post-fracture rust-type corrosive attack, adherent soil, and various amount of mechanical damage are present.

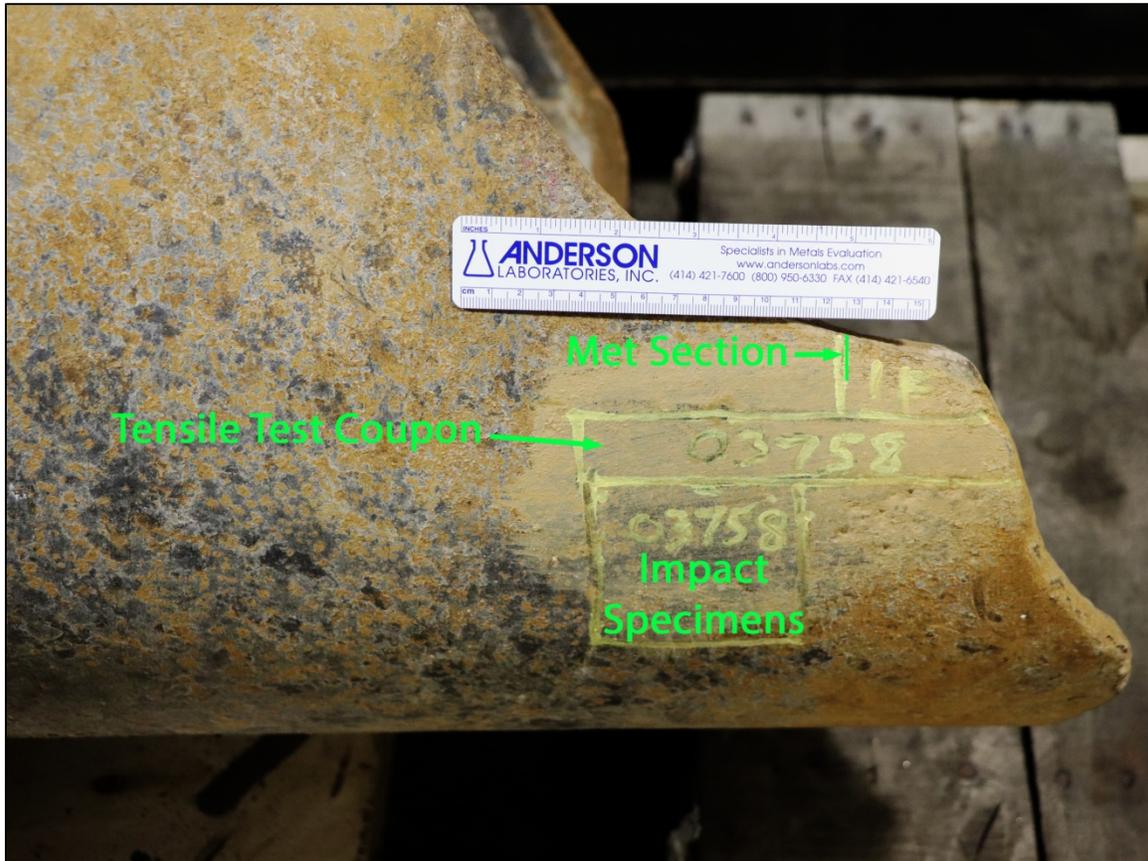
City of Milwaukee Water Engineering M029
Failed 16" Diameter Cast Iron Water Pipe: Pipe #1
Image #5

The locations of the tensile test coupon, impact test specimens, and the metallographic section are indicated near the fracture on pipe #1.

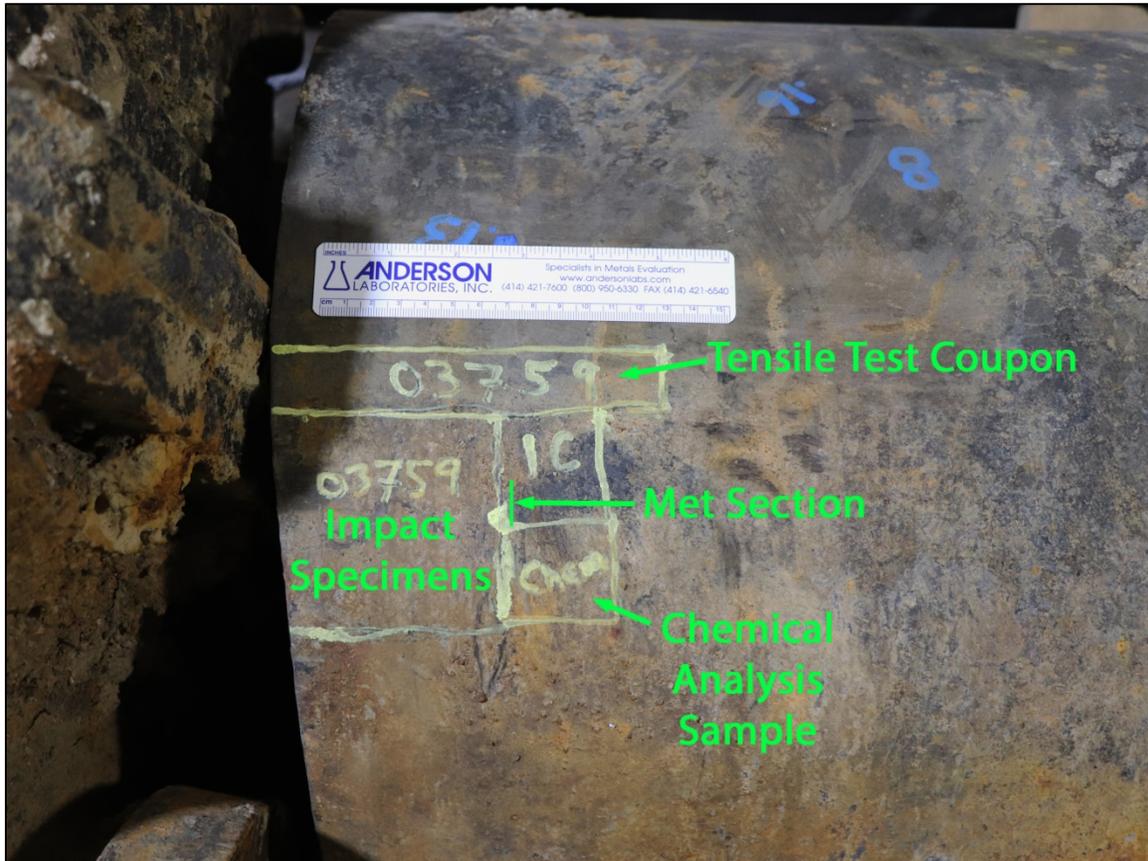
City of Milwaukee Water Engineering M029
Failed 16" Diameter Cast Iron Water Pipe: Pipe #1
Image #6

The locations of the tensile test coupon, impact test specimens, metallographic section, and chemical analysis sample are indicated near the cut end on pipe #1.

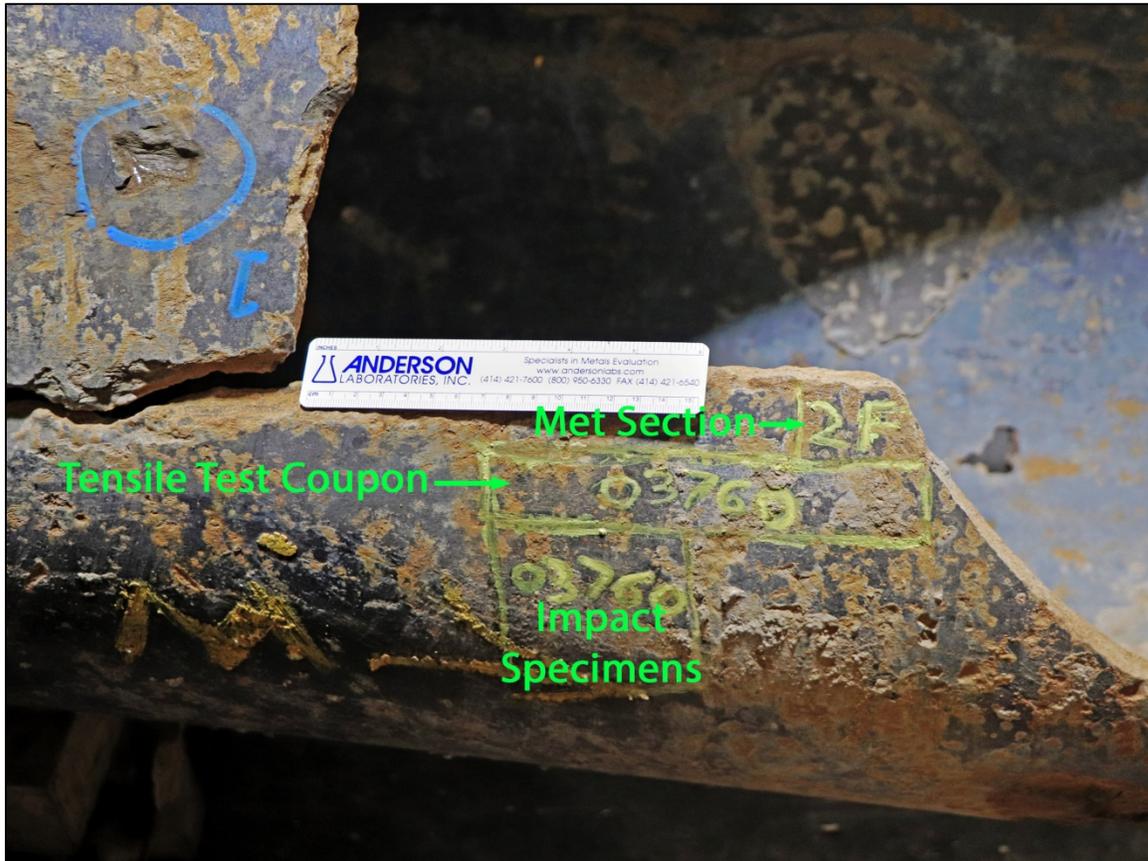
City of Milwaukee Water Engineering M029
Failed 16" Diameter Cast Iron Water Pipe: Pipe #2
Image #7

The locations of the tensile test coupon, impact test specimens, and the metallographic section are indicated near the fracture on pipe #2.

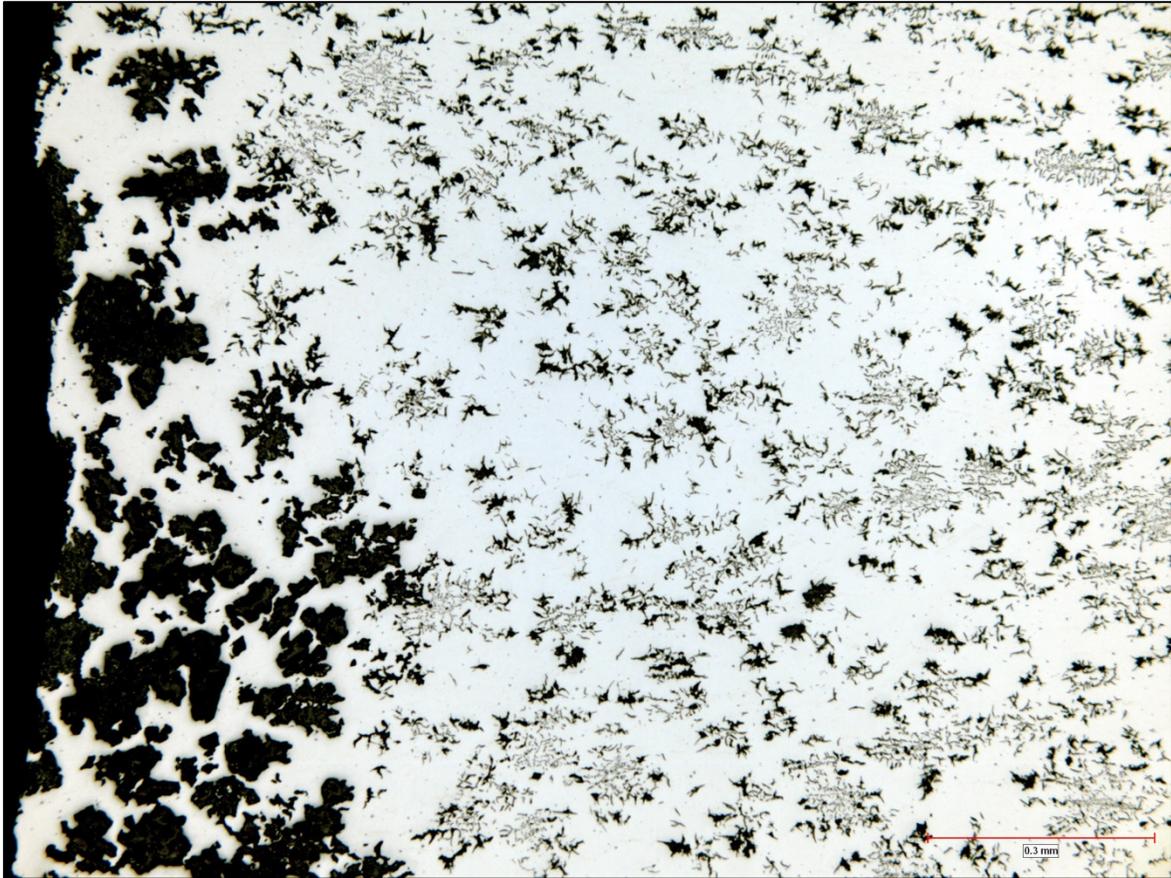
Image #8

The corrosive attack to the OD surface of the pipe was found to a depth of 0.023" in the examined sections. This corrosive attack would have provided stress concentrating sites susceptible to fracture initiation.

The image shows the typical graphite structure from the OD surface (left) near the fracture of pipe #2: predominantly Type B graphite flakes. Corrosive attack is propagating from the OD surface.

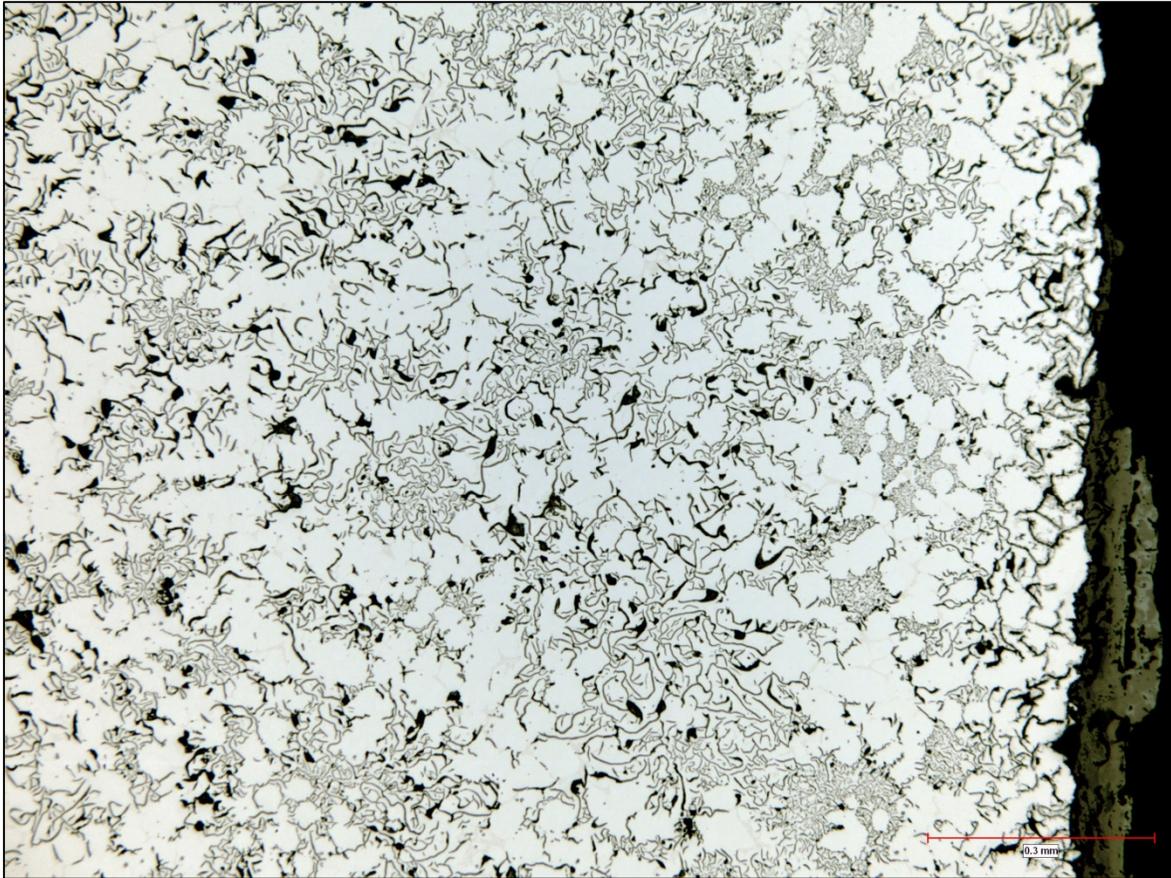
City of Milwaukee Water Engineering M029
Failed 16" Diameter Cast Iron Water Pipe: Pipe #2 ID Surface Near Fracture
Image #9

The image shows the typical graphite structure from the ID surface (right) near the fracture of pipe #2: predominantly Type B graphite flakes.

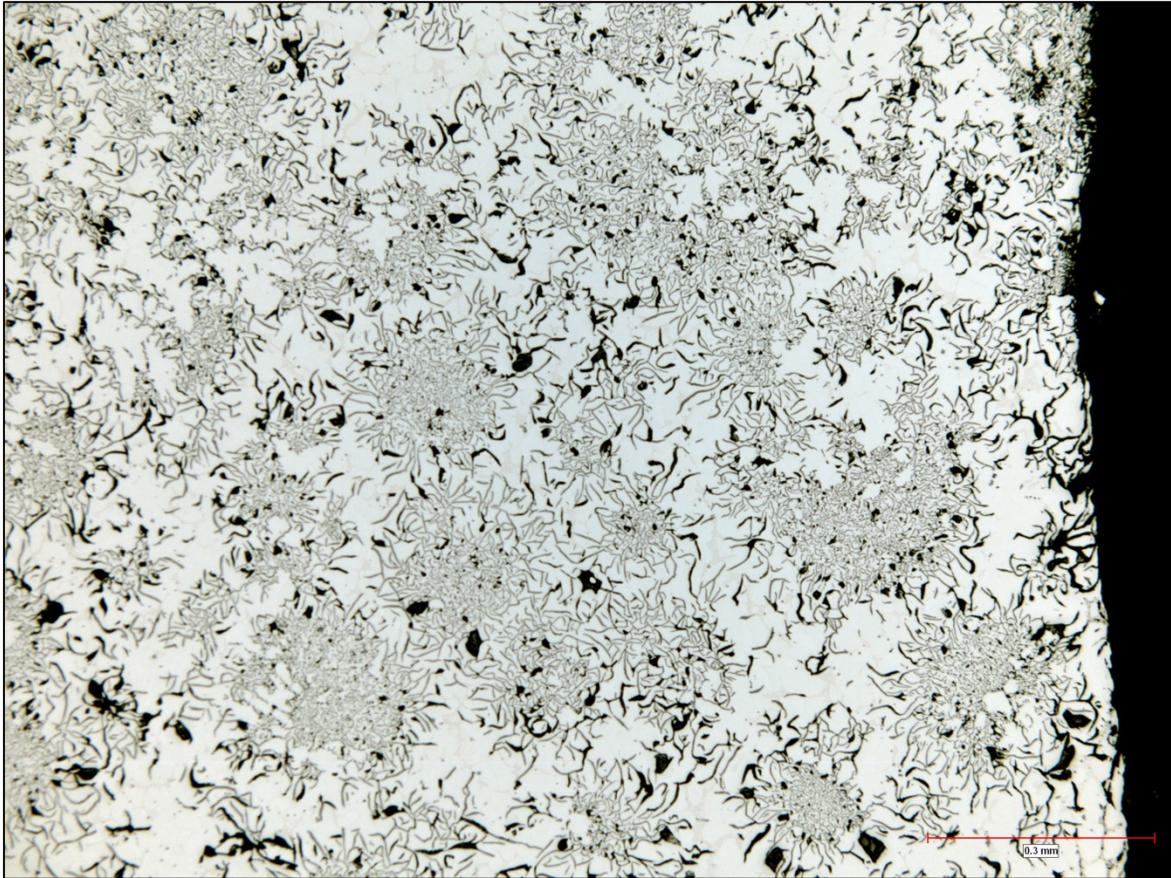
City of Milwaukee Water Engineering M029
Failed 16" Diameter Cast Iron Water Pipe: Pipe #2 Centerline Near Fracture
Image #10

The image shows the typical graphite structure from the centerline of pipe #2 at the fracture face (right): predominantly Type B graphite flakes. Post-fracture mechanical damage has smoothed the fracture surface

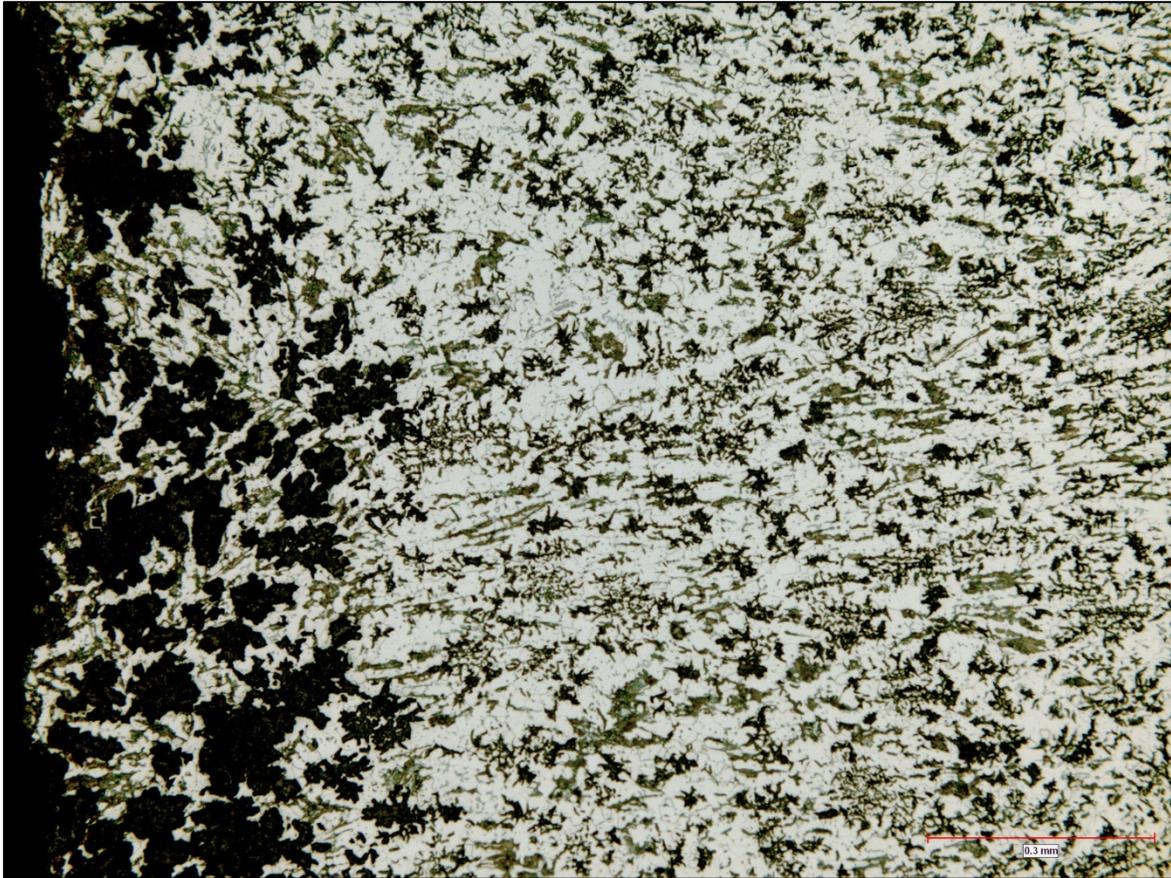
Image #11

Etching the section of pipe #2 from near the fracture with Nital revealed approximately 5-20% pearlite along with carbides and steadite across the pipe wall thickness (see Images #11 through #13).

The image shows the typical graphite structure and matrix microstructure from the OD surface (left) near the fracture of pipe #2: predominantly Type B graphite flakes in a matrix of pearlite, ferrite, steadite, and carbides.

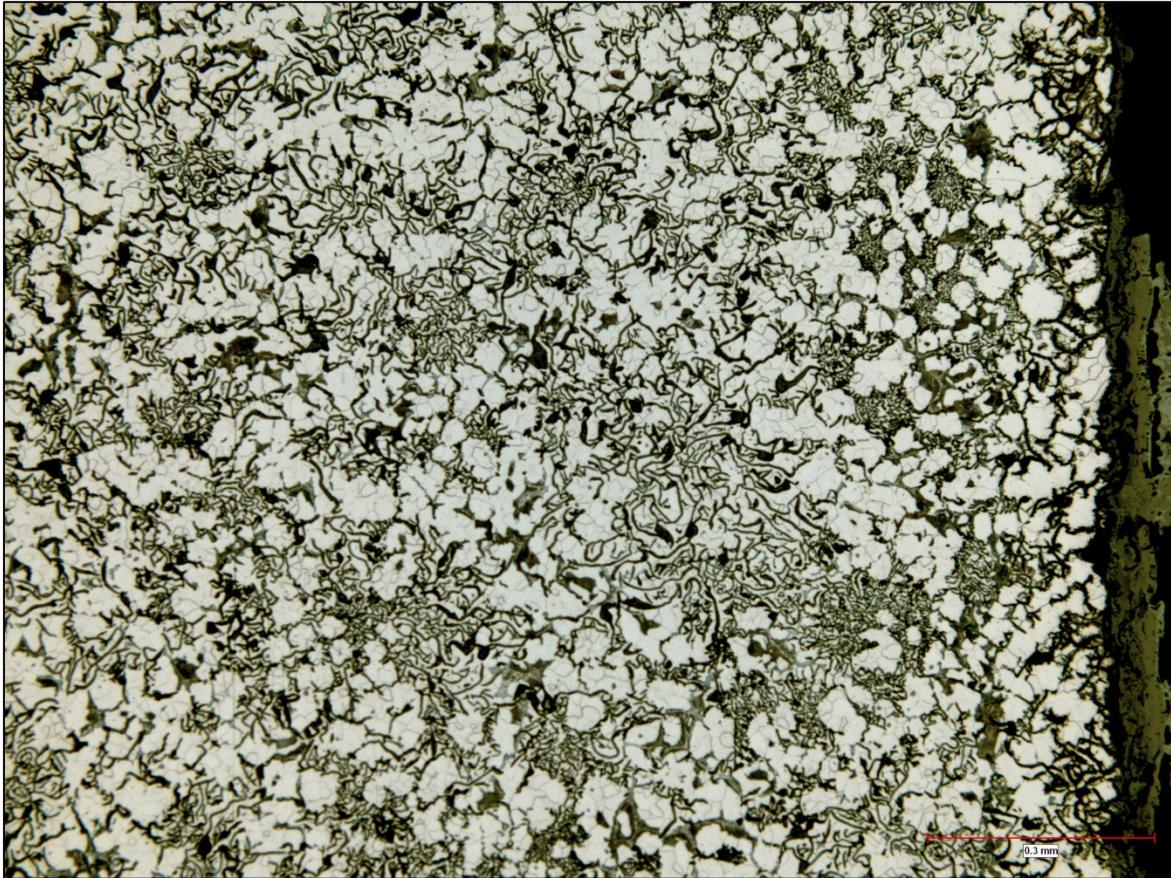
Image #12

The image shows the typical graphite structure and matrix microstructure from the ID surface (right) near the fracture of pipe #2: predominantly Type B graphite flakes in a matrix of pearlite, ferrite, steadite, and carbides.

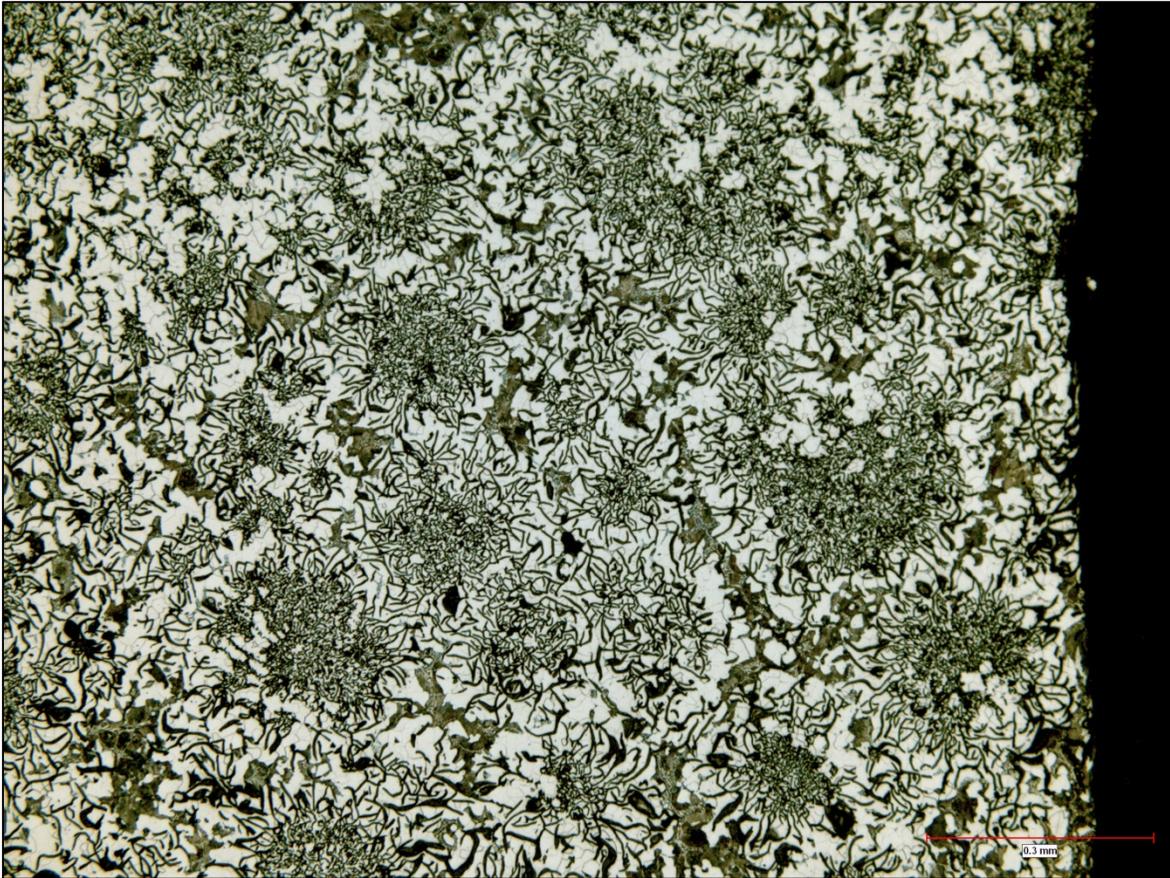
City of Milwaukee Water Engineering M029
Failed 16" Diameter Cast Iron Water Pipe: Pipe #2 Centerline Near Fracture
Image #13

The image shows the typical graphite structure and matrix microstructure from the centerline of pipe #2 at the fracture face (right): predominantly Type B graphite flakes in a matrix of pearlite, ferrite, steadite, and carbides.

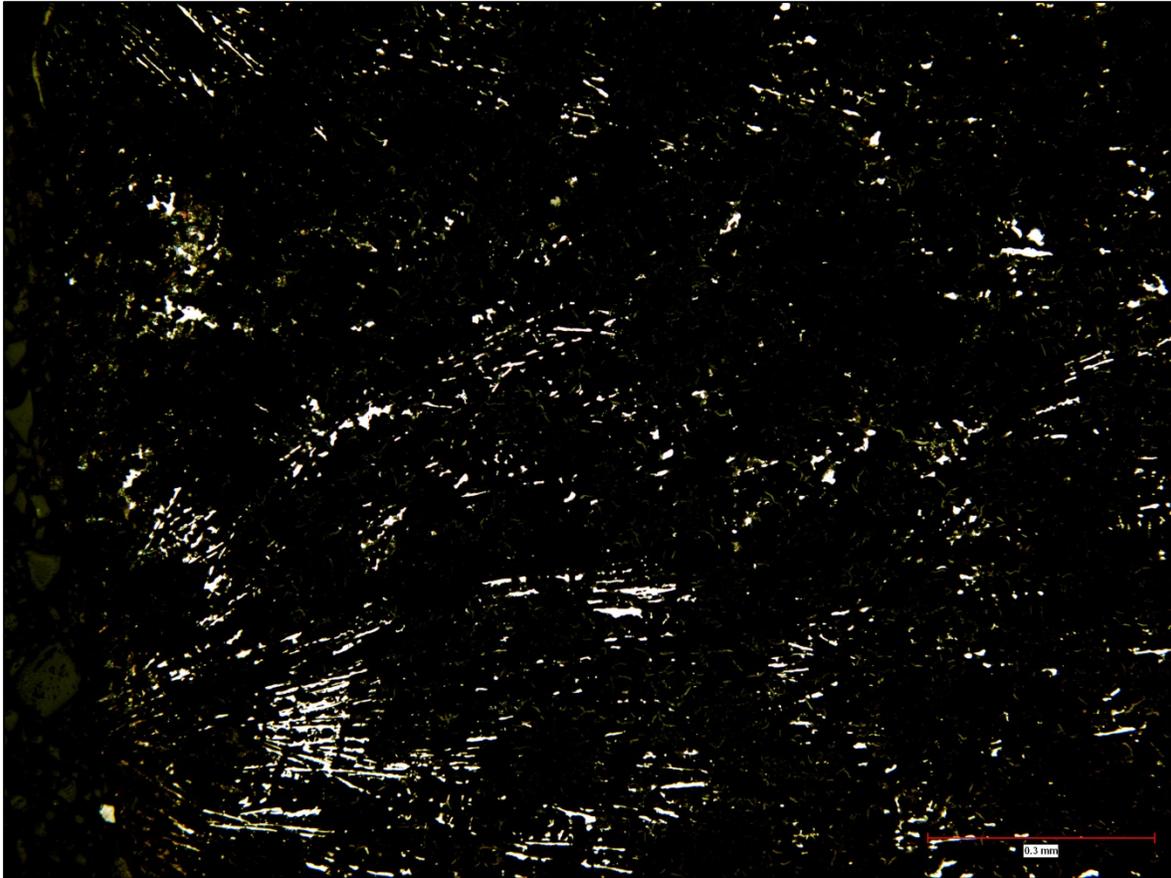
City of Milwaukee Water Engineering M029
Failed 16" Diameter Cast Iron Water Pipe: Pipe #2 OD Surface Near Fracture
Image #14

Etching with ammonium persulfate darkened the pearlite and ferrite revealing the level of steadite and carbides across the wall thickness (see Images #14 through #16). The steadite and carbides were difficult to differentiate in these samples and were combined approximately 3-10% in volume. A concentration of carbides was found along the ID surface.

The image shows the typical level of steady and carbides from the OD surface (left) near the fracture of pipe #2.

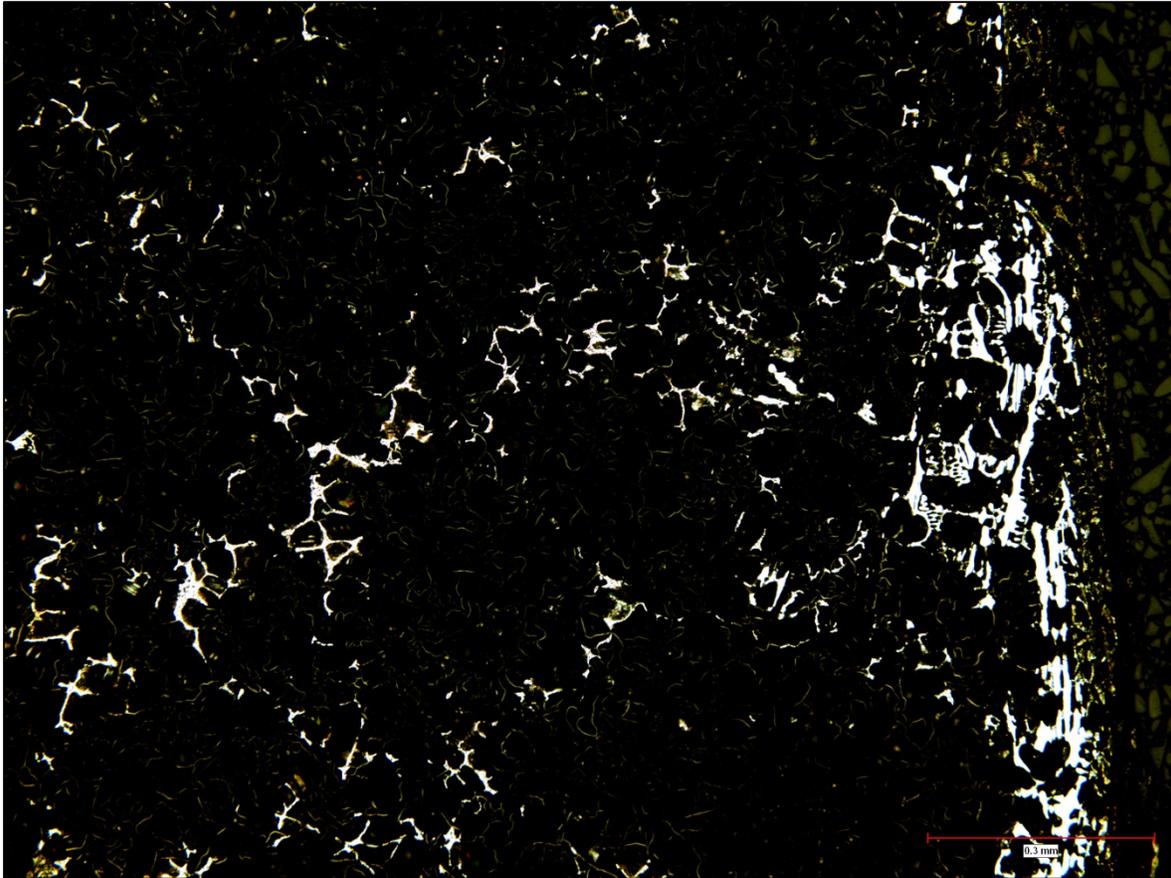
City of Milwaukee Water Engineering M029
Failed 16" Diameter Cast Iron Water Pipe: Pipe #2 ID Surface Near Fracture
Image #15

The image shows the typical level of steadite and carbides from the ID surface (right) near the fracture of pipe #2. Carbides are concentrated on the ID surface.

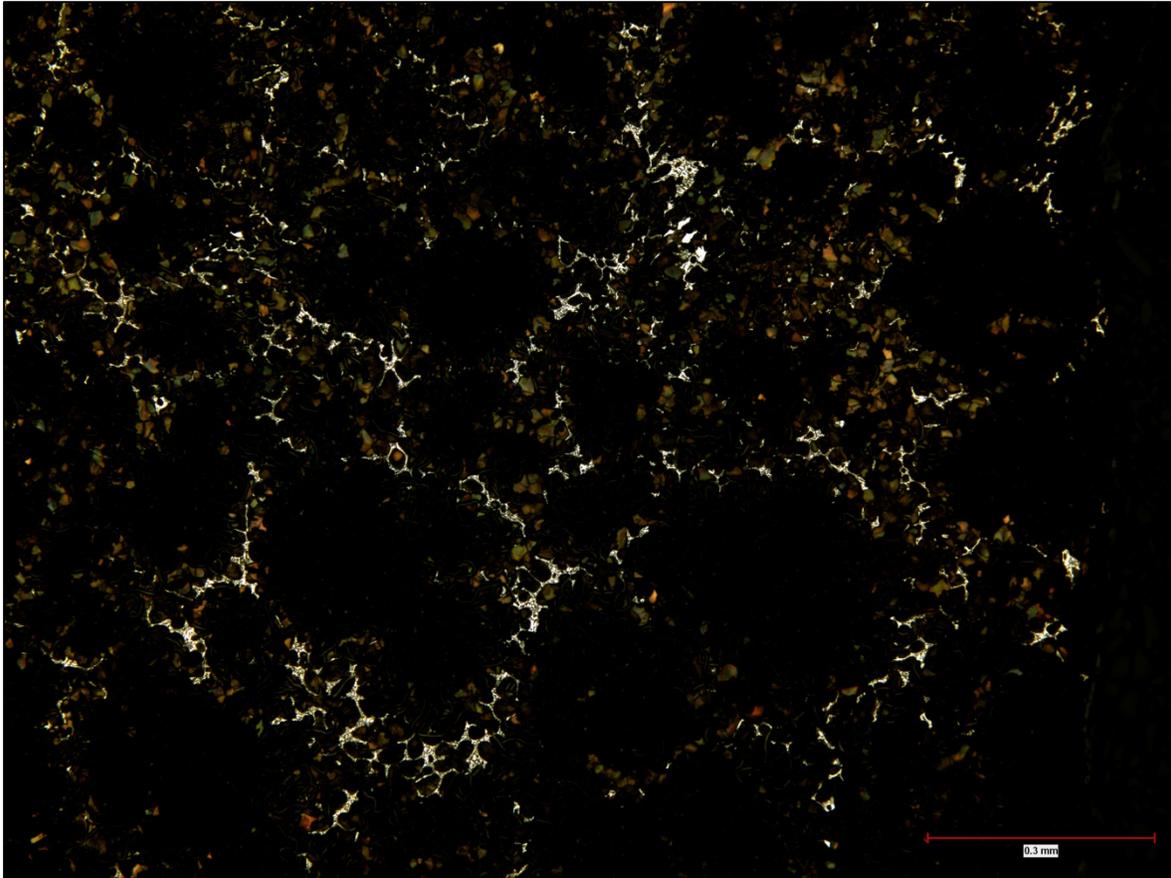
Failed 16" Diameter Cast Iron Water Pipe: Pipe #2 Centerline Near Fracture
Image #16

The image shows the typical level of steadyite and carbides from the centerline of pipe #2 near the fracture face (right).

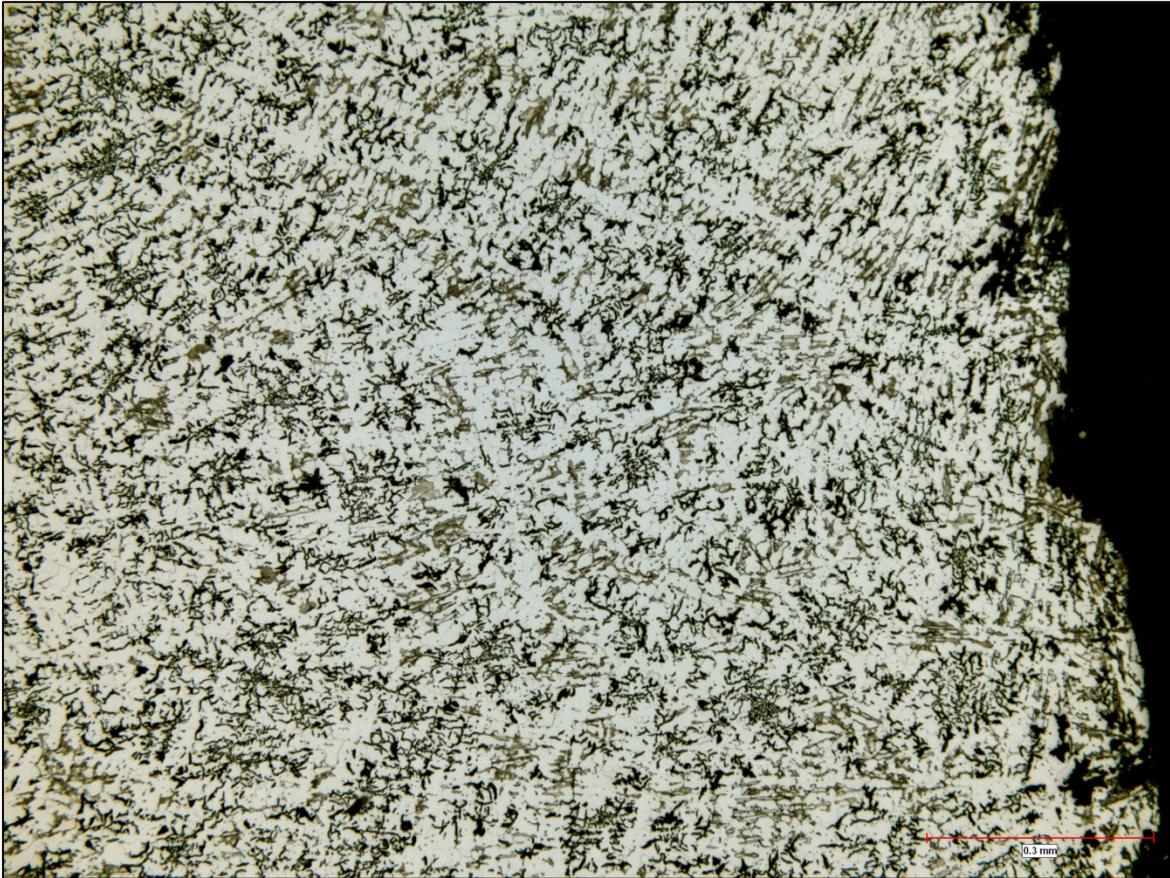
Failed 16" Diameter Cast Iron Water Pipe: Pipe #1 OD Surface Near Fracture
Image #17

The image shows the typical graphite structure and matrix microstructure from the OD surface (right) near the fracture of pipe #1: predominantly Type B graphite flakes in a matrix of pearlite, ferrite, steadite, and carbides.

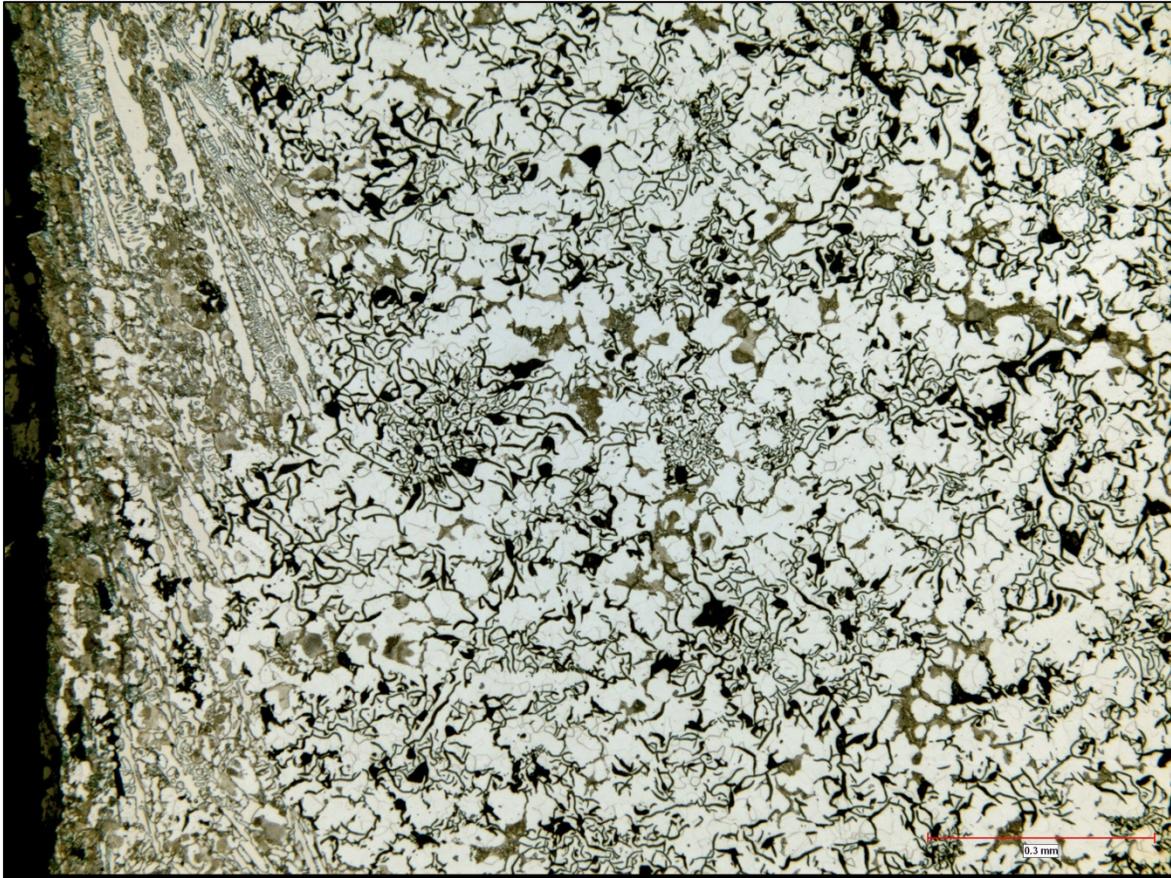
Image #18

The image shows the typical graphite structure and matrix microstructure from the ID surface (left) near the fracture of pipe #1: predominantly Type B graphite flakes in a matrix of pearlite, ferrite, steadite, and carbides. Carbides are concentrated on the ID surface.

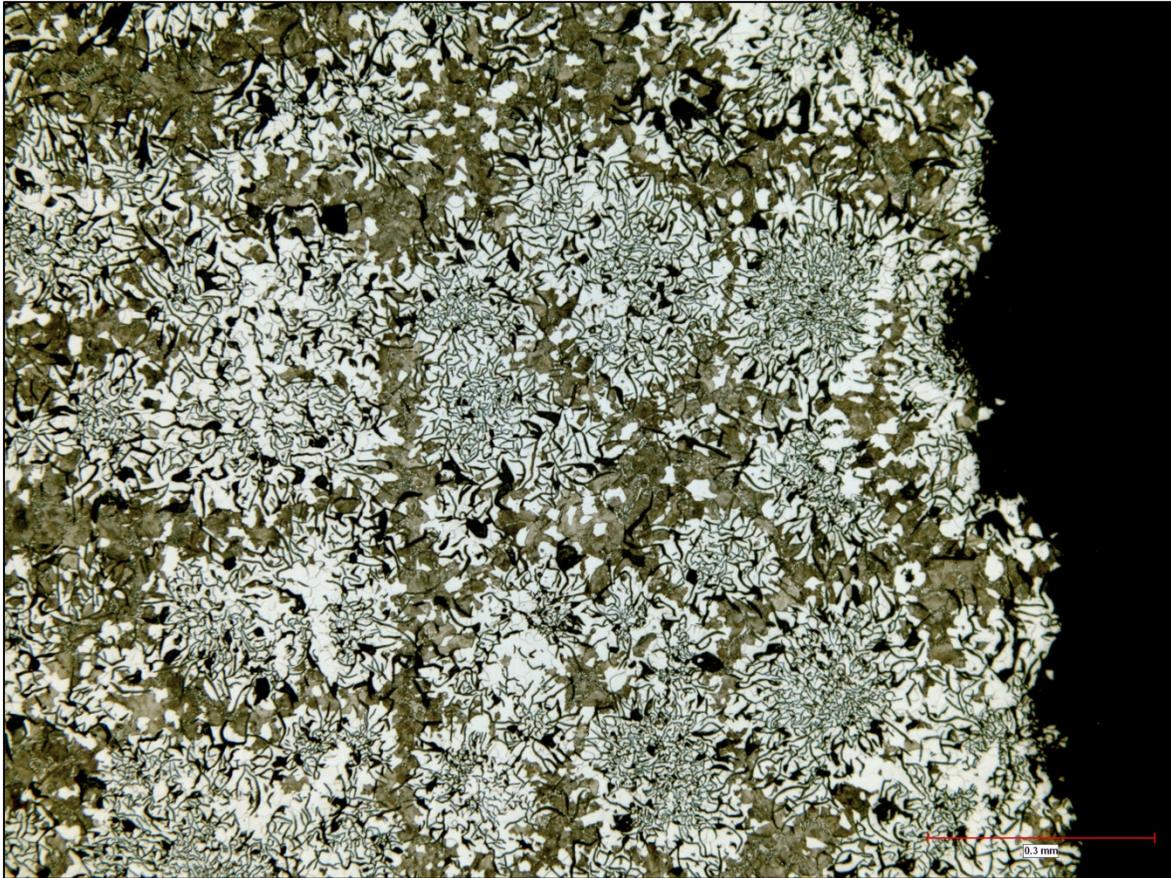
Image #19

The image shows the typical graphite structure and matrix microstructure from the centerline of pipe #1 near the fracture face (right): predominantly Type B graphite flakes in a matrix of pearlite, ferrite, steadite, and carbides.

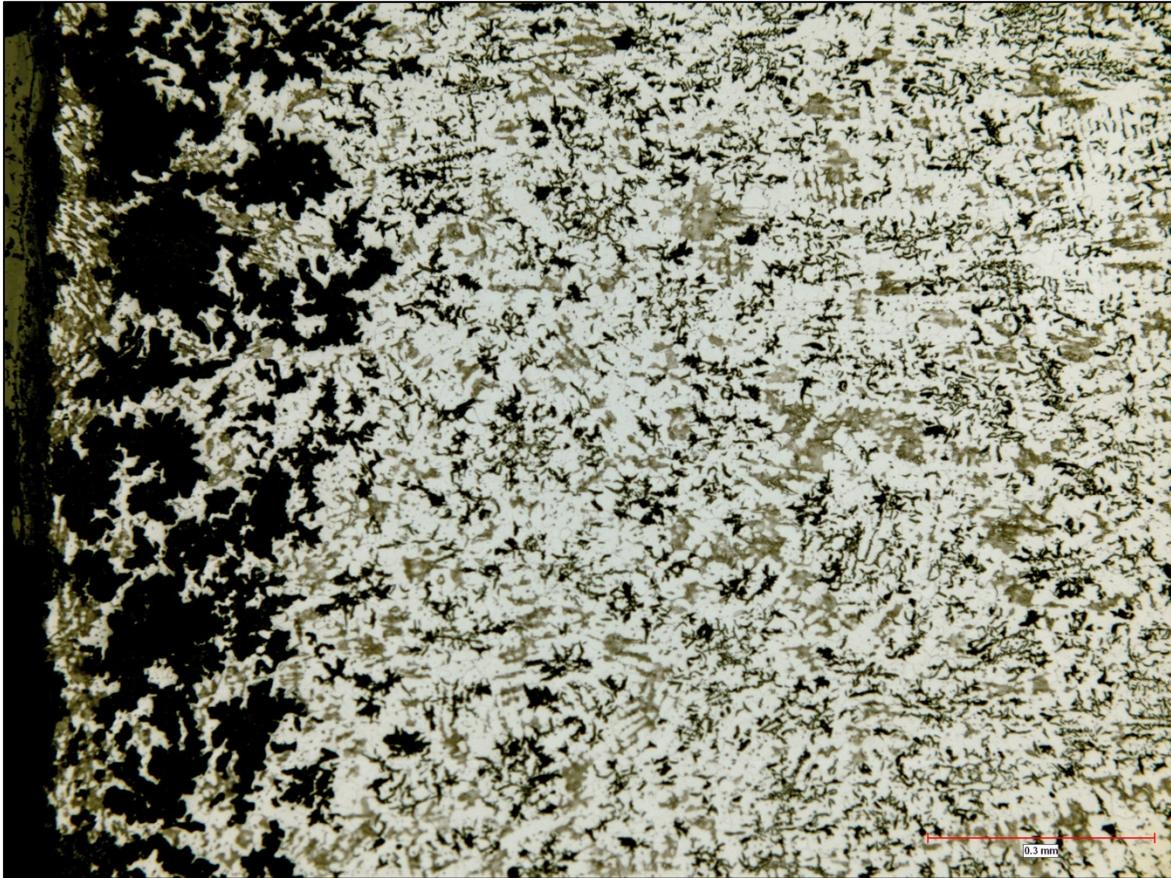
Failed 16" Diameter Cast Iron Water Pipe: Pipe #1 OD Surface Near Cut
Image #20

The image shows the typical graphite structure and matrix microstructure from the OD surface (left) near the cut end of pipe #1: predominantly Type B graphite flakes in a matrix of pearlite, ferrite, steadite, and carbides. Corrosive attack is propagating from the OD surface.

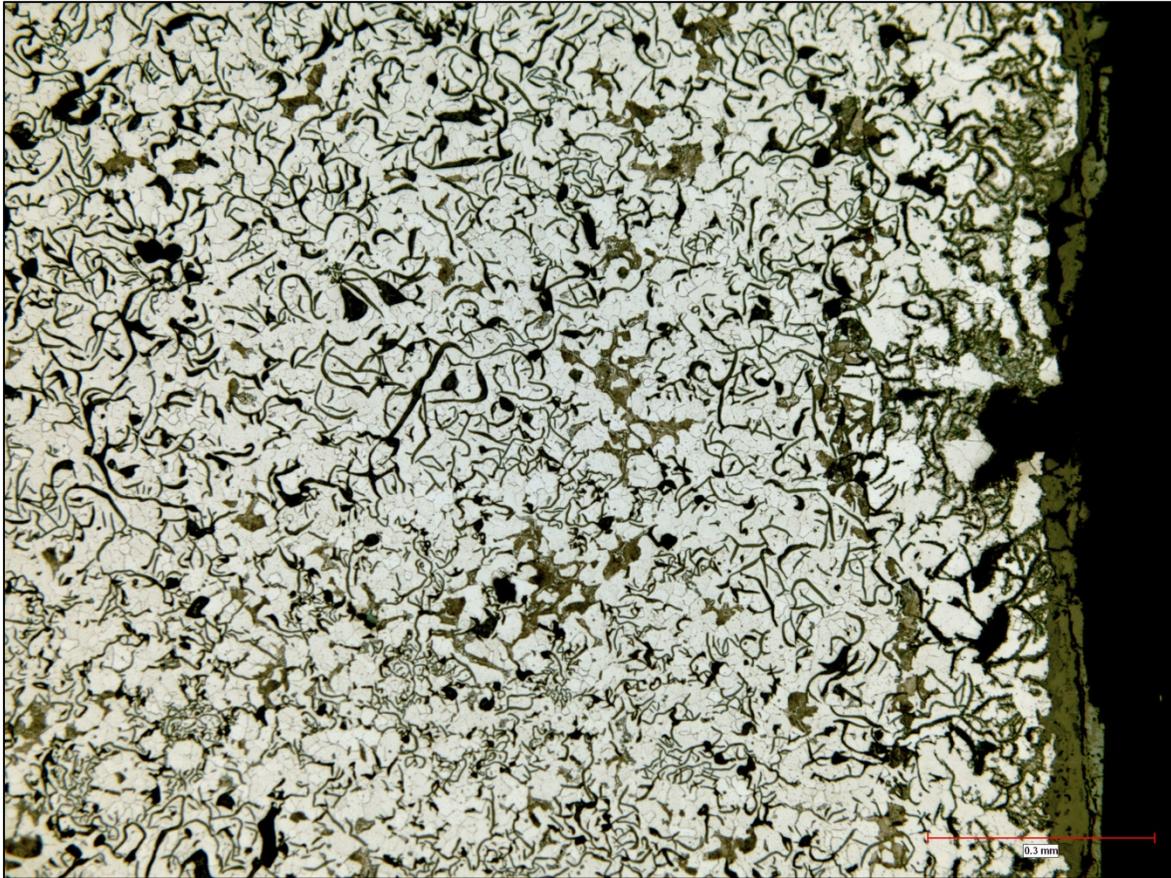
Failed 16" Diameter Cast Iron Water Pipe: Pipe #1 ID Surface Near Cut
Image #21

The image shows the typical graphite structure and matrix microstructure from the ID surface (right) near the cut end of pipe #1: Types A and B graphite flakes in a matrix of pearlite, ferrite, steadite, and carbides.
