Mr. Anthony Fahres
City of Milwaukee Water Engineering M029
3850 N. 35th Street, Room 235
Milwaukee, WI 53216

Sample Identification - **(2) Segments of Failed 16" Diameter Cast Iron Water Pipe**

Project Number: P20-0162

Objective: We were requested to perform chemical analysis, mechanical testing and microstructural evaluation of the failed pipe sections. We were further requested to comment on any material conditions that may have contributed to the failure of the pipe.

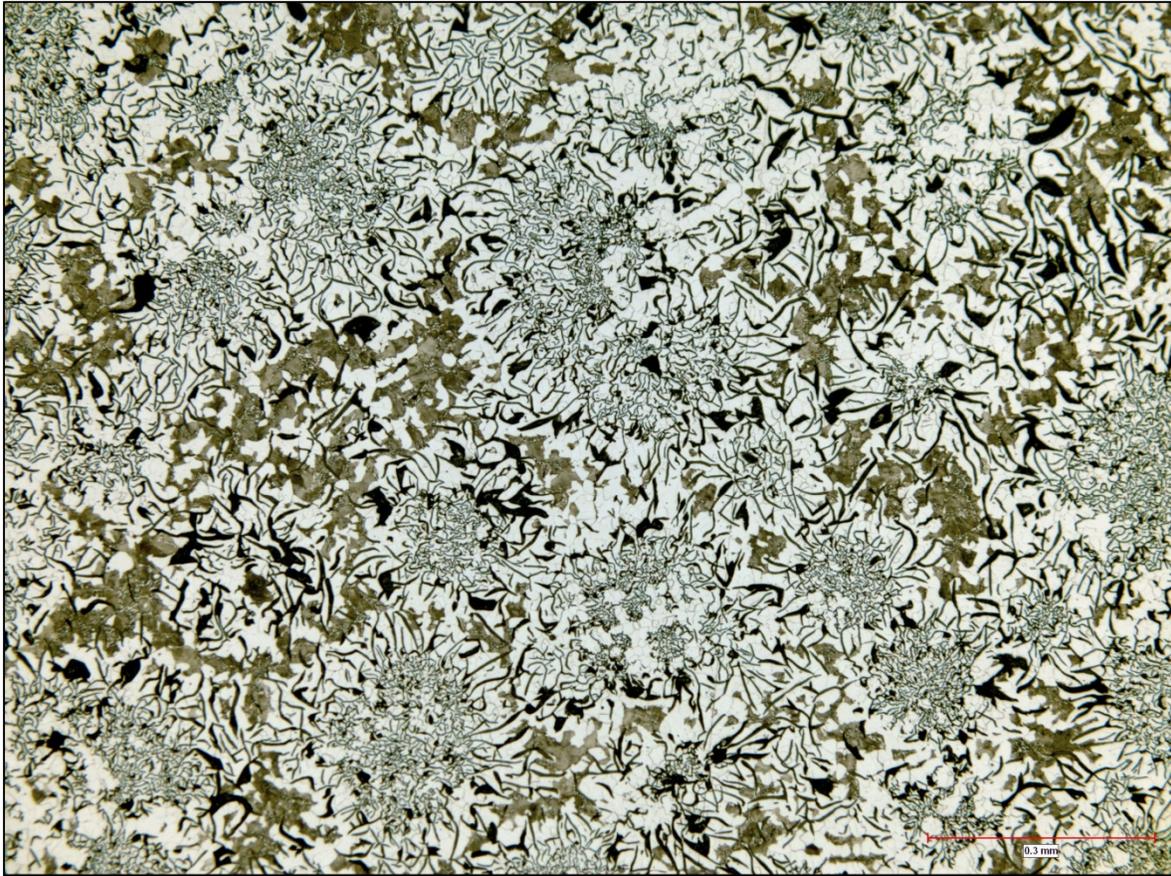
City of Milwaukee Water Engineering M029
Failed 16" Diameter Cast Iron Water Pipe: Pipe #1 Centerline Near Cut
Image #22

The image shows the typical graphite structure and matrix microstructure from the centerline of pipe #1 near the cut end: predominantly Type B graphite flakes in a matrix of pearlite, ferrite, steadite and carbides.
