The City of Milwaukee

North Point Water Tower Roof Conditions

North Point Water Tower Roof Renovations

CHI-00227212-A0

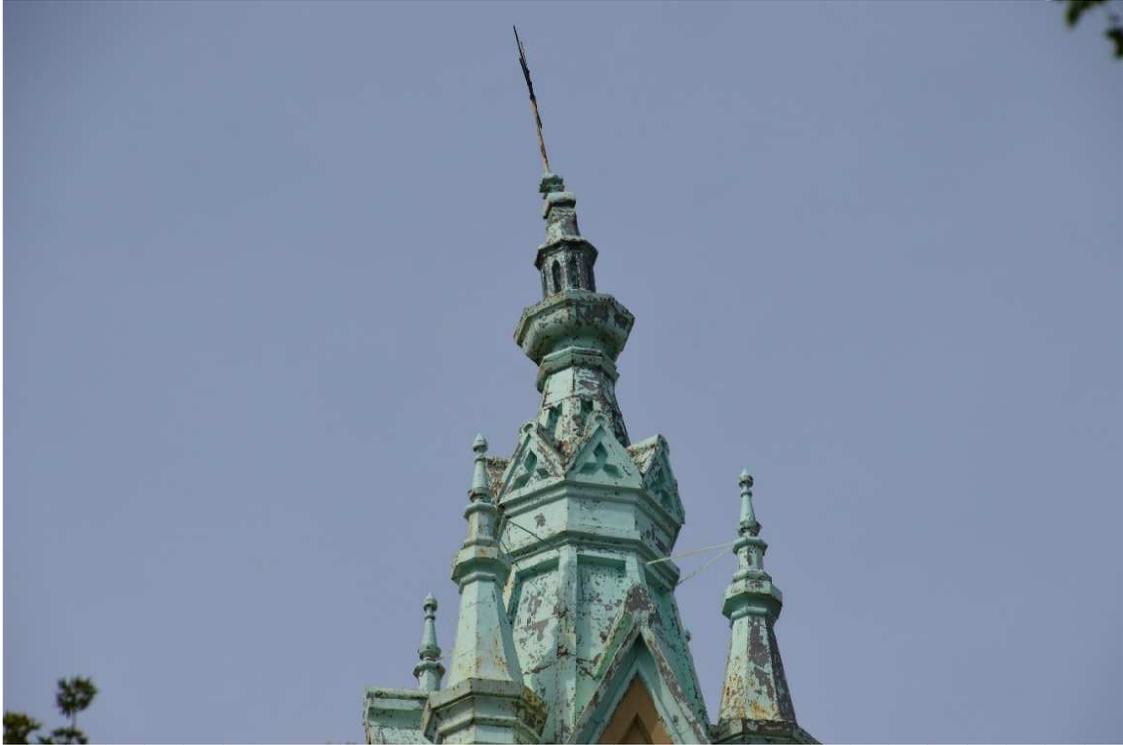
On May 17, 2017, a contractor working on the restoration of the NPWT masonry, noticed that the weathervane was tilted and swaying in the wind. They reported their observation to Milwaukee DPW.

Photograph No. 1 Photo taken 5/17/2017 showing the weather vane and a portion of the sheet metal Roof noticeably tilting or leaning

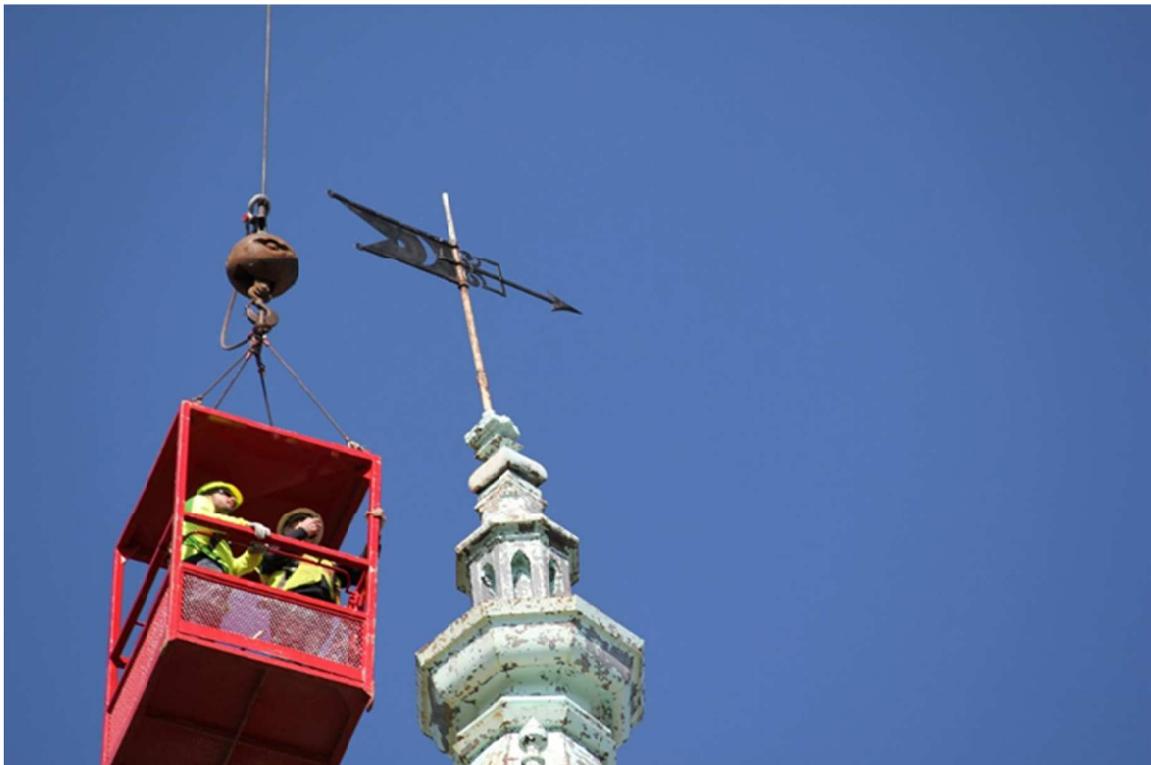
Photograph No. 2 F.J.A. Christiansen Roofing Co., Inc. Preparing to remove the damaged weathervane.

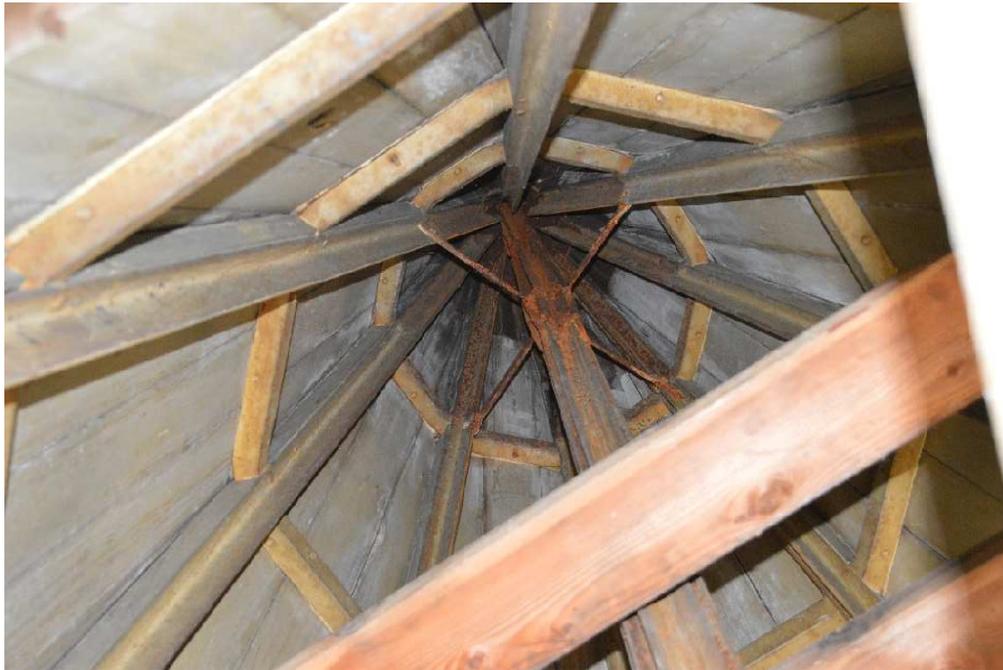
A visual review the interior of the tower at the very top(peak), indicates that there may be moisture present in the wood decking material.

1. Moisture from standing water present in the stand pipe, on interior of tower. (hot moist air rises to peak of roof and collects).
2. The seal around the weathervane shaft was deficient and water was able to infiltrate into the roof construction over time.
3. Small openings in the sheet metal roofing (cracks or pin holes) allowed water to infiltrate the roof construction.

Photograph No. 3 Interior roof construction under the peak possible moisture present in wood deck.

10. Remove water damaged or moisture damages wood decking. Install replacement treated wood deck pieces.
11. Install weathervane shaft
12. Install new sheet metal roof components that match the original sheet metal roofing and configuration.

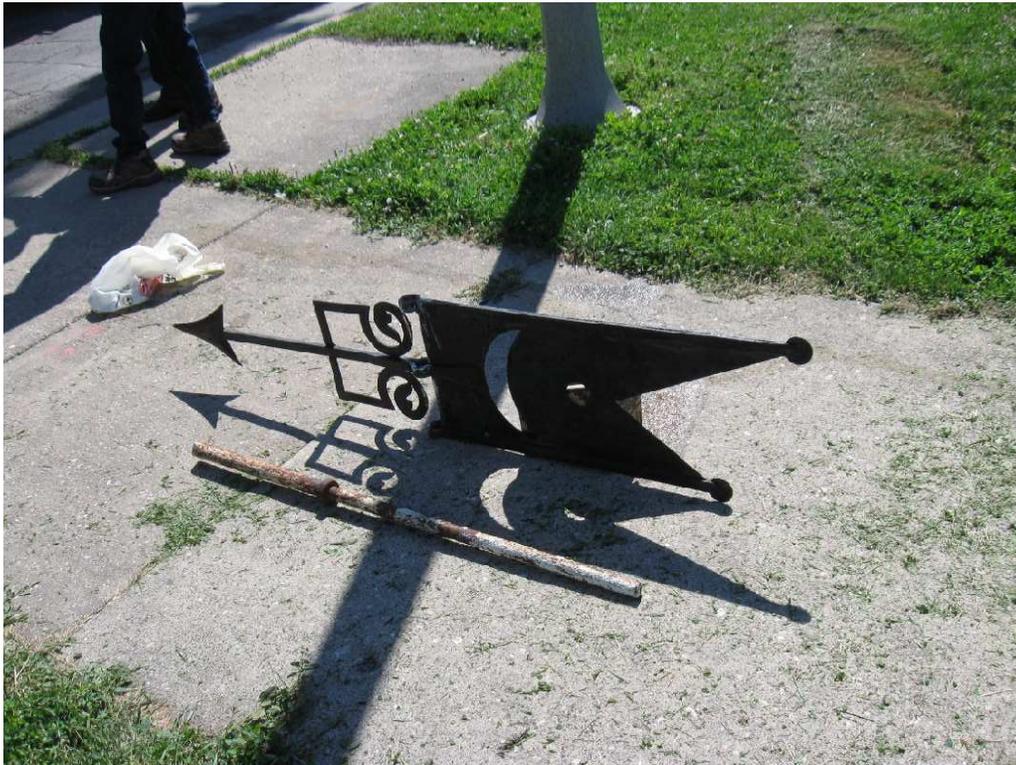
Photograph No. 4 Weathervane and shaft after removal from tower.

1. Remove paint from the existing weathervane.
2. Inspect weathervane for damage.
3. Repair/Restore weathervane.
4. Prime all surfaces with an appropriate industrial epoxy primer.
5. Paint weathervane with the appropriate industrial coating that is compatible with the epoxy primer. (match color of the existing weathervane paint color)

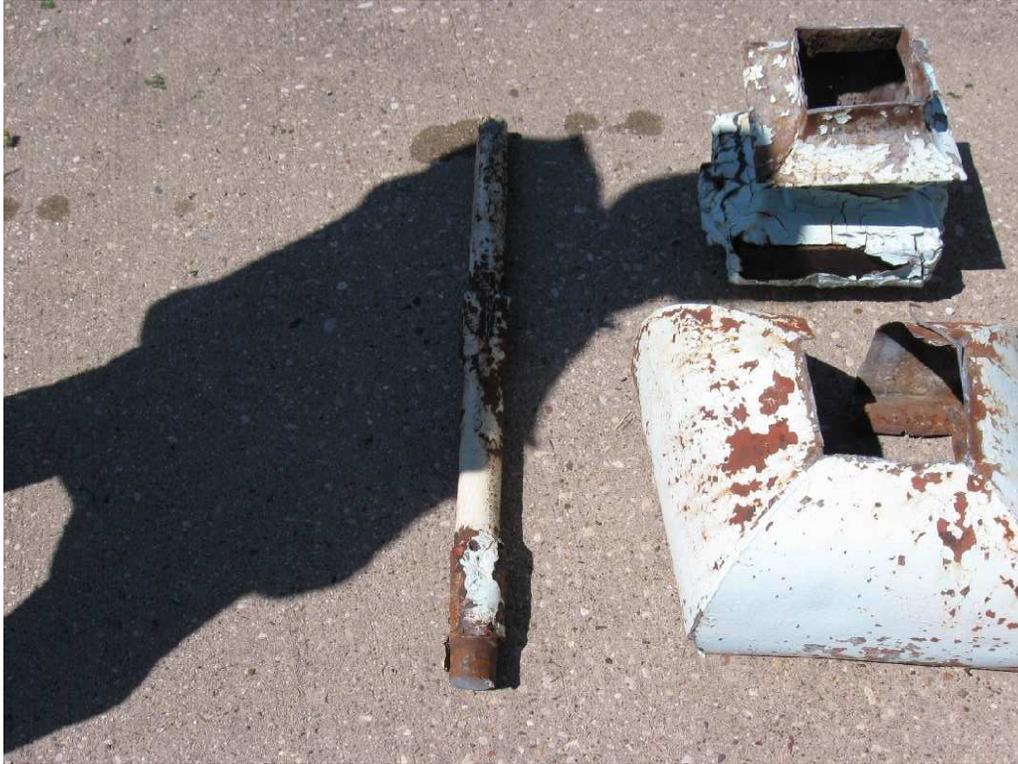
Photograph No. 5 Second piece of weathervane shaft, collar with pitch pocket and the sheet metal cap.

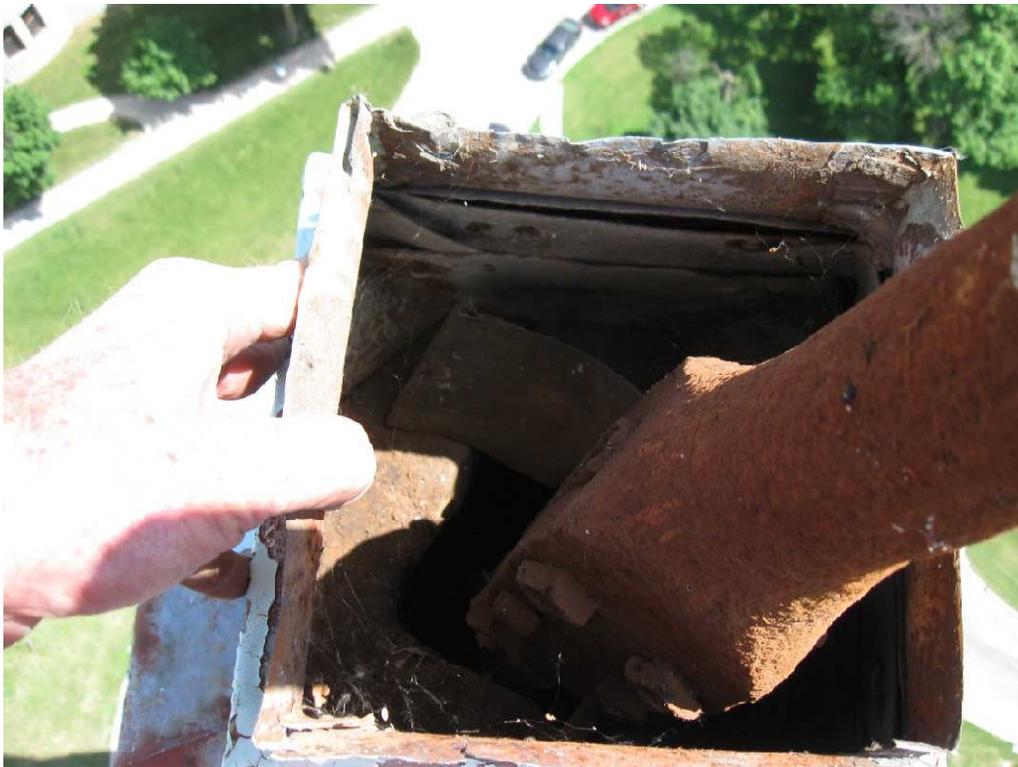
Photograph No. 6 Forged base of shaft at attachment to interior tower structural supports.

3. Documents the connections, member sizes, and configuration, of the shaft support steel with photographs and measured drawings.
4. Carefully remove the existing base of the shaft that was left in place. (noting orientation, bolt configuration, etc.)

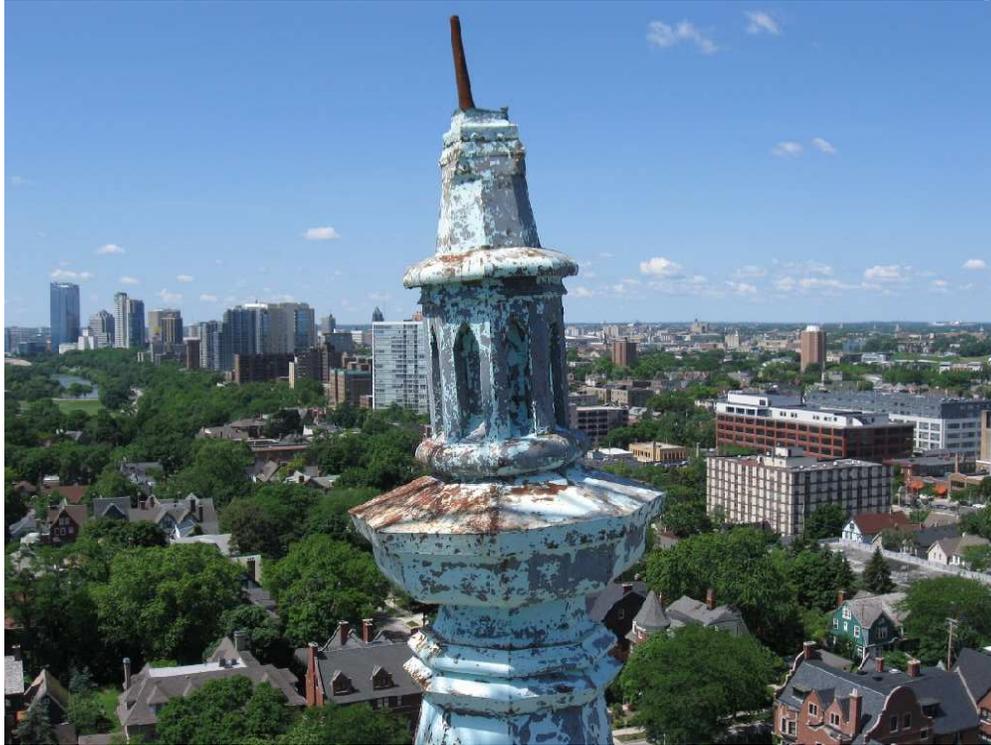
Photograph No. 7 View, from the north, of tilted sheet metal enclosure with remaining shaft section. From North.

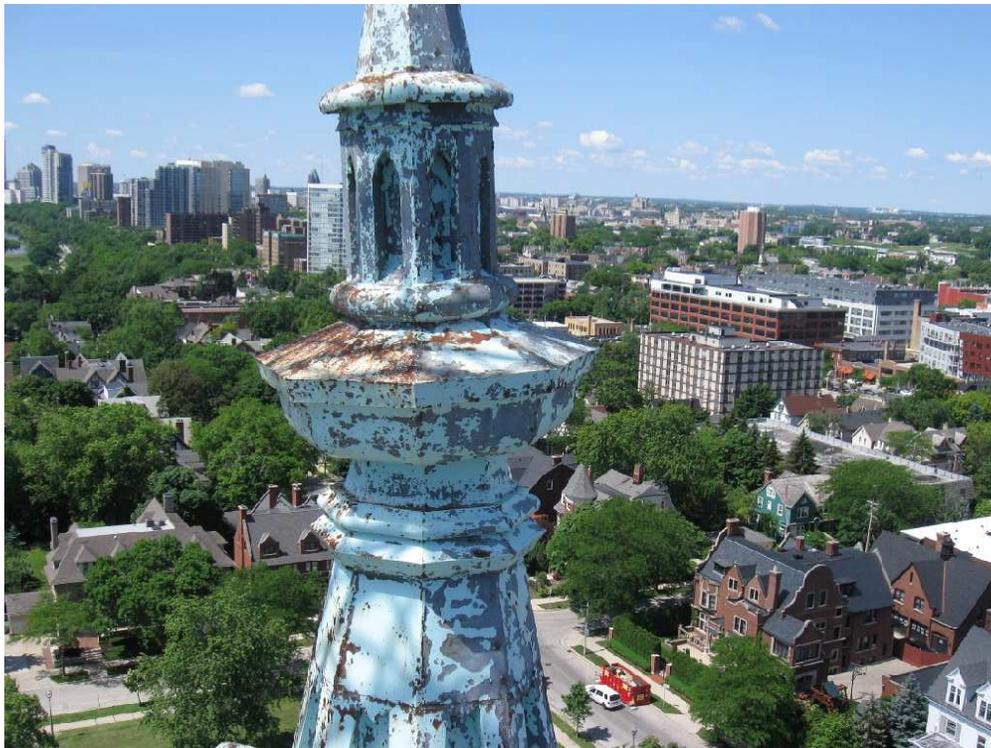
It was also observed that a portion of the decorative sheet metal roofing, located approximately 3 ft below the weathervane, was also damaged, and is now unstable. It moved with the weathervane when the weathervane was swaying. The sheet metal is bent out of its original shape (tilting eastward) and may be cracked at that location (east face at overhang).

Photograph No. 8 View of damaged section from North.

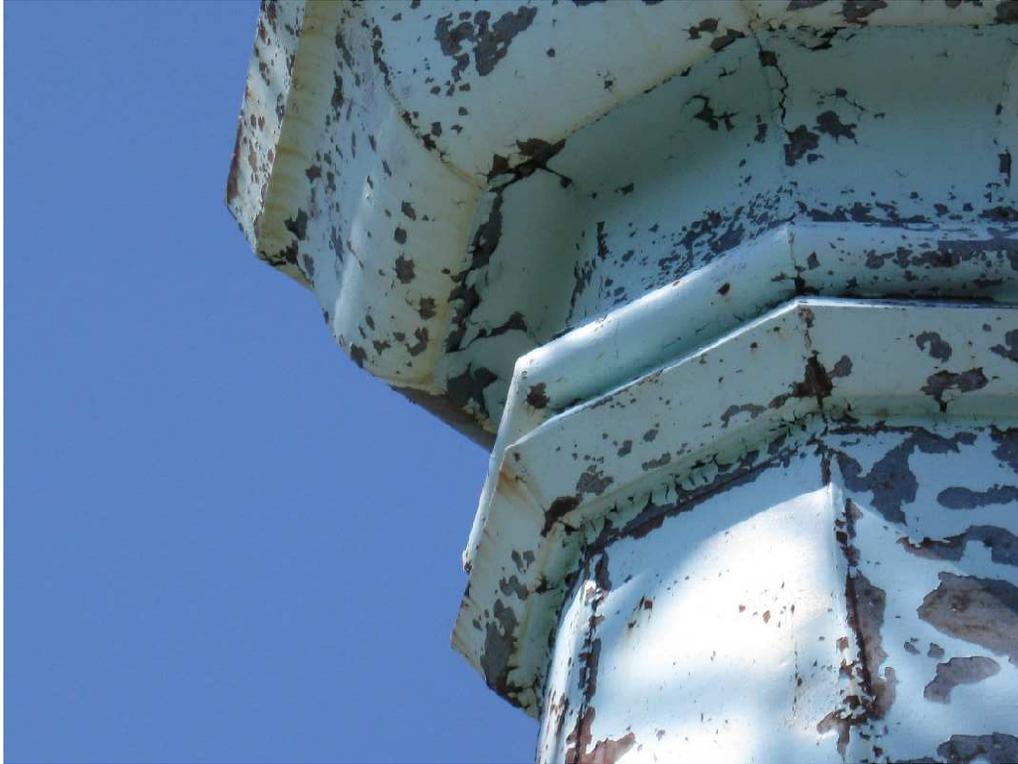
Photograph No. 15 View of damaged Sheet metal.

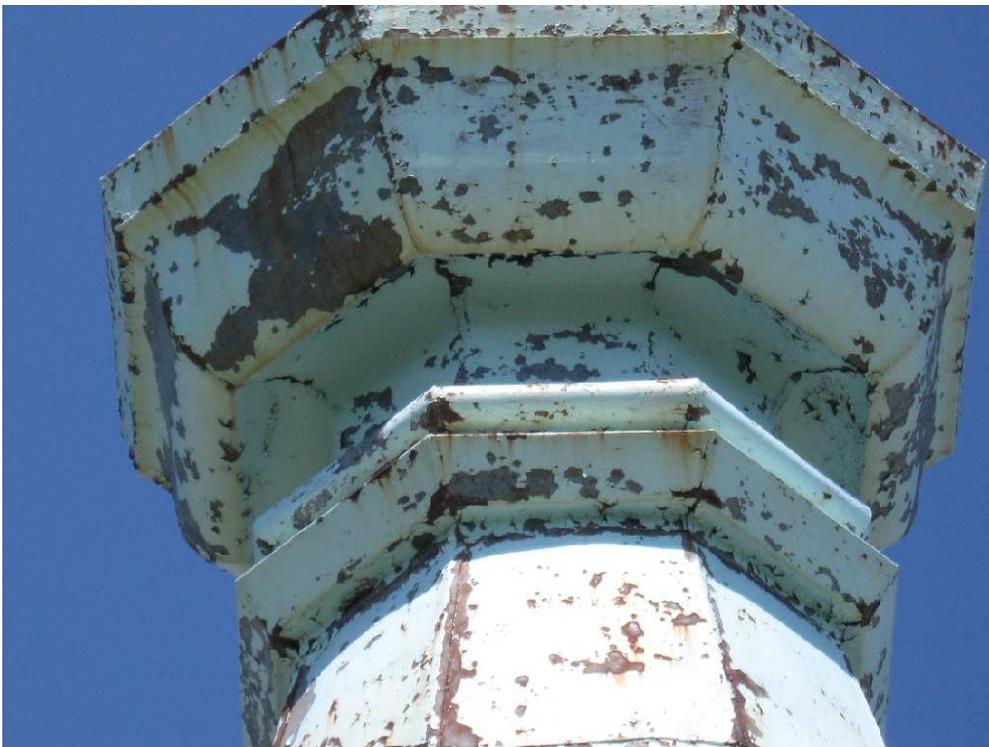
Photograph No. 29 View of damaged portion of sheet metal roof, from east.

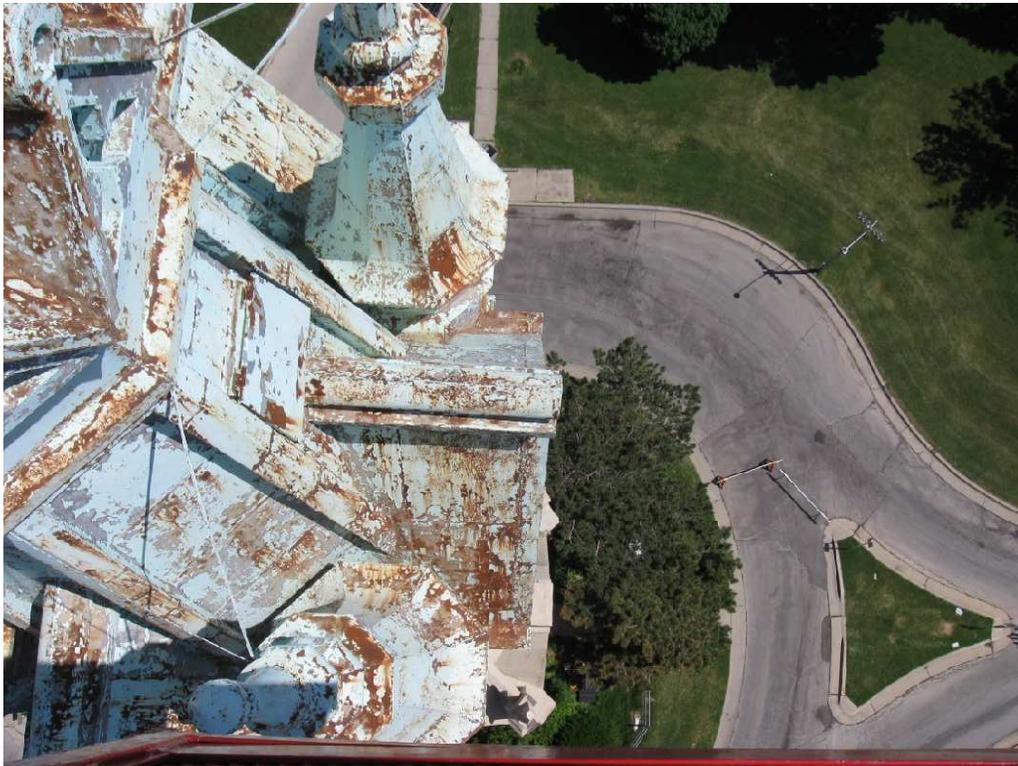
Photograph No. 33 View from SE corner showing access hatch on the east face of roof.

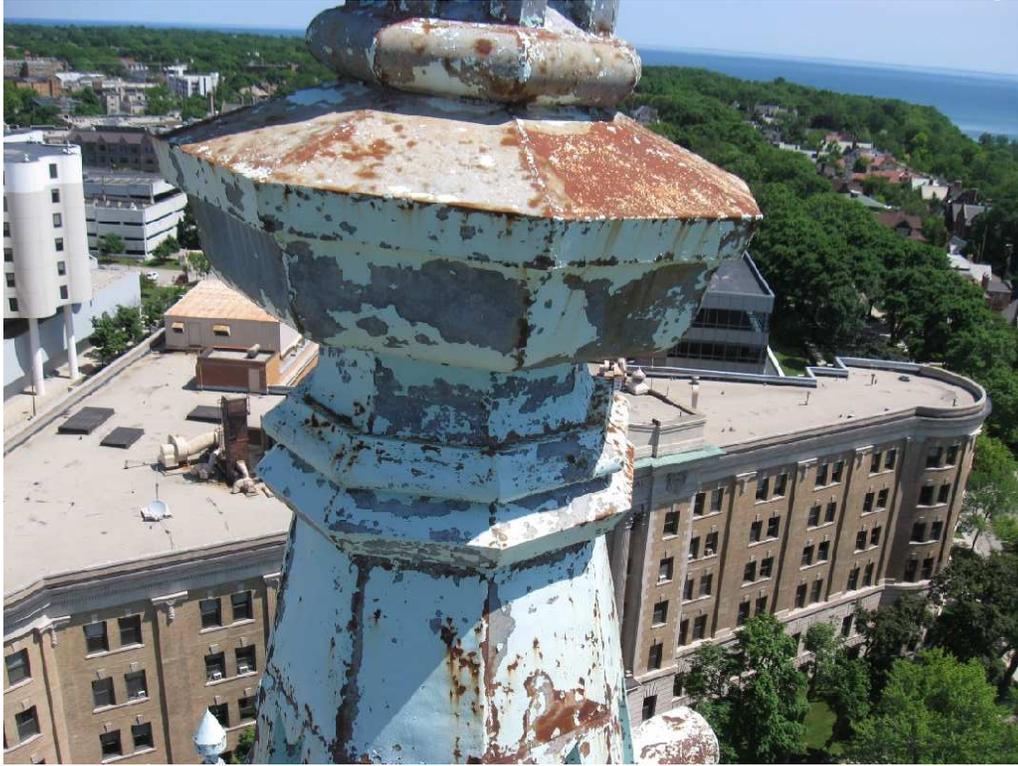
Photograph No. 37 View of damaged sheet metal roof section from the south.

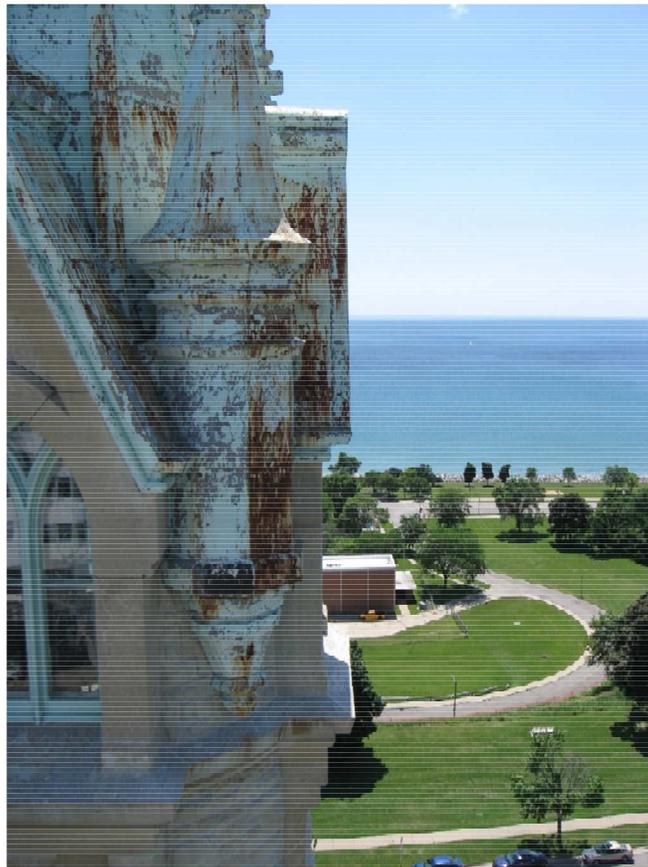
1. Overall the decorative sheet metal roofing is intact with large areas of peeling paint, exposed galvanized finish, and some areas of rusted sheet metal.
2. The North, West, and East, sides of the roof had primarily peeling paint with minor to moderate amounts of exposed rusted surfaces.
3. The South and Southeast sides of the roof had a much larger amount of exposed rusted sheet metal surfaces.
4. There were no holes in the sheet metal roof observed.
5. From the interior, the only observable signs of moisture were at the very uppermost peak of the roof. The wood surfaces appear much darker than the adjacent wood which appears to indicate the presence of moisture. This is consistent with water infiltrating from the top of the roof where the shaft for the weathervane penetrates the sheet metal assembly.

Photograph No. 46 View from west showing south face of lower finial body observed to be the most visible rust.

1. Remove loose paint and rust scale from all exposed sheet metal surfaces. (take necessary measures to address the presence of LBP and its removal and disposal. Follow all ordinances and code requirements)

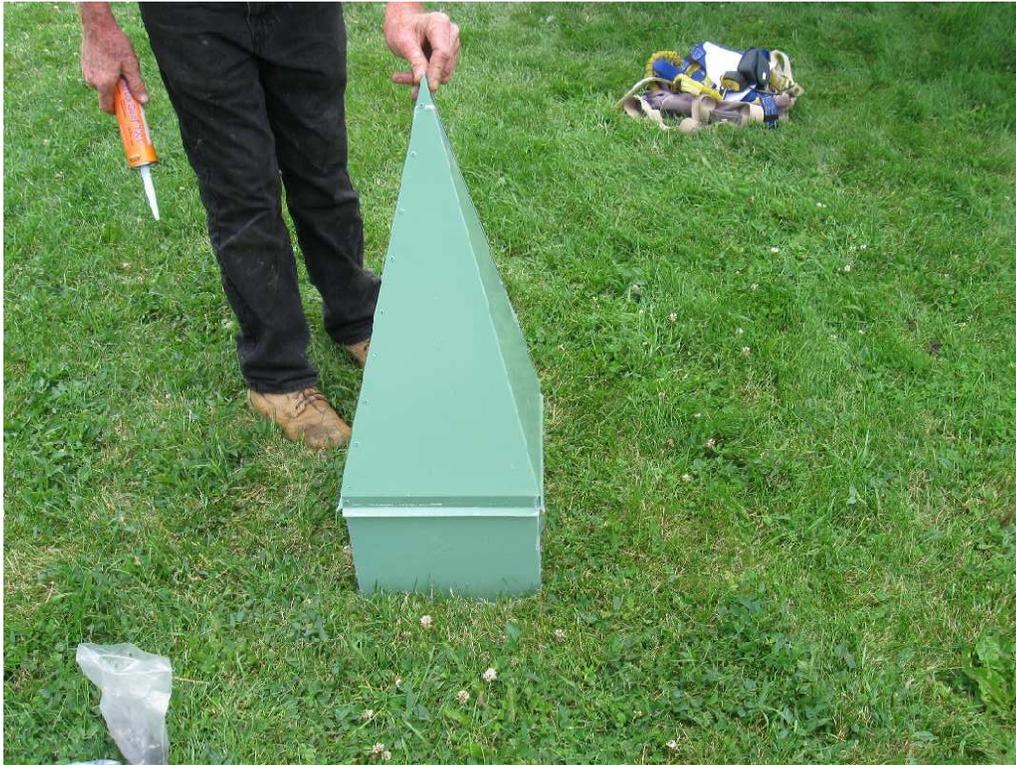
Photograph No. 47 Prefinished sheet metal cover fabricated to cover the remaining section of the shaft and enclose the open sheet metal roof.

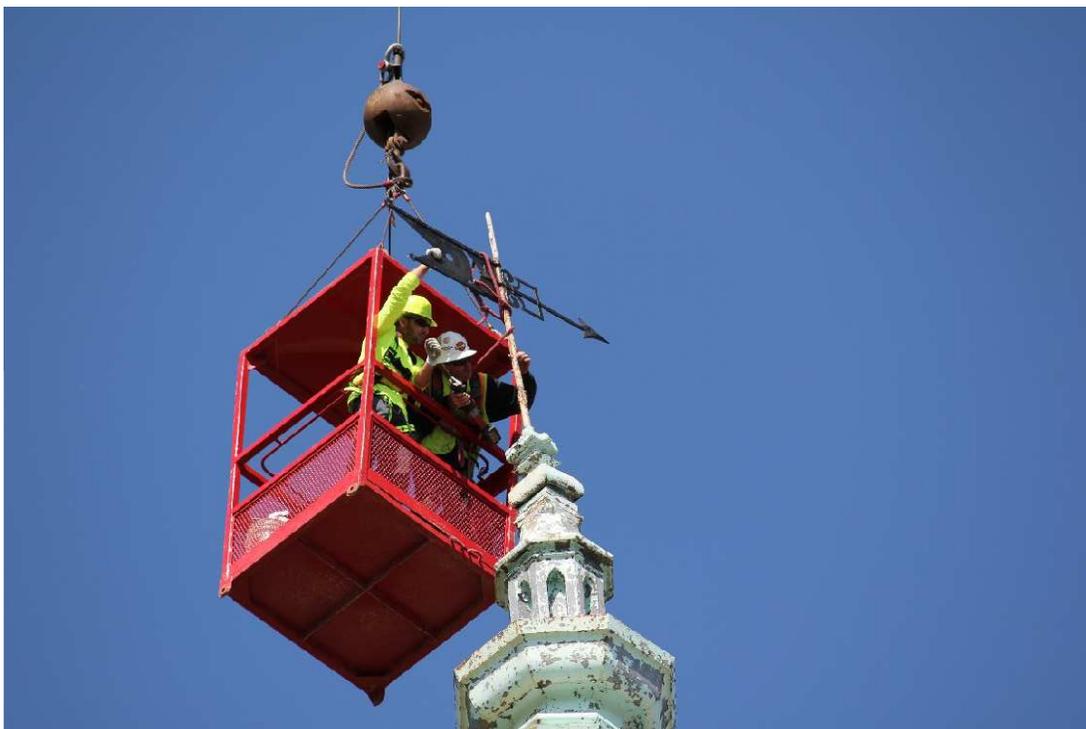
Photograph No. 48 Removing the weathervane and shaft.

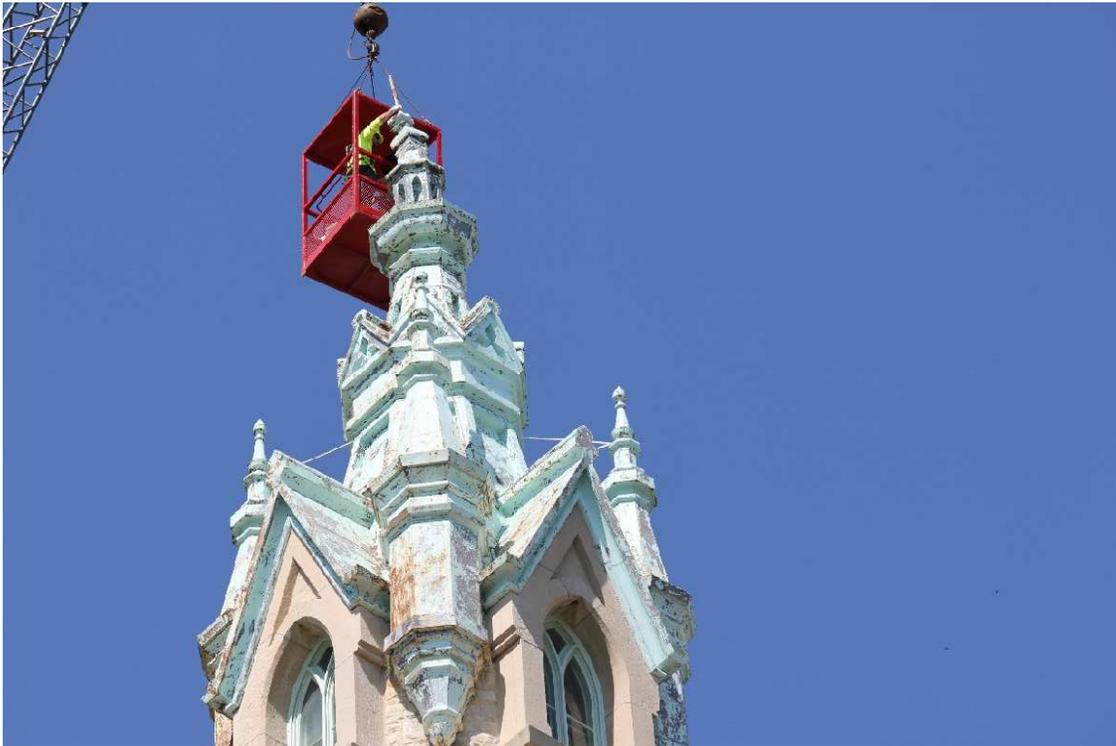
Photograph No. 49 Removing the second section of the shaft.

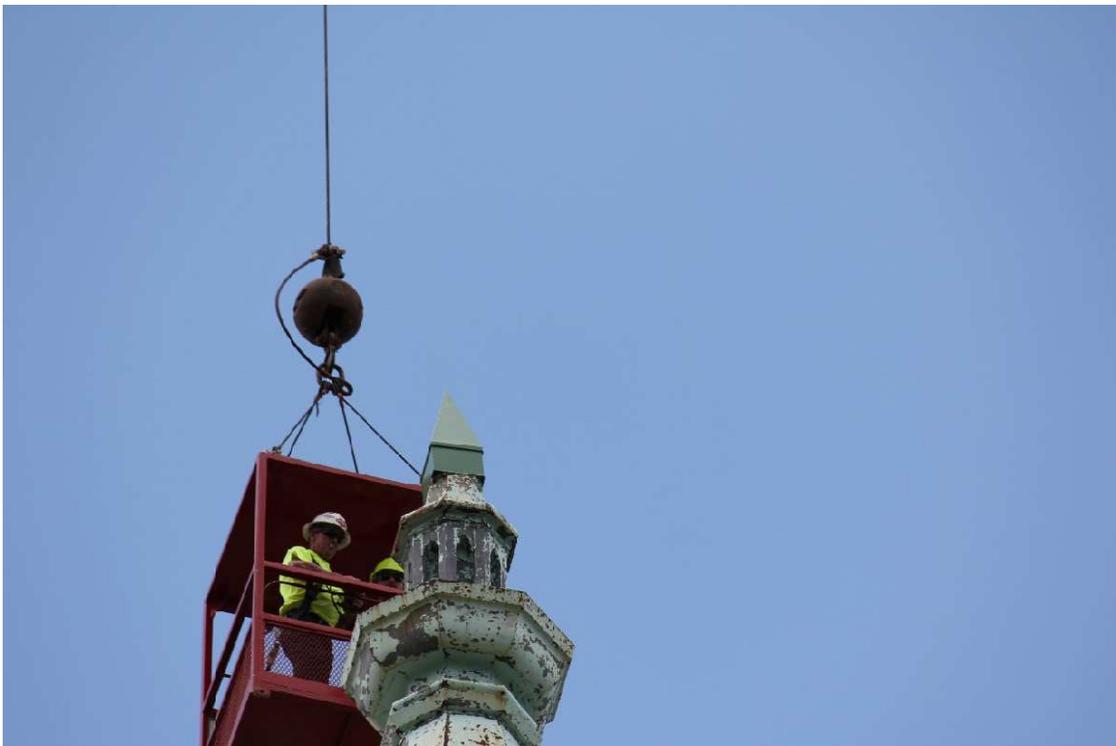
Photograph No. 50 Installing the new temporary prefinished sheet metal enclosure over shaft and opening in the sheet metal.

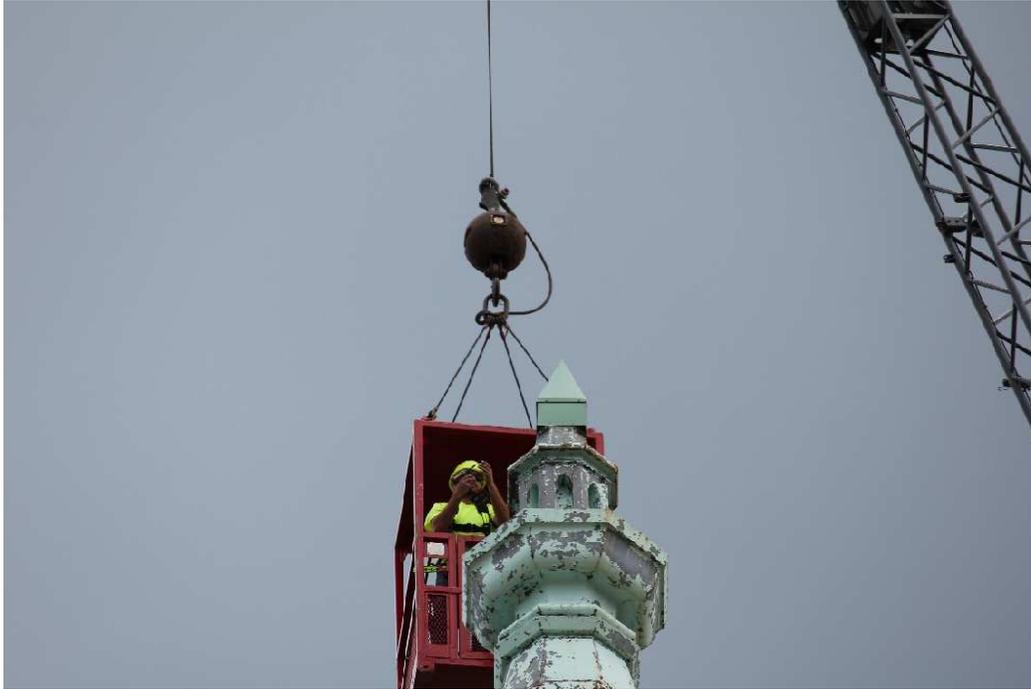
Photograph No. 51 Temporary sheet metal enclosure installation is complete.
