North Point Tower Restoration Project July 18, 2017 Update

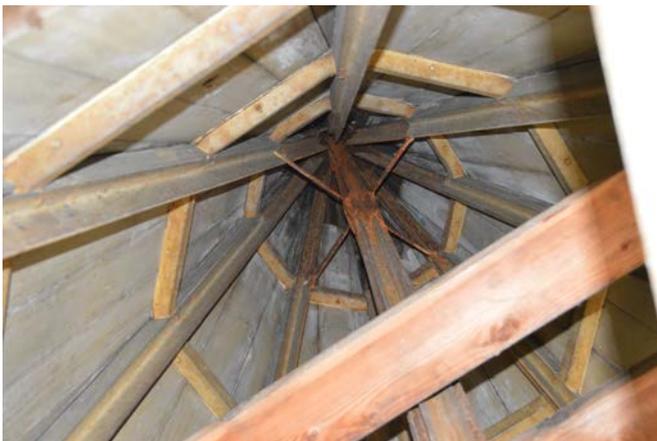
The weather vane had recently taken on a decided lean to the side. Project coordinators suspect a severe, early spring storm exacerbated an existing but hidden deteriorated and weakened condition. Although the roof is in good shape, there is rusting visible in the interior of the peak. The ornamental sheet metal above the peak hid three or more feet of the rod holding the weather vane upright, and the cause of the leaning was not readily apparent. Because the cause of the deterioration appears to be within the structure of the roof, a permanent fix was not possible at this time.

The interior of the peak of the roof and the area that held the steel rod on which the weather vane rested.

The repair of the roof structure will be included in the scope of roofing and repainting work proposed for the Department of Public Works 2018 capital budget.

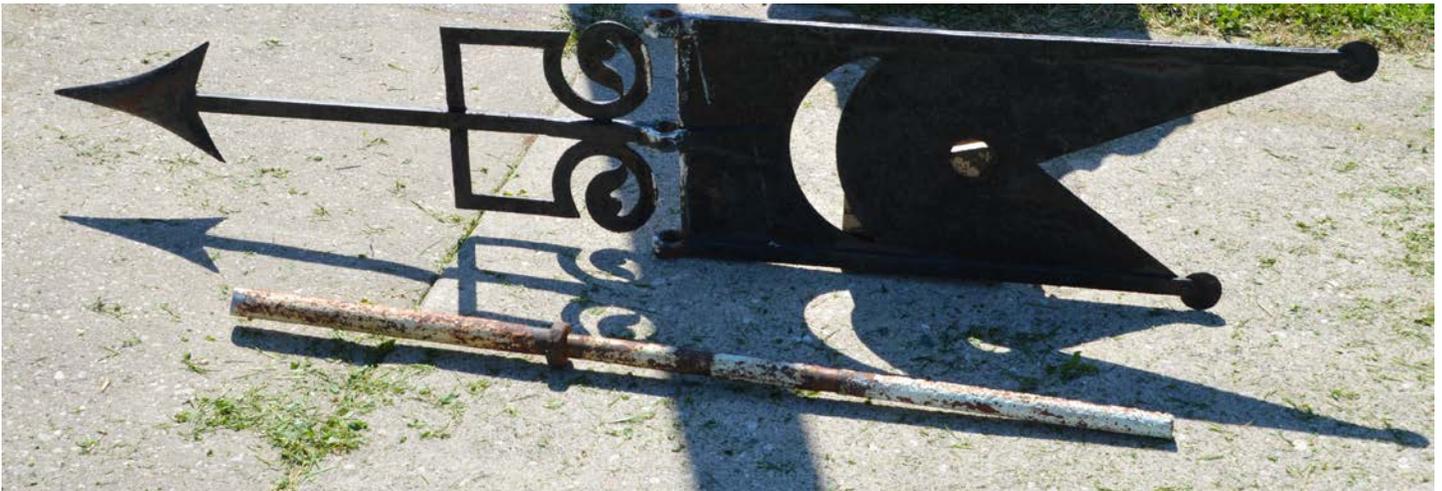
The weather vane is back on solid ground after 143 years and was found to be in good condition. It measures six feet long, 14" wide and weighs just under 30 pounds. The vane swung from three loops that encircled the steel rod in the foreground. The loops are visible on the left side of the rectangular piece with the cutout at the right. (photo credit Sean Schutten)

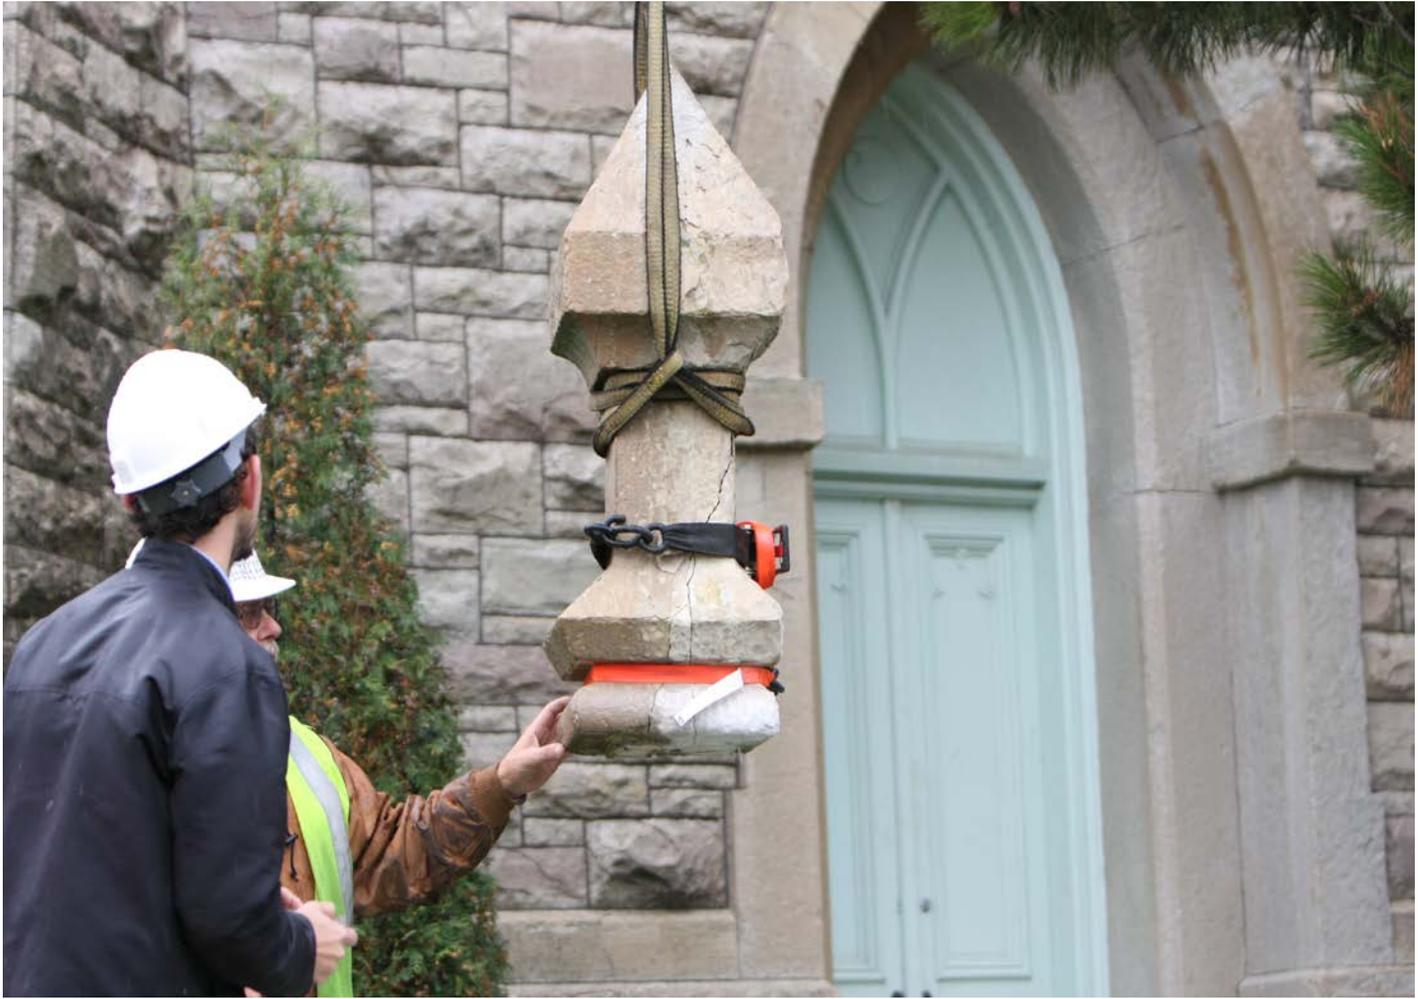
A closeup view reveals cracks in one of the old finials.
