Historical Land Use Investigation

827-29 E. Brady Street
Milwaukee, Wisconsin

File: 360-13

March 18, 2013

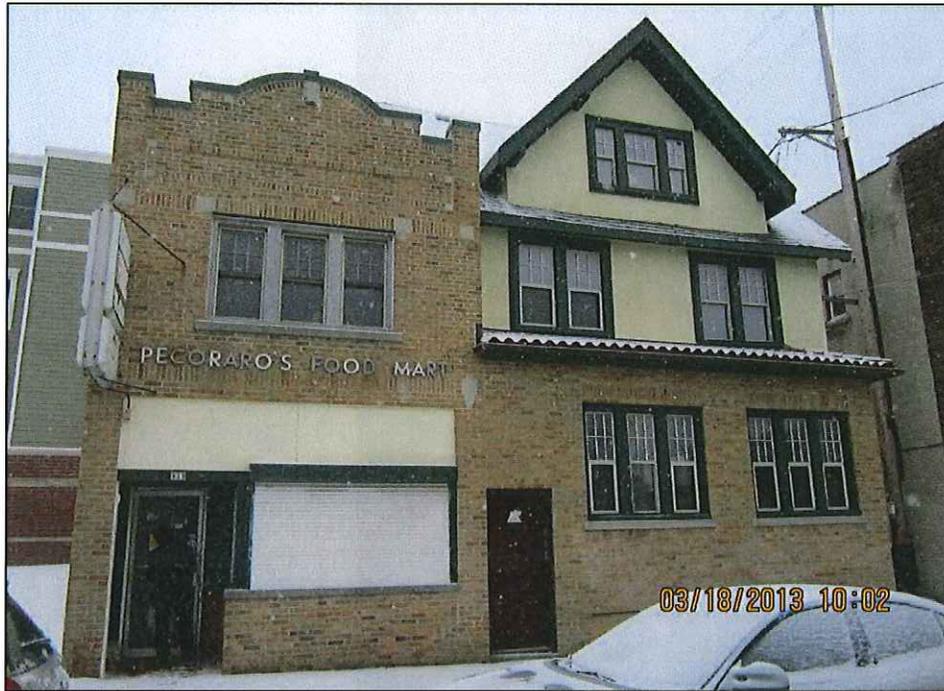
View of project site, facing south from E. Brady St.

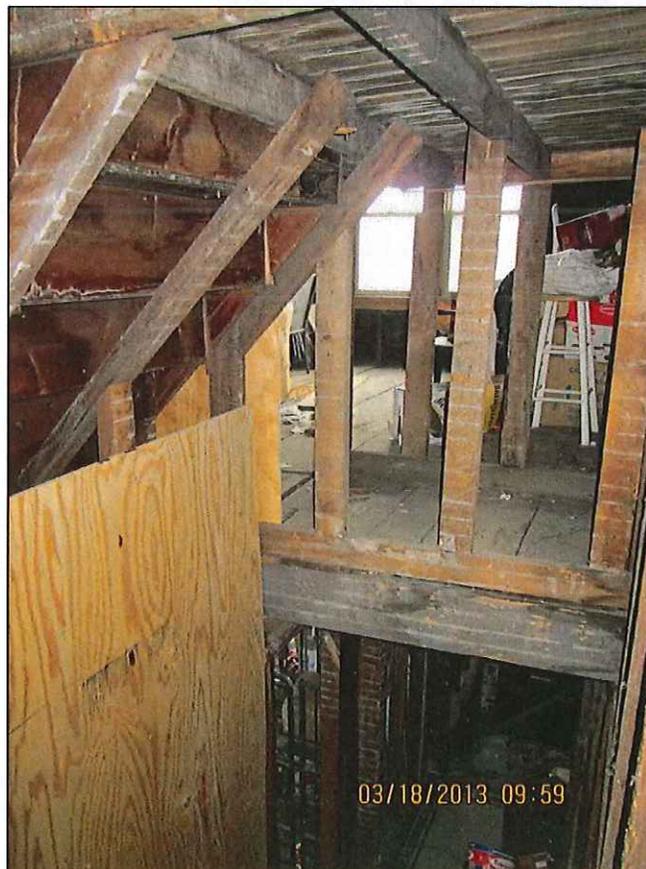
View of project site interior, facing south from second floor landing.

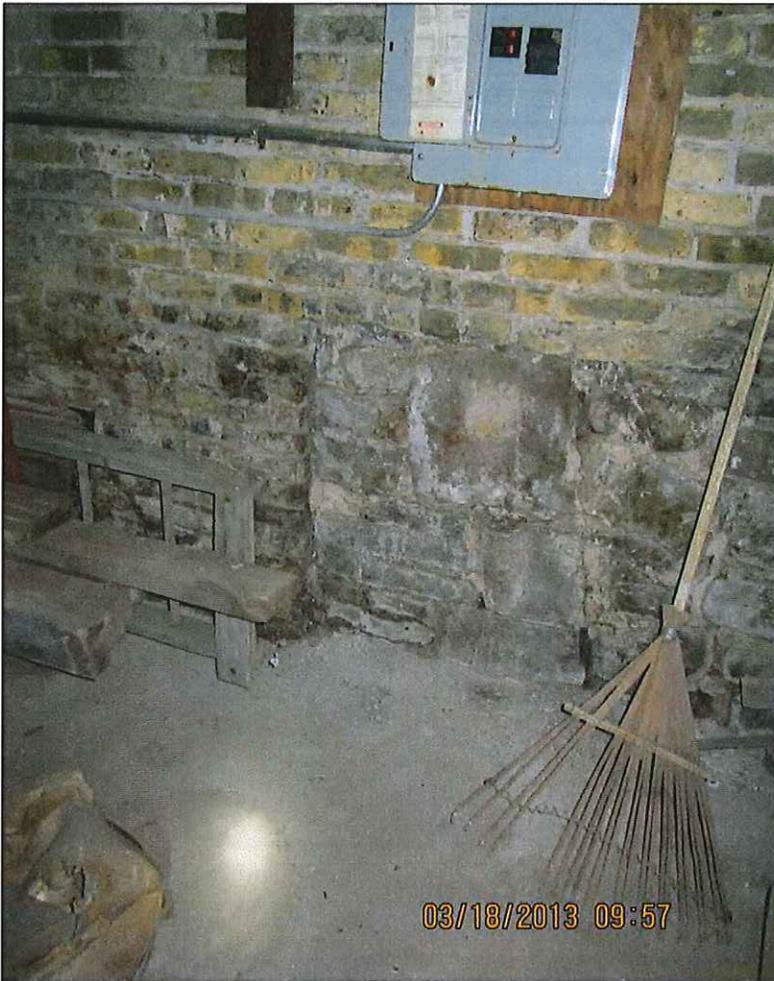
The basement below the western portion of the building was inspected. Ice covered the several steps down into the basement. Within the western portion of the basement, indentations on the ground and an unidentified pipe connection were observed, which may indicate the former presence of an oil tank. No other environmental concerns were identified.

Indentations were observed in the basement floor, which may suggest the former presence of a tank.

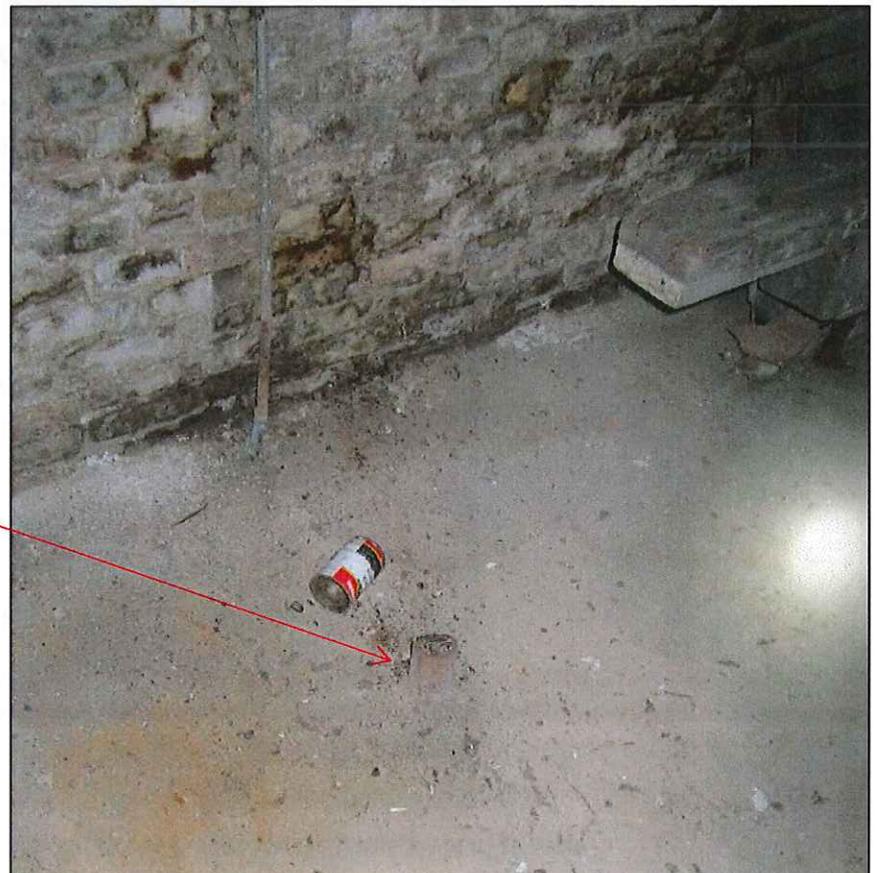
A pipe extension was observed protruding from the basement floor.

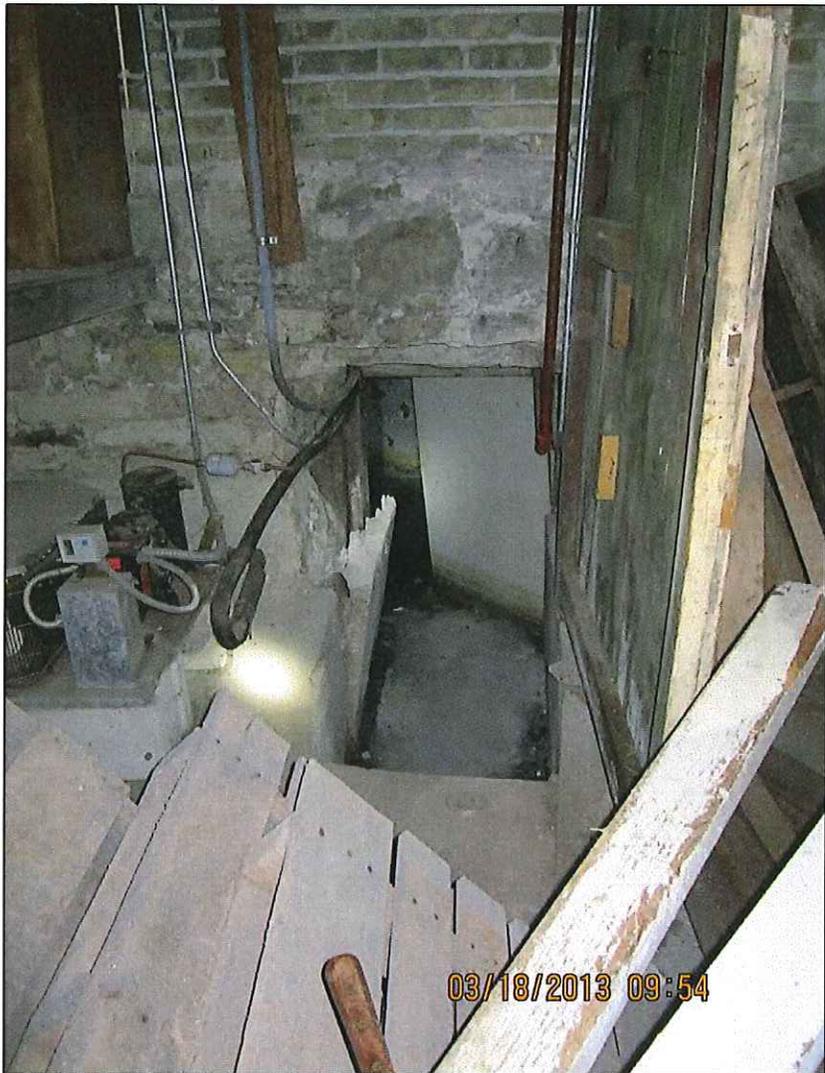
From the western basement area, several steps lead further down below the eastern portion of the building. This basement area appeared unsafe as it was covered in ice and had a low ceiling, and was not inspected.

View from the western portion of the basement down into an eastern portion of the basement, which is further below grade. This lower section was not inspected as it appeared to have a low ceiling and the ground was covered in ice.

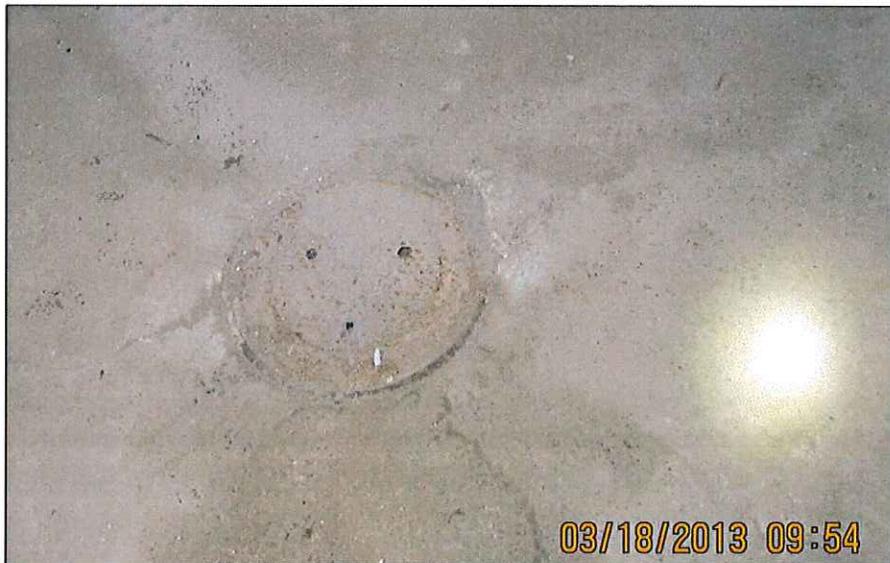
Basement floor drain.
