**SUBJECT:** Final Case Closure with Continuing Obligations  
 Diversified Machine – Former, 2021 and 2039 S. Lenox St., Milwaukee, Wisconsin  
 DNR BRRTS # 02-41-563513 FID # 241021880

ENGINEERED BARRIER LOCATION MAP  
2021 S. LENOX STREET  
MILWAUKEE, WI

**ENGINEERED BARRIER LOCATION MAP**

**GROUNDWATER ISOCONCENTRATION MAP**  
 2021 & 2039 S. LENOX STREET  
 MILWAUKEE, WI

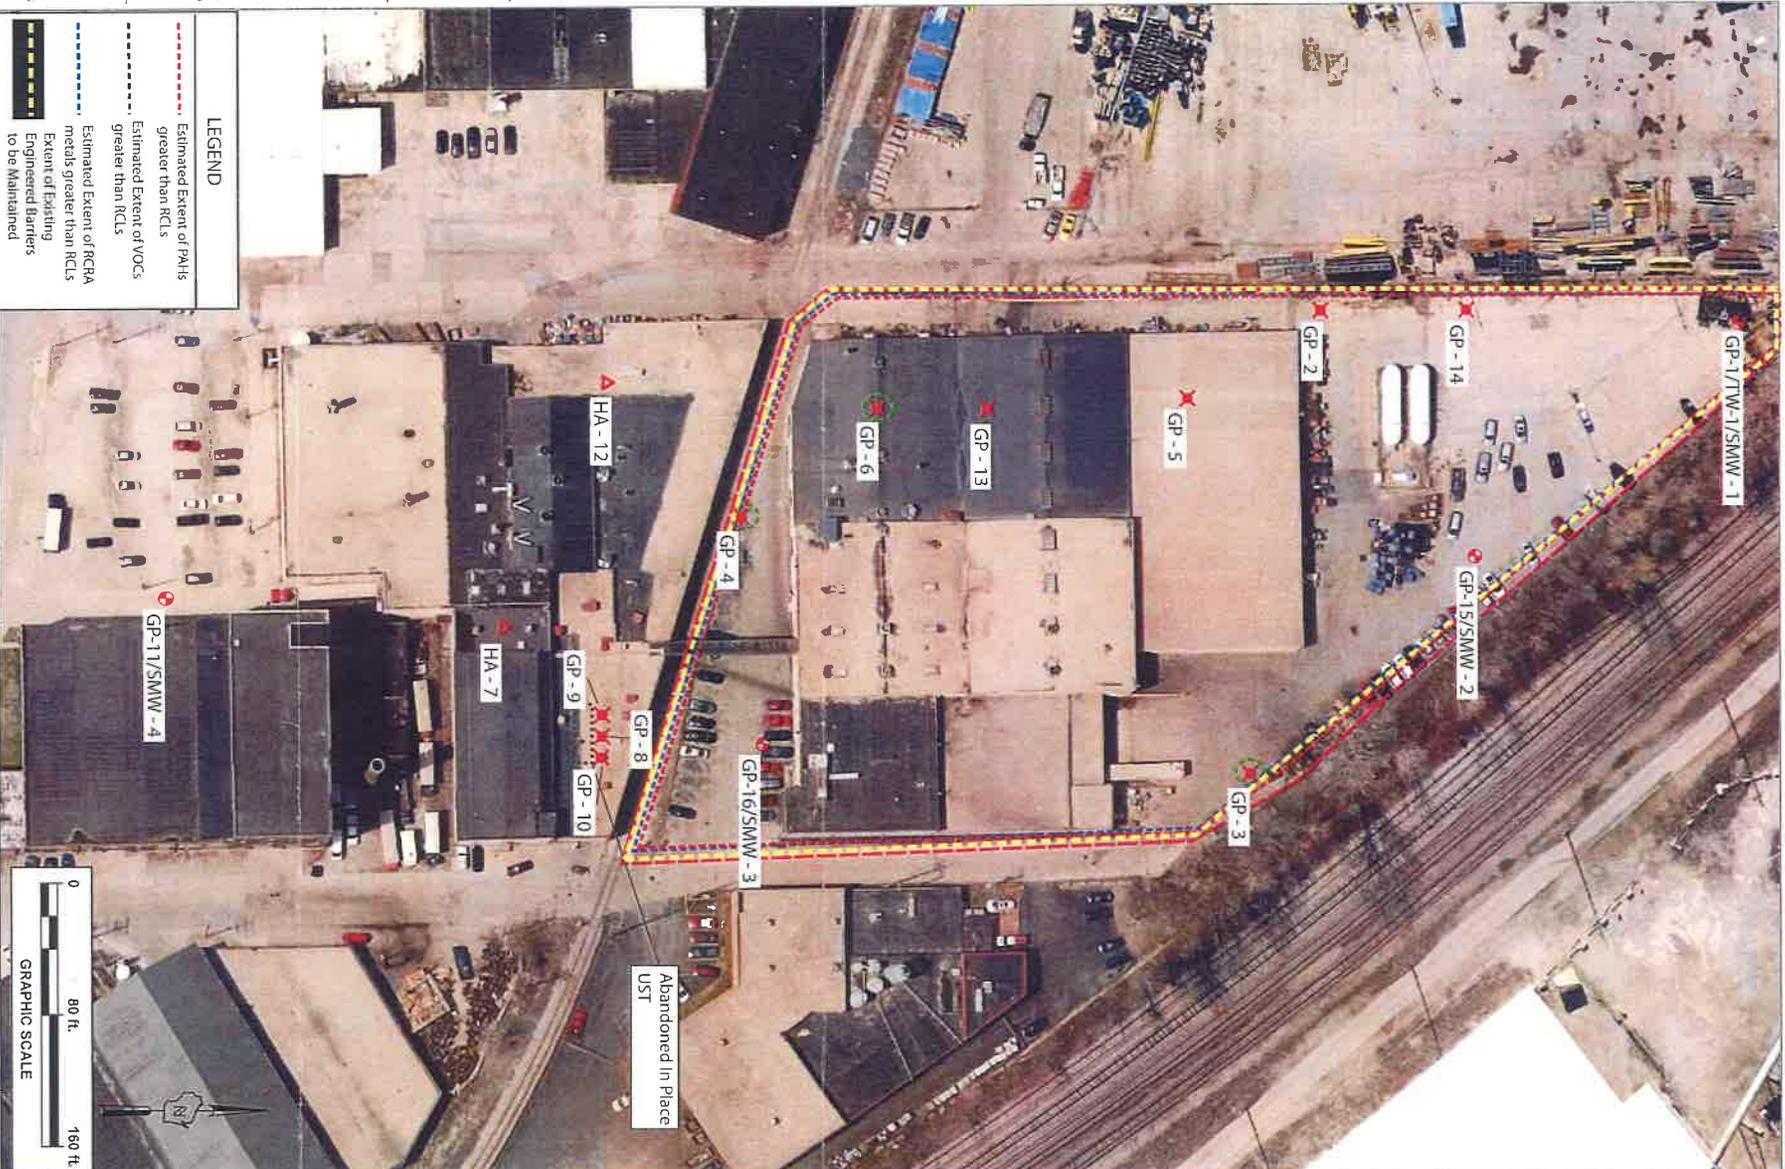
FIGURE  
**D.1.**

The barrier consists of minimum 4-inch thick asphalt pavement or minimum 4-inch thick concrete pavement or building floor slab. These pavements/buildings are located across the entire site (except for the railroad and railroad right-of-way which are not part of the Site) as shown on Figure D.1.

The pavement and building foundations that exist over the two parcels, identified as 2021 and 2039 South Lenox Street, as shown in the attached maps titled Engineered Barrier Location Map, Figure D.1., shall be maintained in compliance with the attached maintenance plans. When properly maintained, these barriers should minimize the infiltration of water and prevent additional groundwater contamination that would violate the groundwater quality standards in ch. NR 140, Wis. Adm. Code, and to prevent direct contact with residual soil contamination that might otherwise pose a threat to human health.

The building slabs and pavement overlying the contaminated soil and as depicted in Figure D.1 will be inspected once a year, normally in the spring after all snow and ice is gone, for deterioration, cracks and other features that could cause additional infiltration into or exposure to underlying soils. The inspections will be performed by the property owner or their designated representative. The inspections will be performed to evaluate damage due to settling, exposure to the weather, wear from traffic, increasing age and other factors. Any area where soils have become or are likely to become exposed and where infiltration from the surface will not be effectively minimized will be documented. A log of the inspections and any repairs will be maintained by the property owner and is included as Exhibit B, Cap Inspection Log. The log will include recommendations for necessary repair of any areas where underlying soils are exposed and where infiltration from the surface will not be effectively minimized. Once repairs are completed, they will be documented in the inspection log. A copy of the inspection log will be kept at the address of the property owner and available for submittal or inspection by Wisconsin Department of Natural Resources ("WDNR") representatives upon their request.

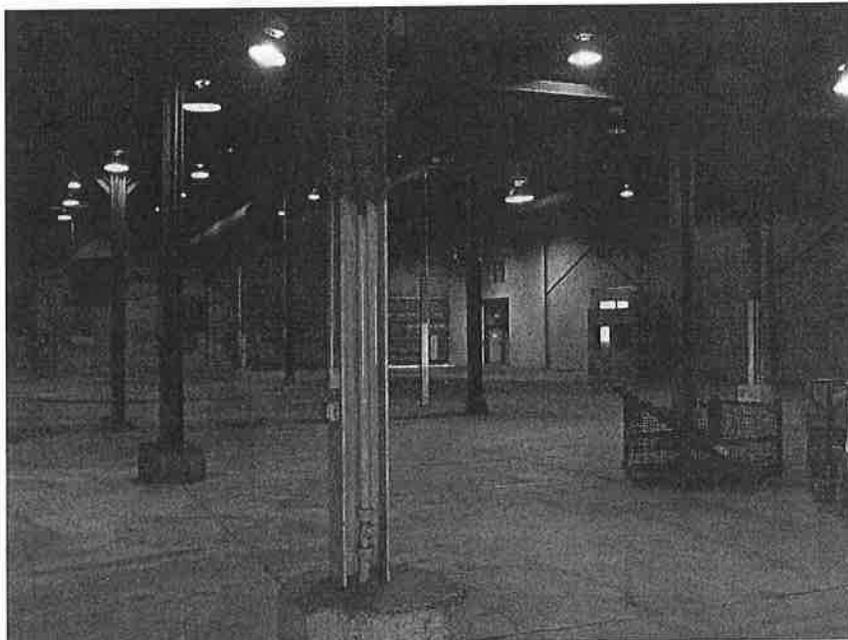
Photo 1: Typical building slab. View to east; photograph taken on March 5, 2015.

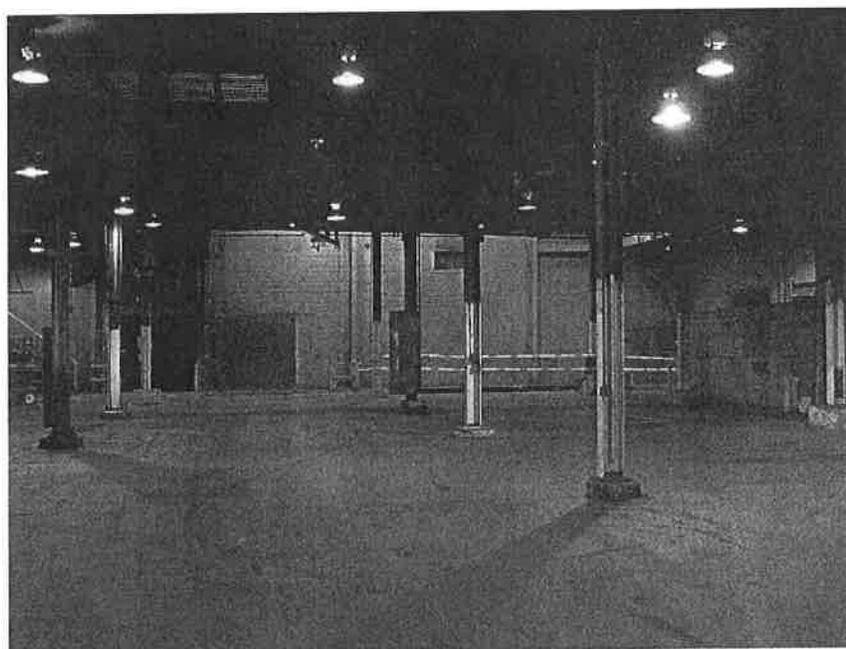
Photo 2: Typical building floor slab. View to north; photograph taken on March 5, 2015.

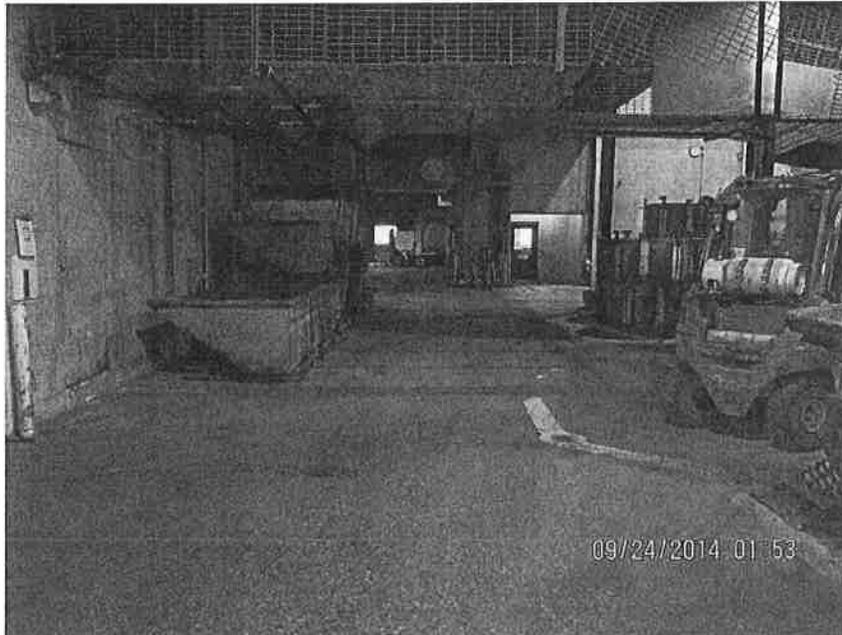
Photo 3: Typical building floor slab in south building. View to west; photograph taken on September 24, 2014.

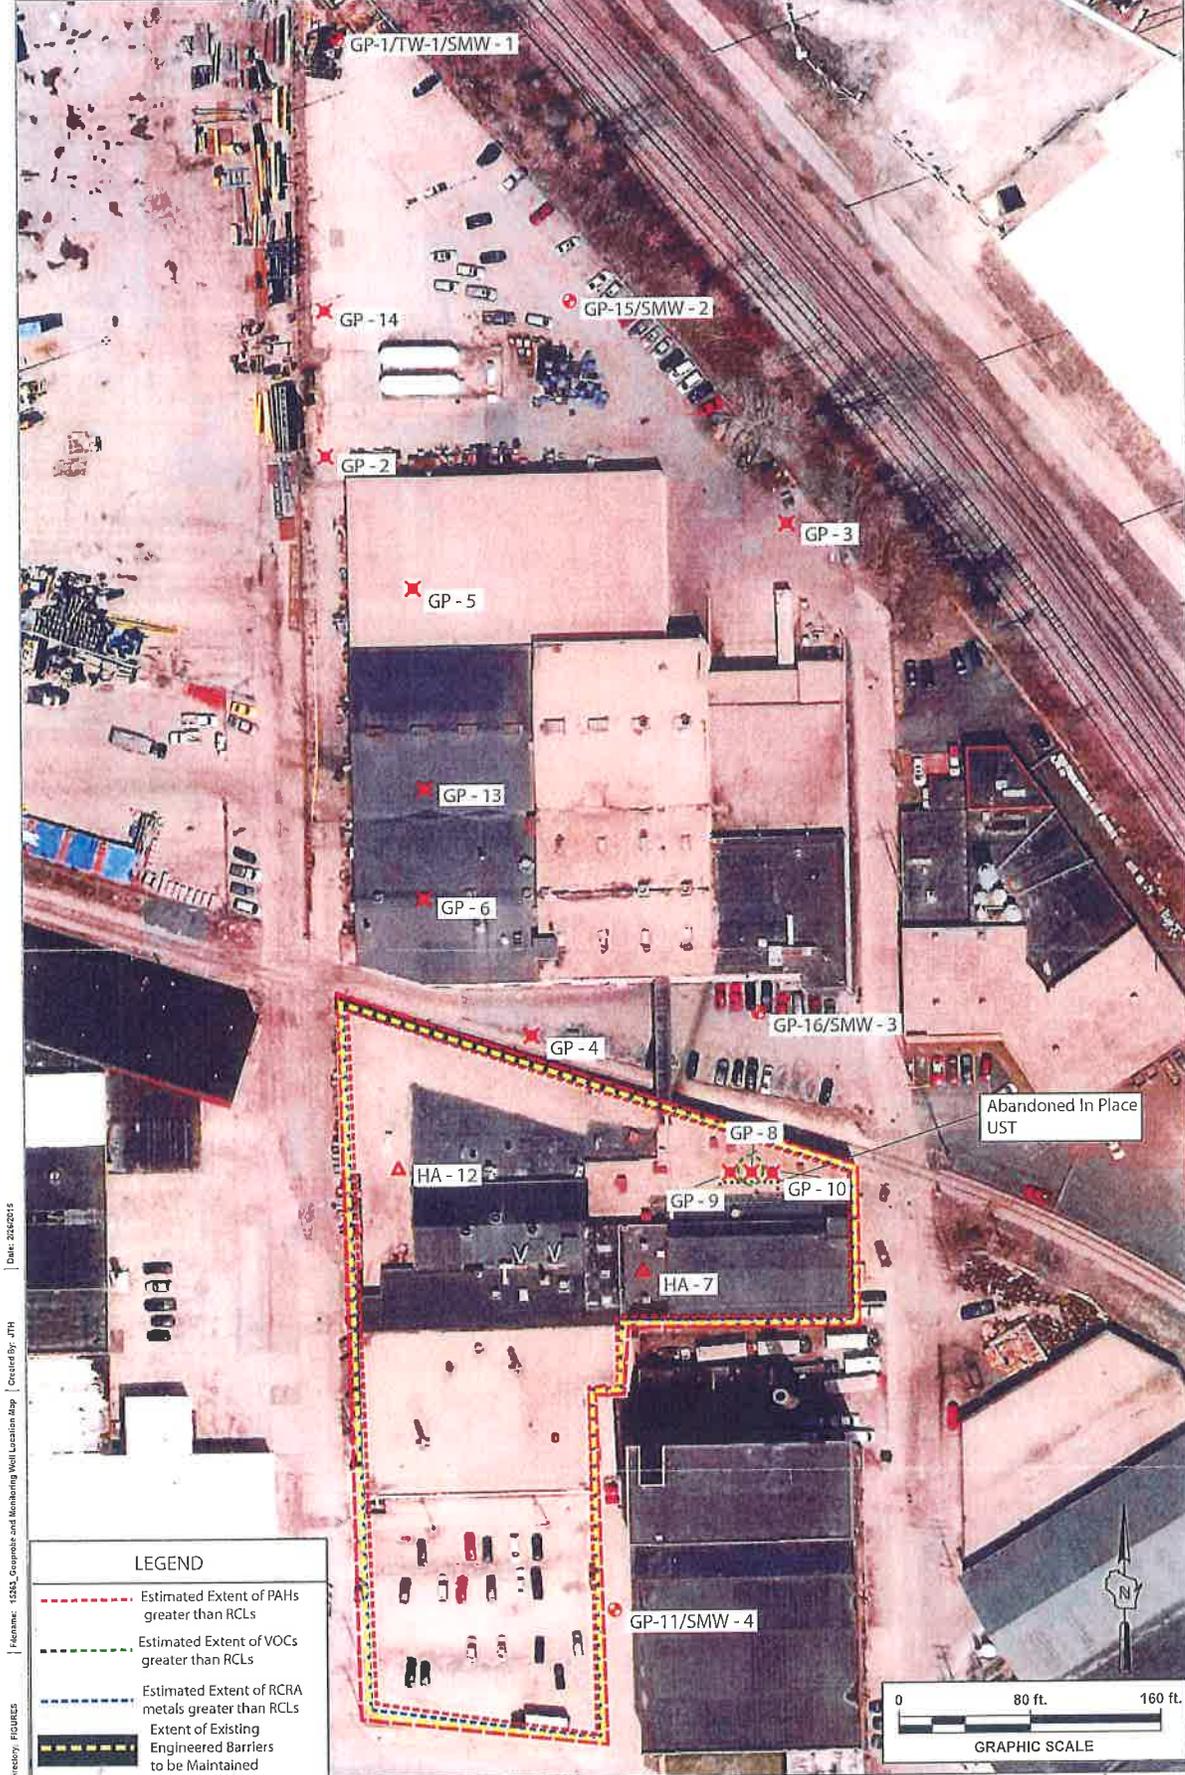
**D.1.**

2039 S. LENOX STREET  
MILWAUKEE, WI

The barrier consists of minimum 4-inch thick asphalt pavement or minimum 4-inch thick concrete pavement or building floor slab. These pavements/buildings are located across the entire site (except for the railroad and railroad right-of-way which are not part of the Site) as shown on Figure D.1.

The building slabs and pavement overlying the contaminated soil and as depicted in Figure D.1 will be inspected once a year, normally in the spring after all snow and ice is gone, for deterioration, cracks and other features that could cause additional infiltration into or exposure to underlying soils. The inspections will be performed by the property owner or their designated representative. The inspections will be performed to evaluate damage due to settling, exposure to the weather, wear from traffic, increasing age and other factors. Any area where soils have become or are likely to become exposed and where infiltration from the surface will not be effectively minimized will be documented. A log of the inspections and any repairs will be maintained by the property owner and is included as Exhibit B, Cap Inspection Log. The log will include recommendations for necessary repair of any areas where underlying soils are exposed and where infiltration from the surface will not be effectively minimized. Once repairs are completed, they will be documented in the inspection log. A copy of the inspection log will be kept at the address of the property owner and available for submittal or inspection by Wisconsin Department of Natural Resources ("WDNR") representatives upon their request.

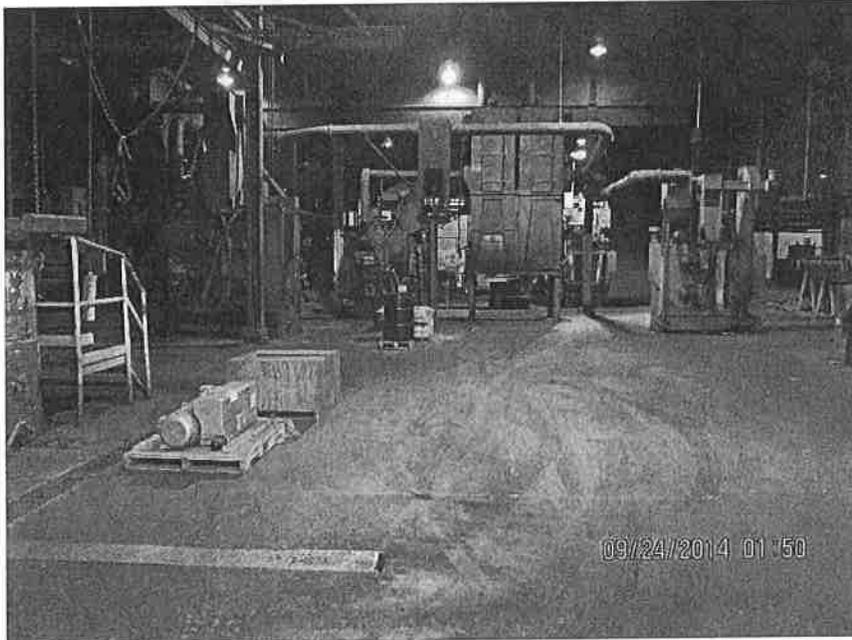
Photo 1: Typical building floor slab in south building. View to west; photograph taken on September 24, 2014.

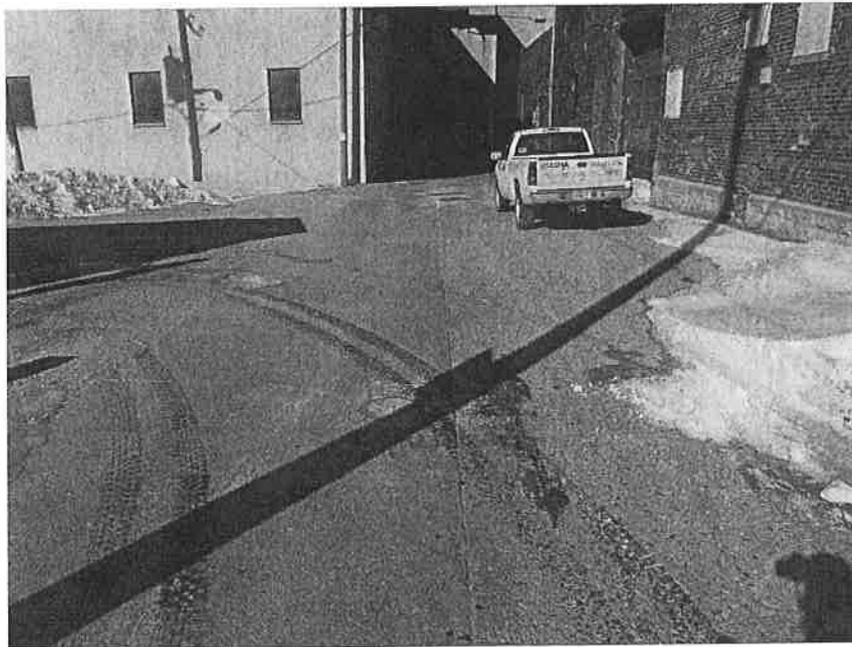
Photo 2: Typical pavement View to north; photograph taken on February 19, 2015.

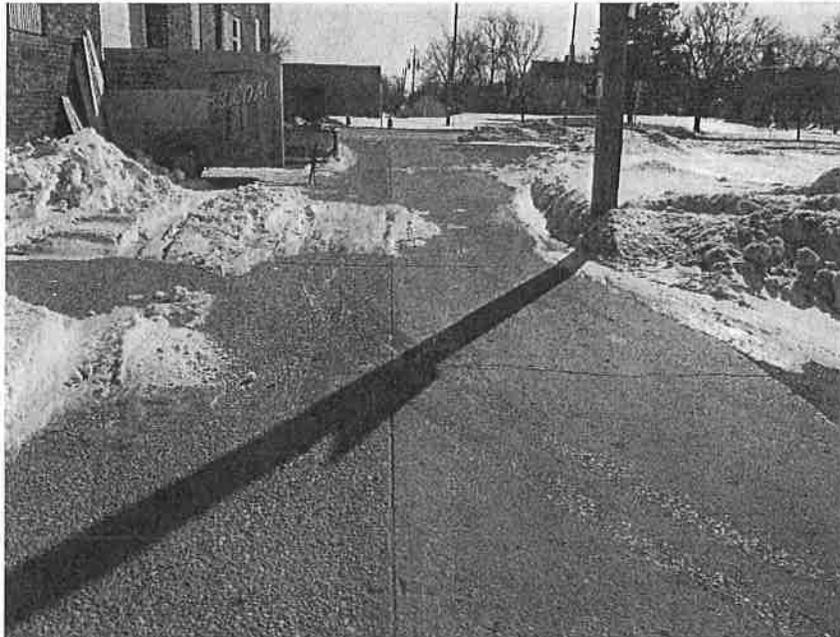
Photo 3: Typical pavement. View to south; photograph taken on February 19, 2015.

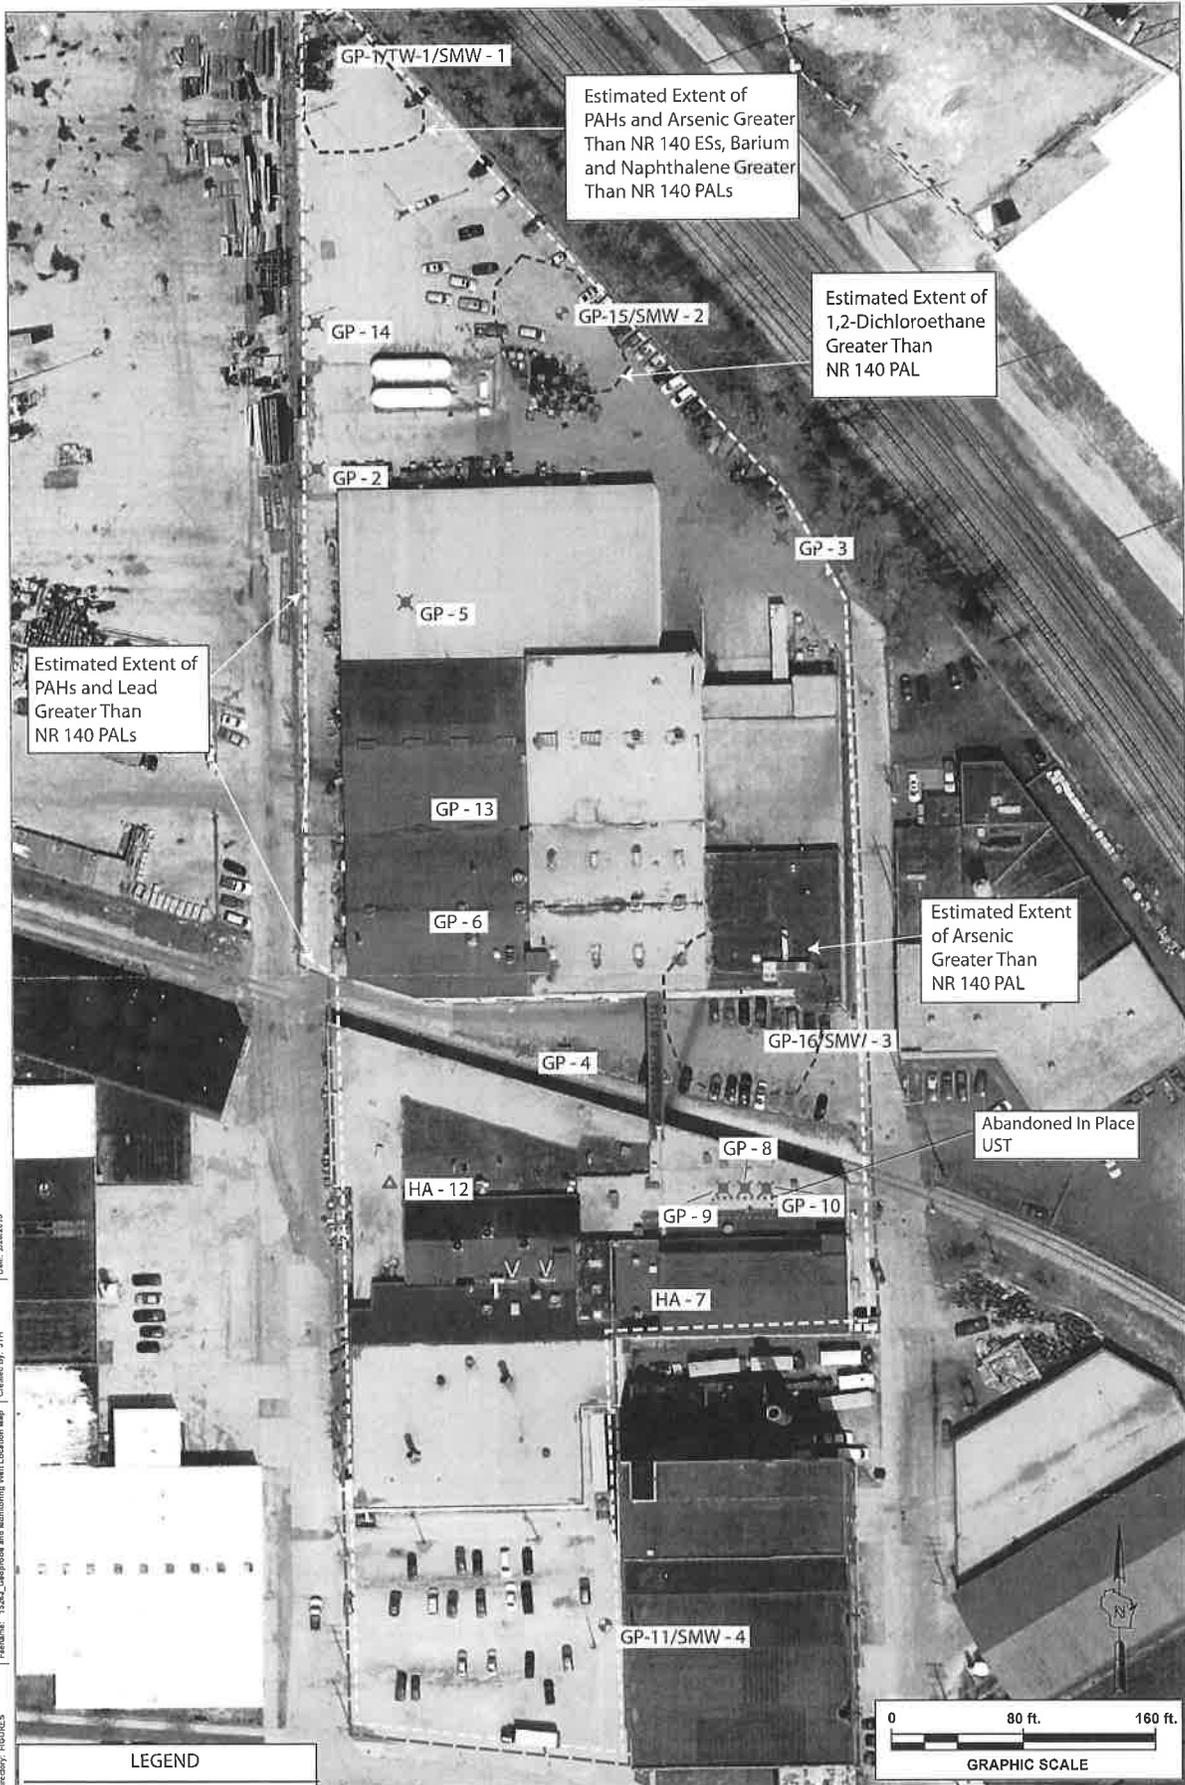
FIGURE  
**B.3.B.**

Groundwater contamination greater than enforcement standards is present on this contaminated site, as shown on the attached map, Groundwater Isoconcentration Map, Figure B.3.B., dated February 26, 2015. If you intend to construct a new well, or reconstruct an existing well, you'll need prior DNR approval.

Historic fill/soil contaminated by select volatile organic compound (VOC) constituents is located at depths within 4 feet of the existing ground surface at sporadic locations across the site. Historic fill/soil contaminated by select polynuclear aromatic hydrocarbon (PAH) and RCRA metal constituents is located generally across the site at beneath existing pavement and building floor slabs to depths of approximately 8 feet below ground surface. Groundwater contaminated by select VOC, PAH, and RCRA metal constituents is located at depths between 5 to 9 feet below the existing ground surface. The extent of the soil and groundwater contamination is shown on the attached Figures B.2.C. and B.3.B.

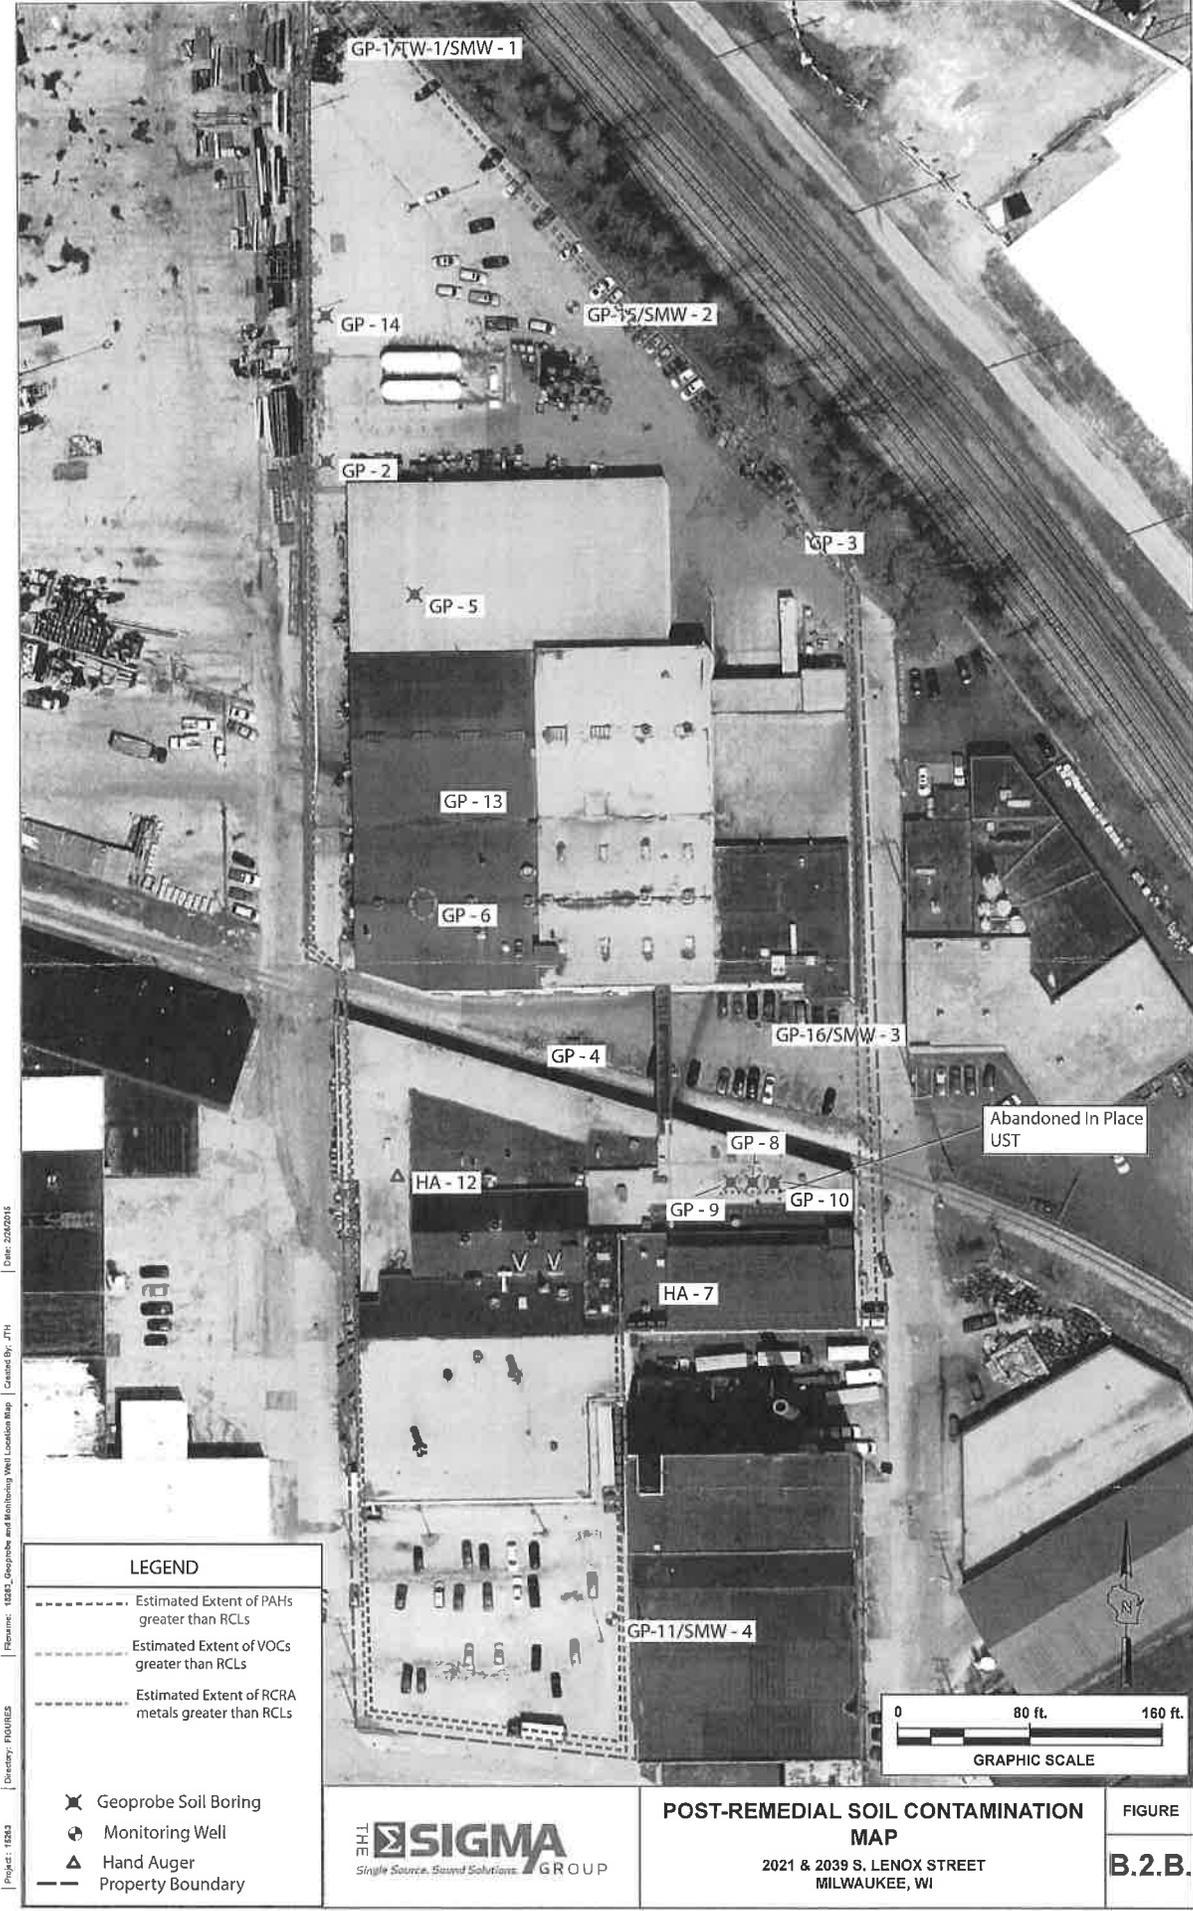
FIGURE  
**B.2.B.**

Soil contamination remains across these properties as indicated on the attached map, Post-Remedial Soil Contamination Map, Figure B.2.B., dated February 26, 2015. If soil in the specific locations described above is excavated in the future, the property owner or right-of-way holder at the time of excavation must sample and analyze the excavated soil to determine if contamination remains. If sampling confirms that contamination is present, the property owner or right-of-way holder at the time of excavation will need to determine whether the material is considered solid or hazardous waste and ensure that any storage, treatment or disposal is in compliance with applicable standards and rules. Contaminated soil may be managed in accordance with ch. NR 718, Wis. Adm. Code, with prior DNR approval.

**POST-REMEDIATION SOIL CONTAMINATION MAP**  
 2021 & 2039 S. LENOX STREET  
 MILWAUKEE, WI
