Audit Date: 3/7/2011

ABOUT THIS REPORT

EVALUATION REPORT

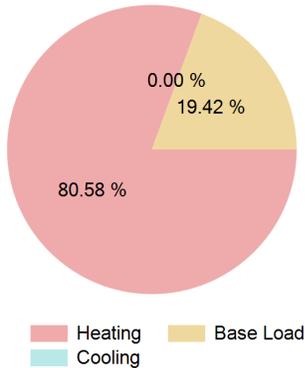
Current Energy Use

Heating usage includes all energy used to heat your home, similarly for cooling. They are both weather dependent. Base load is the energy use that is independent of the weather. This includes uses like appliances and lighting as well as hot water. This chart shows how your home is currently using energy among these different end uses.

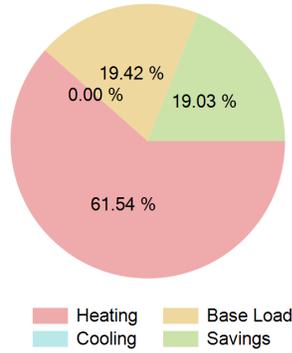
Proposed Energy Use

Each improvement affects the energy profile of your house in different ways. Insulation will improve both heating and cooling while replacing a refrigerator will only improve the base-load. This chart indicates the proposed energy usage of your house with all the recommended improvements installed to indicate from where your savings will come.

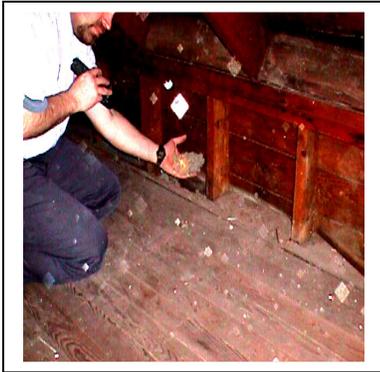
Insulation is in poor shape abut roof shows little sign of damage from ice damming. Insulation will be removed and replaced with densely packed fiberglass or cellulose after air sealing below the floor. The combination of air sealing and increased insulation will prevent ice damming

ATTIC INSULATION

Improve 200 sq. ft. of attic floor insulation from 3 inches to 6 inches.

Workscope: Densely packed cellulose or fiberglass will be installed under the existing attic floor.

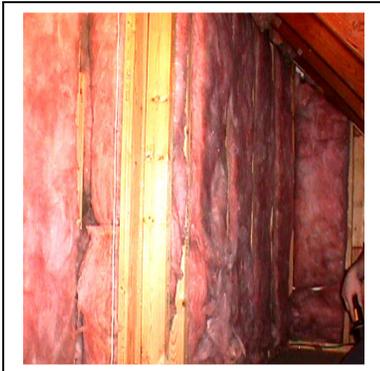
Short wall, or kneewall between attic and bedrooms is poorly insulated and not insulated in other areas. Air sealing and adding insulation will increase comfort and energy savings.

ATTIC KNEE WALL INSULATION

Improve 30 sq. ft. of attic knee wall insulation from 0 inches to 3.5 + 1 Foamboard inches

Workscope: Shared wall between attic and bedroom wall is not insulated. Insulation will be added at the same time as attic insulation

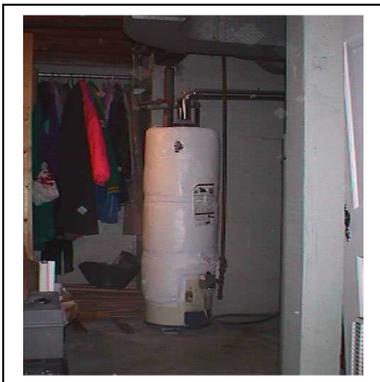
Water heater is currently venting properly, but as building infiltration is reduced the water will fail draft. recommend replacing with a power vented water heater

WATER HEATER IMPROVEMENT

Replace existing Natural Gas Storage Water Heater with new Natural Gas Storage Water Heater.

Workscope: While water heater does draft now, the insulation and air sealing improvements will cause water heater to fail. Unit needs to be replaced

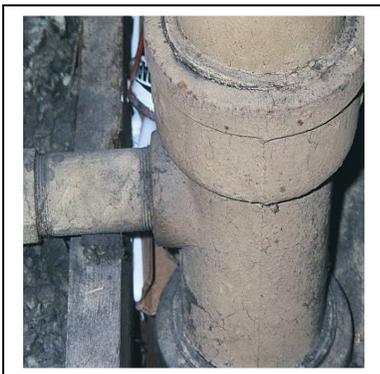
Opportunity for air sealing around plumbing stack where a large opening is visible from attic all the way to the basement.

AIR SEALING

Reduce the house air leakage from 2800 CFM50 to 2000 CFM50.
