**SITE ASSESSMENT REPORT
FOR
BUFFUM MKE SITE
MILWAUKEE, MILWAUKEE COUNTY, WISCONSIN**

Date Prepared	February 24, 2014
Technical Direction Document No.	S05-0001-1310-003
Document Control No.	2252-2A-BLET
Contract No.	EP-S5-06-04
WESTON START Project Manager	Marita Stollenwerk
Telephone No.	(414) 935-2597
EPA On-Scene Coordinator	Kathy Halbur

Figures and tables are presented after Section 7. In addition, this site assessment report contains three appendices. **Appendix A** provides photographic documentation of Site conditions and activities at the time of the reconnaissance and site assessment. **Appendix B** provides documents used to create the chronology for the Site presented in **Table 2-1**. **Appendix C** provides the laboratory analytical and data validation reports for samples collected during the site assessment.

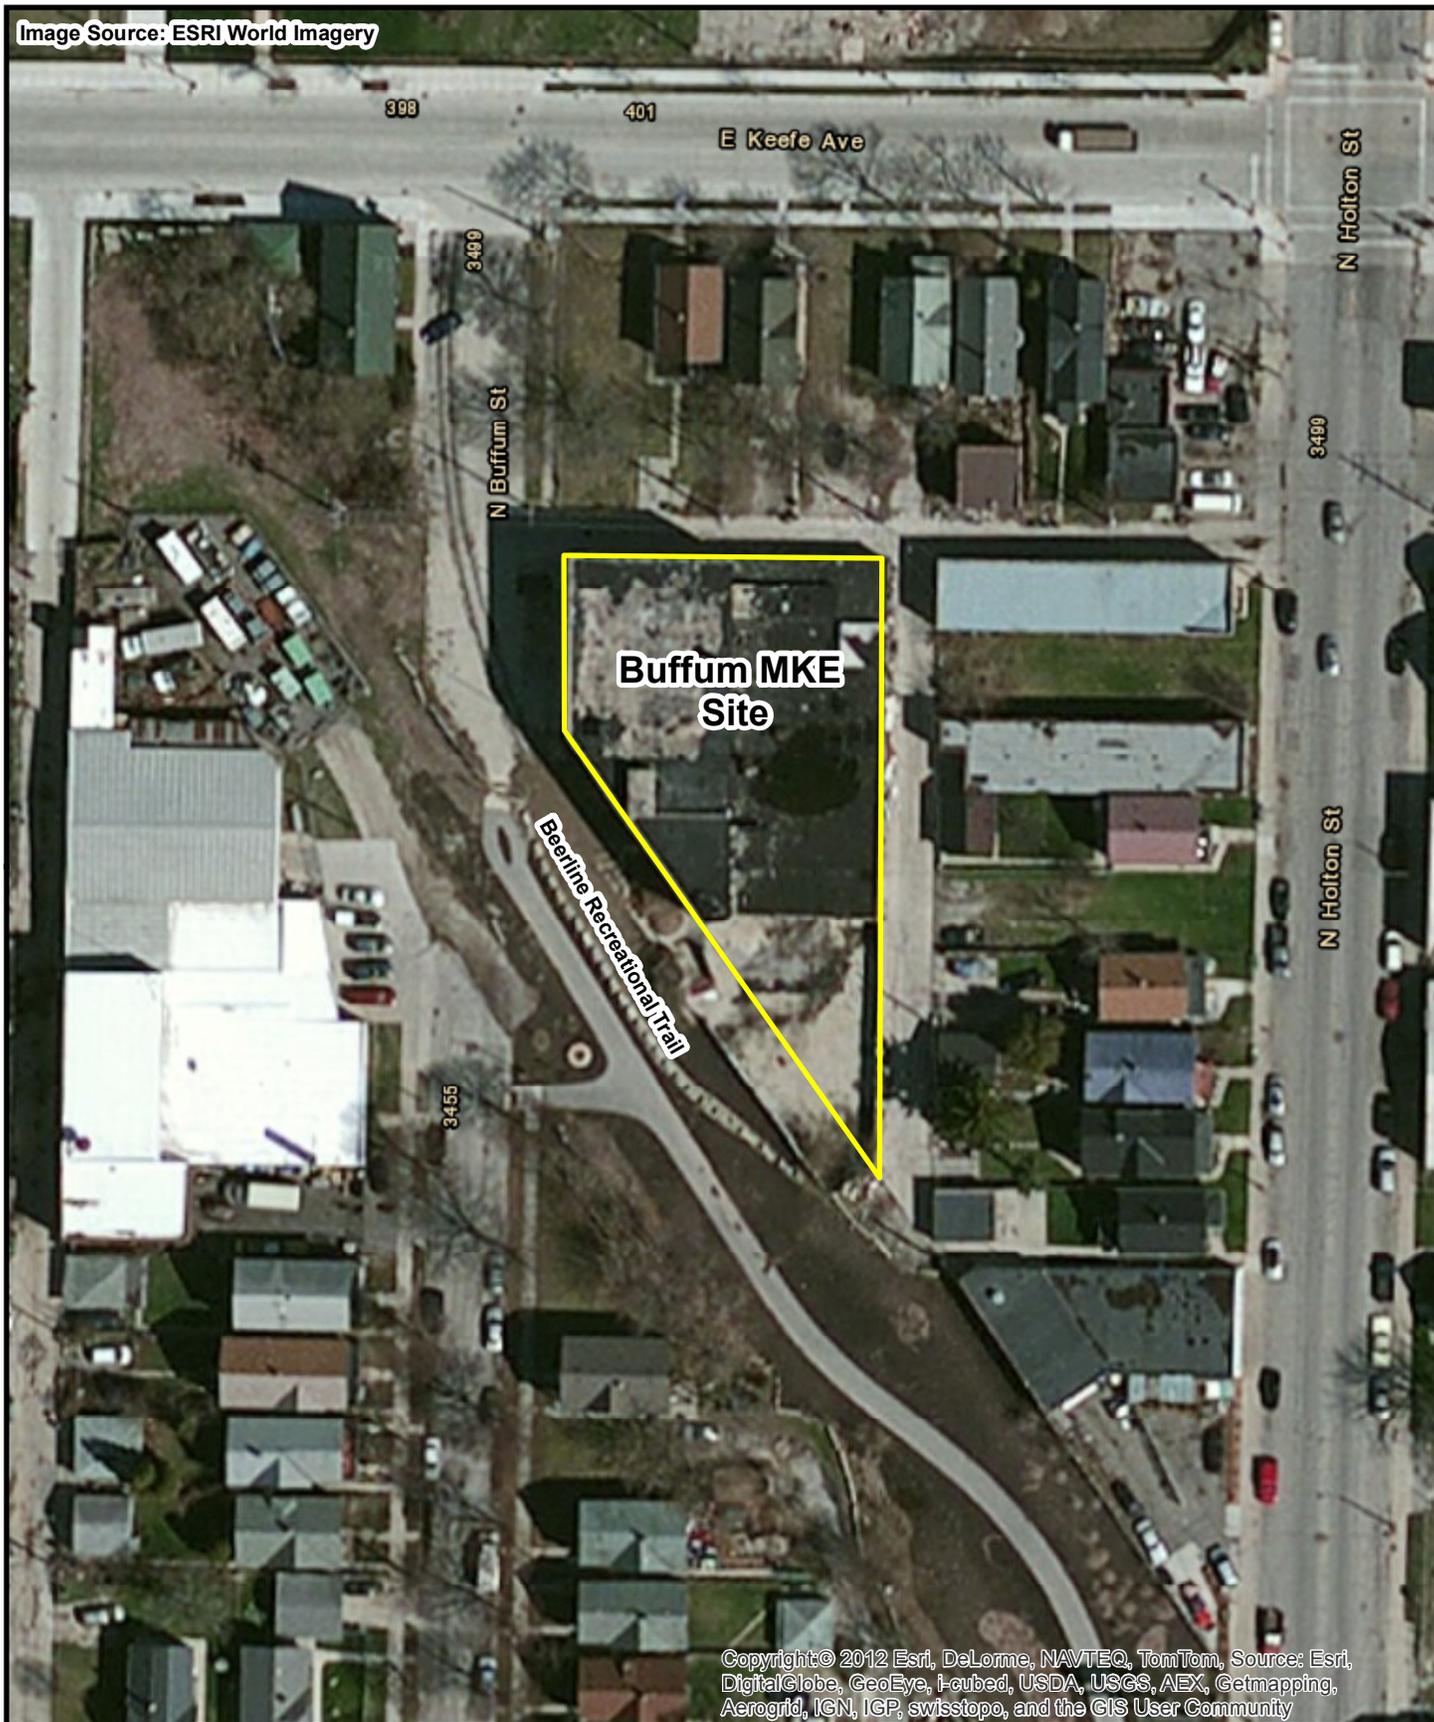
Figure 2-1
Site Features Map
Buffum MKE Site
Milwaukee, Milwaukee County, WI

The Site is located at 3456 North Buffum Street in Milwaukee, Milwaukee County, Wisconsin. **Figure 1-1** shows the Site location. The Site's approximate geographical coordinates are 43°4'53.0" North latitude and 87°54'21.0" West longitude. The Site occupies approximately 0.42 acre and contains a three-story building occupying approximately 27,500 square feet (ft²) and an asphalt lot. **Figure 2-1** shows the Site features. **Appendix A** provides photographic documentation of Site conditions and site assessment activities.

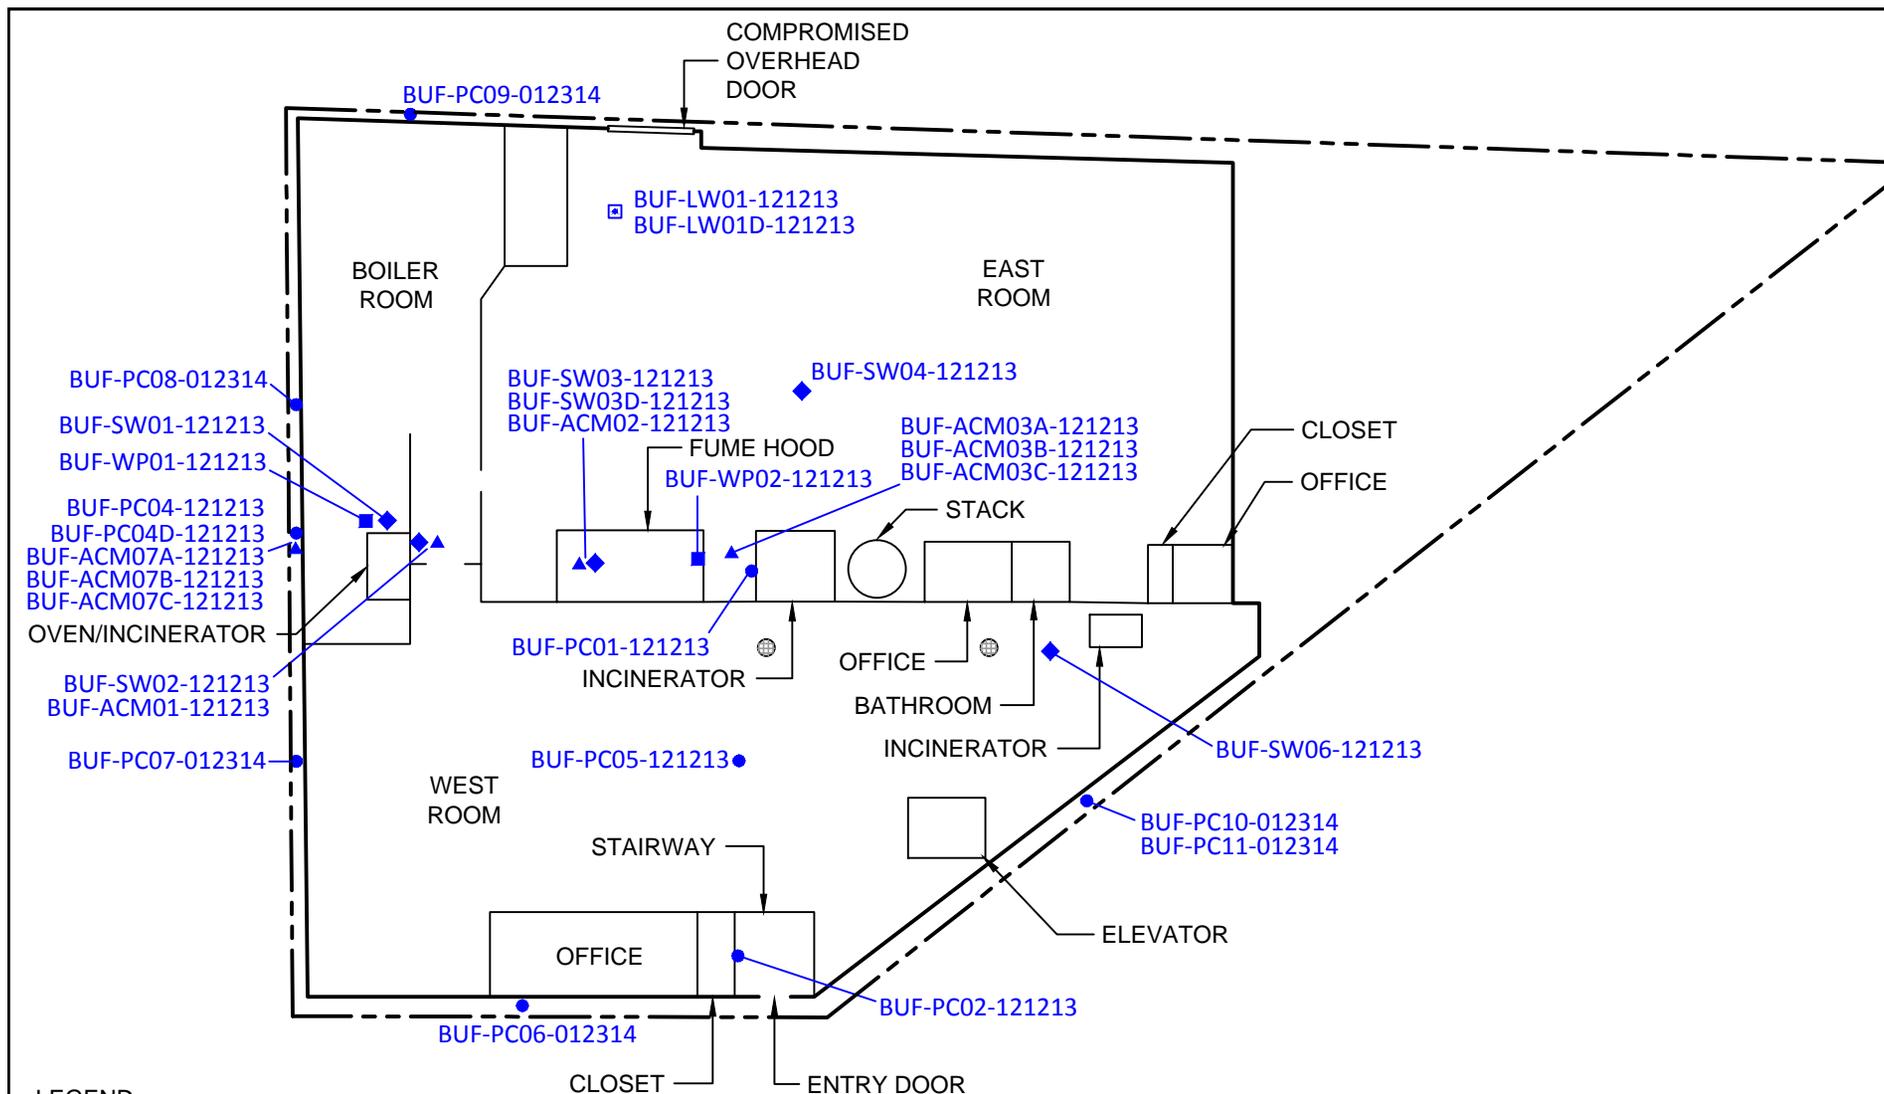
Figure 3-1
 Sampling Location Map - Ground Floor
 Buffum MKE Site
 Milwaukee, Milwaukee County, WI

Upon entering the first floor of the Site building through the one operable entrance, the group observed paint peeling from the walls and ceiling; ten to twelve 5-gallon buckets, some containing a red liquid and some spilled onto the floor; an overturned 55-gallon drum of ash spilled on the floor; two compressed gas cylinders near the entryway labeled “oxygen”; and two 2- to 3-foot-diameter floor drains. One floor drain is open and contains black sludge. **Figure 3-1** shows the locations of these floor drains.

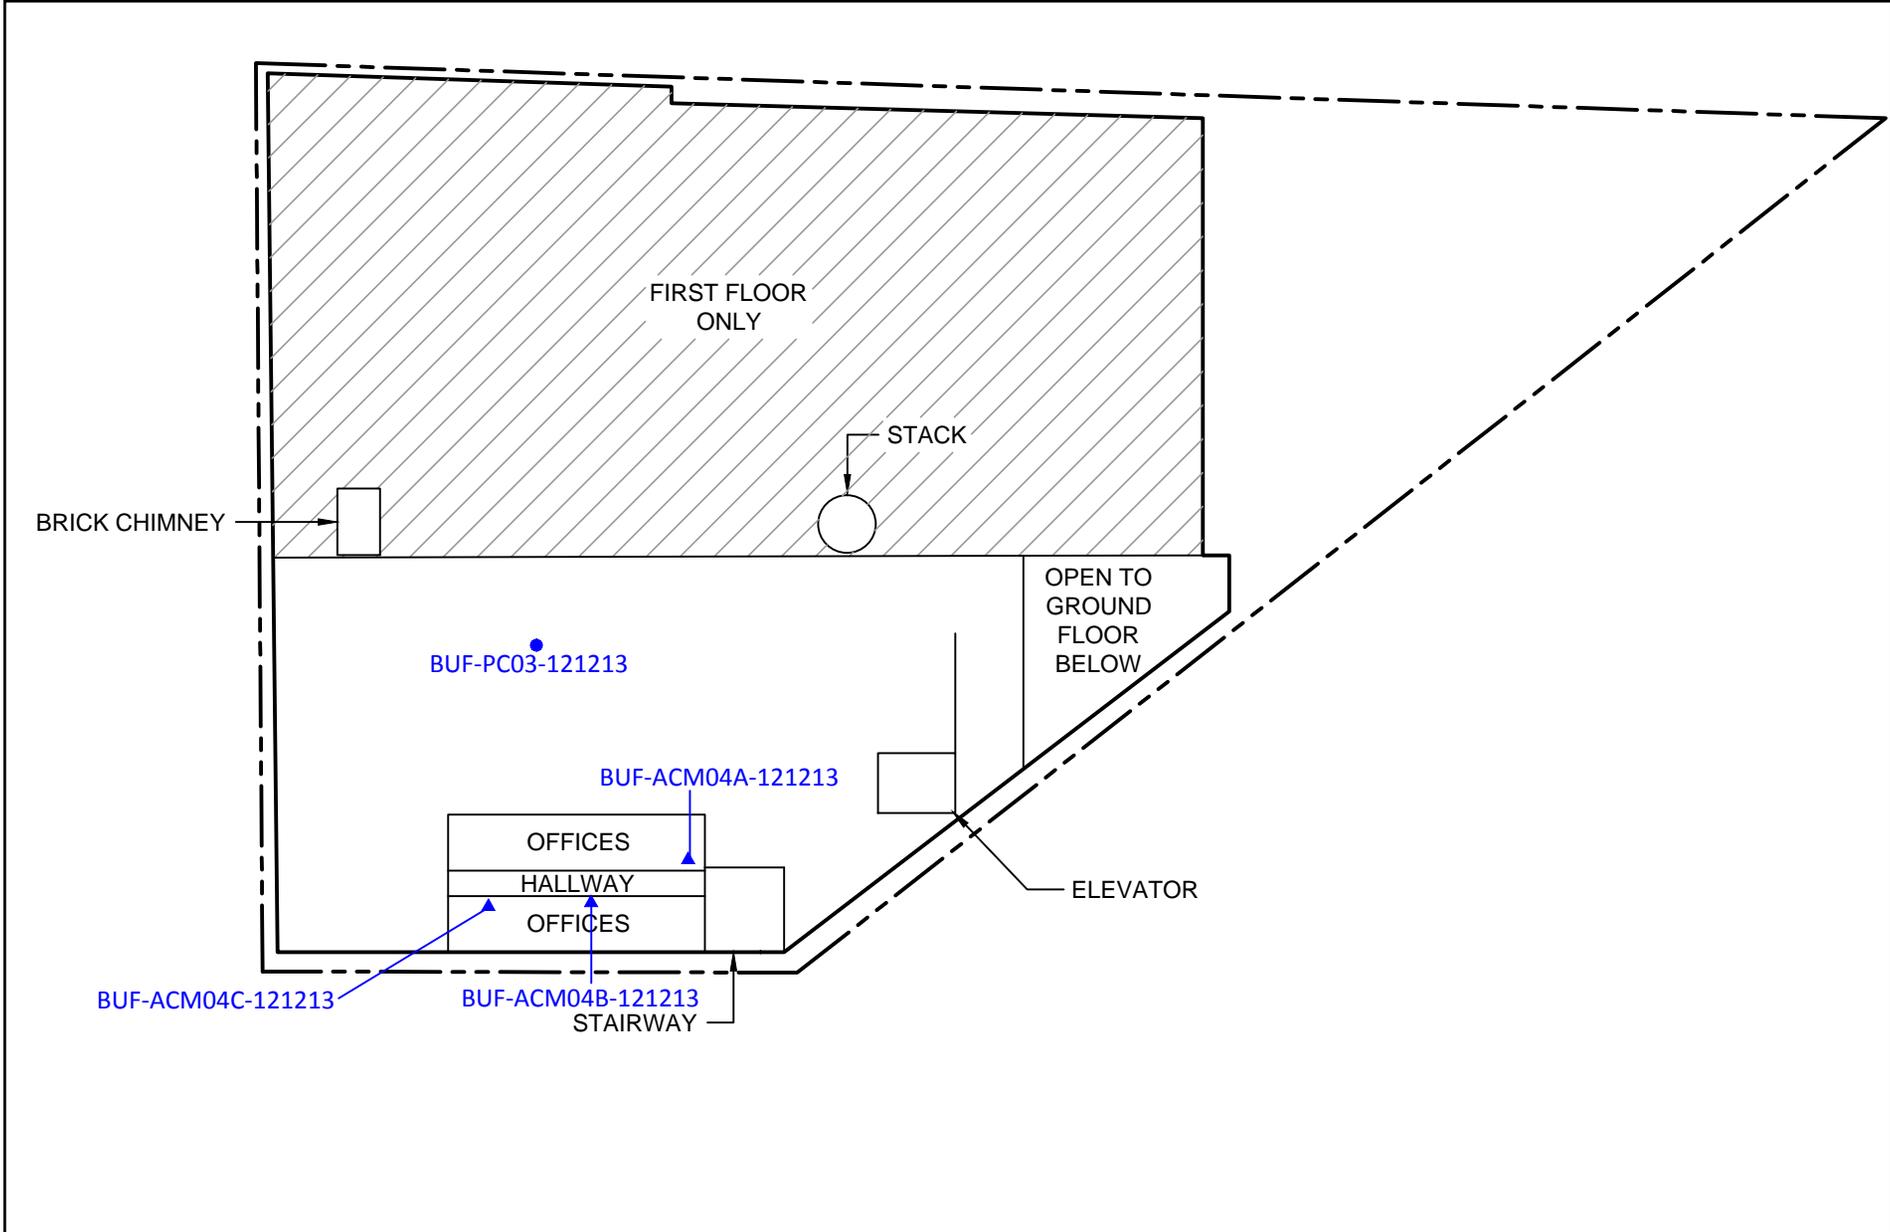
Figure 3-2
 Sampling Location Map - Second Floor
 Buffum MKE Site
 Milwaukee, Milwaukee County, WI

The second floor of the Site building contains offices and a large area with tile and peeling paint. Insulation was observed to be falling from overhead ductwork. Ceiling tiles were observed to be crumbling and on the floor.

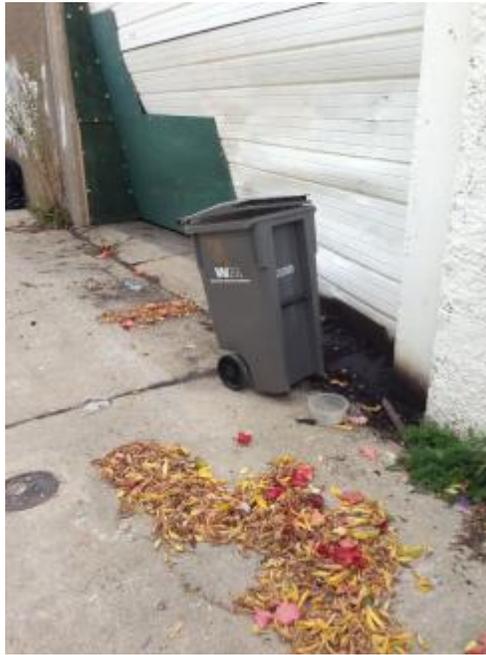
Photograph No.: 3

Subject: Outside view of repaired compromised overhead door and stained pavement adjacent to drums near door inside Site building

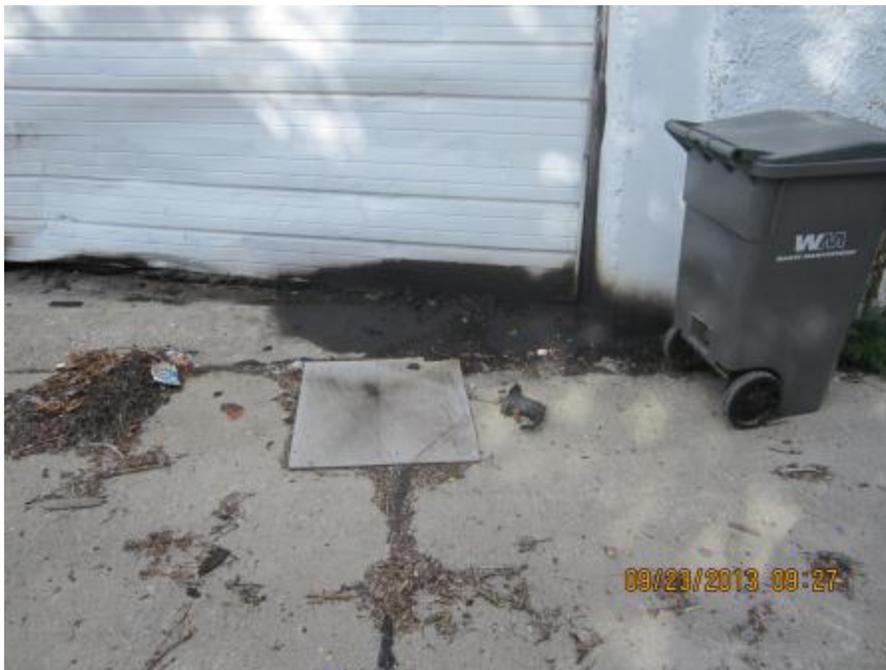
Photograph No.: 4

Subject: Closeup of stained area at compromised overhead door

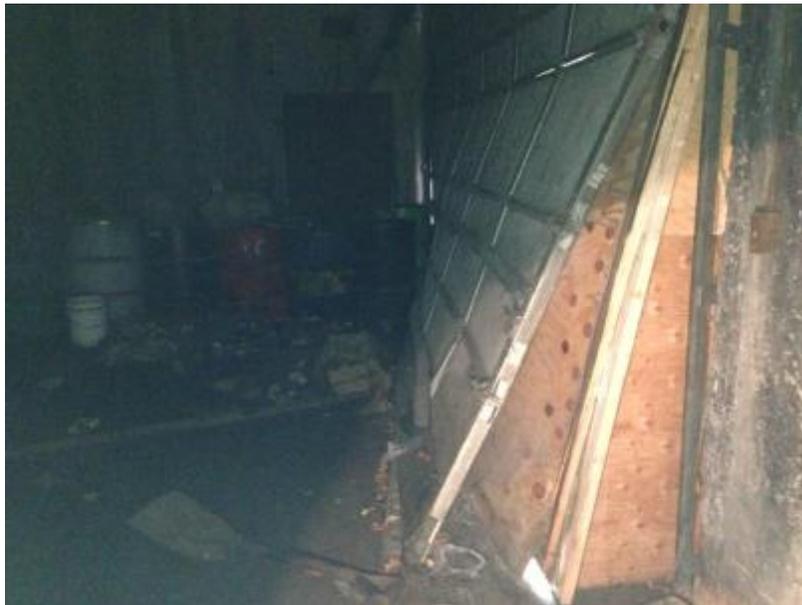
Photograph No.: 16

Subject: Compromised overhead door with repairs visible; note drums next to door; samples BUF-LW01-121213 and BUF-LW01D-121213 collected from 5-gallon bucket on left side of photograph

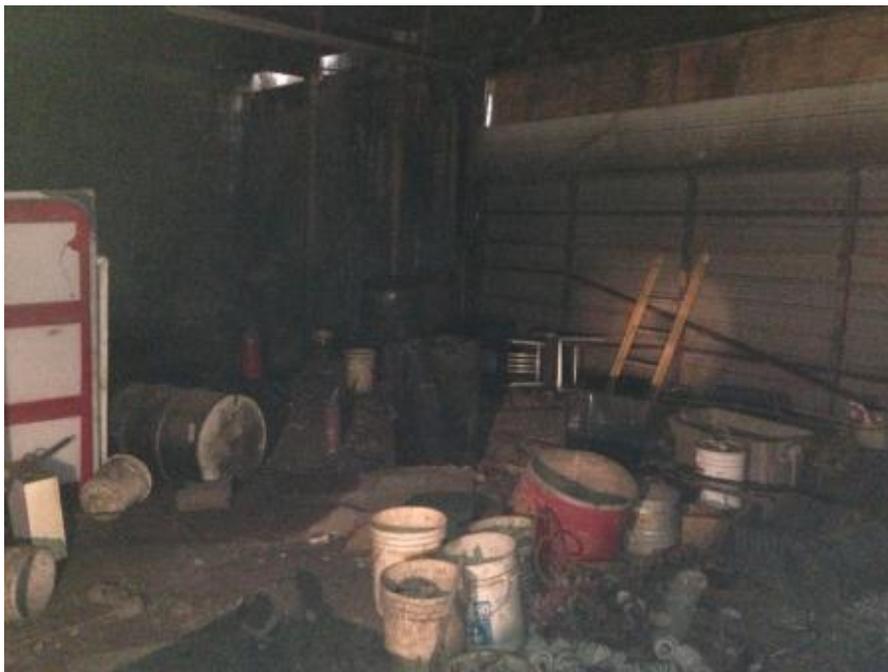
Photograph No.: 18

Subject: 55-Gallon drums, 5-gallon buckets, and electrical pieces and light bulbs on south end of the east room; leaking distended drum lying on its side on left side of photograph

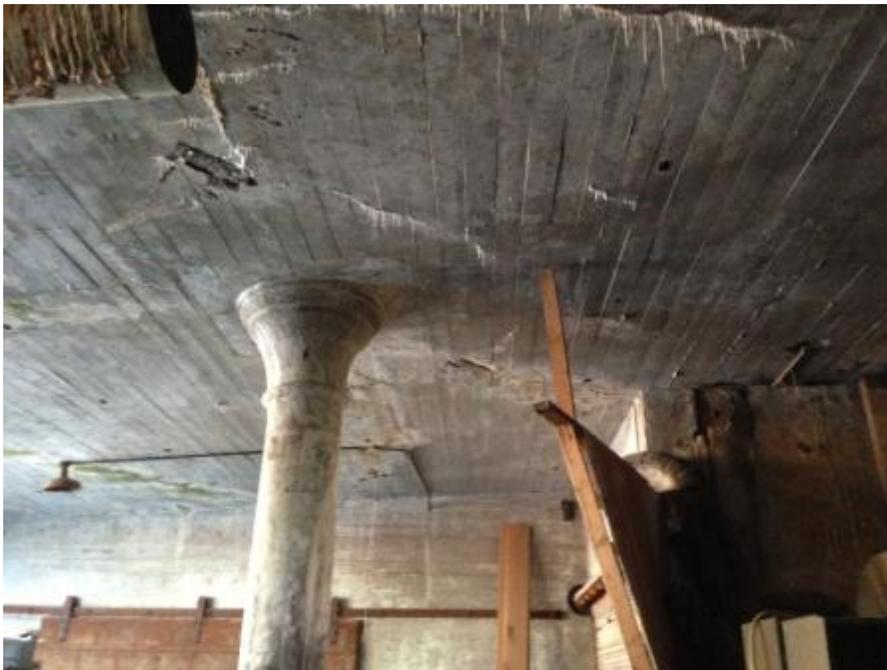
Photograph No.: 22

Subject: Ceiling of third floor woodworking area; note icicles along ceiling cracks
