ASBESTOS MANAGEMENT PLAN REPORT

DEPARTMENT 380
HEALTH - ADMINISTRATION

BUILDING 1378
ISAAC COGGS COMMUNITY HEALTH CENTER
2770 NORTH 5th STREET
MILWAUKEE, WISCONSIN 53212

December, 1990

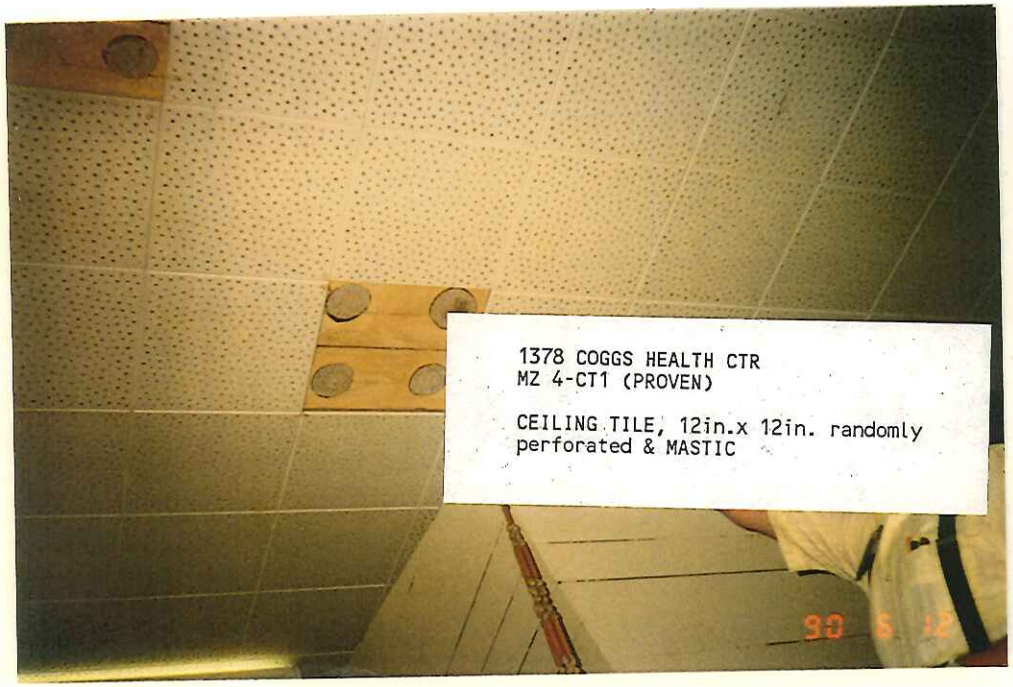
1378 COGGS HEALTH CTR
MZ 4-CT1 (PROVEN)
CEILING TILE, 12in.x 12in. randomly perforated & MASTIC
90 6 12

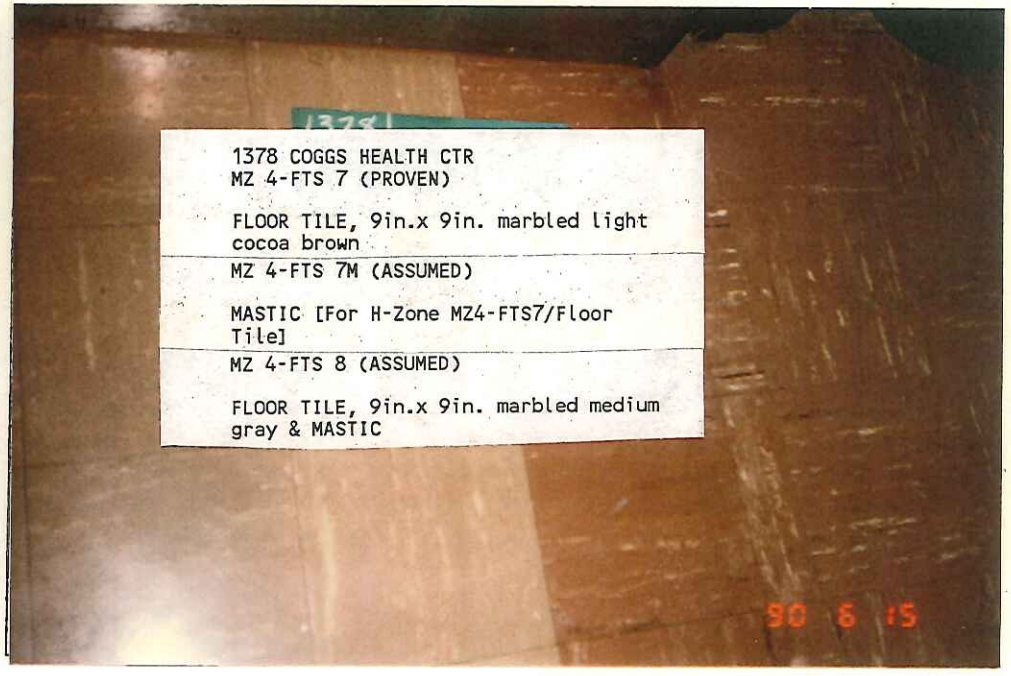
1378 COGGS HEALTH CTR
MZ 4-FTS 7 (PROVEN)
FLOOR TILE, 9in.x 9in. marbled light cocoa brown
MZ 4-FTS 7M (ASSUMED)
MASTIC [For H-Zone MZ4-FTS7/Floor Tile]
MZ 4-FTS 8 (ASSUMED)
FLOOR TILE, 9in.x 9in. marbled medium gray & MASTIC
90 6 15

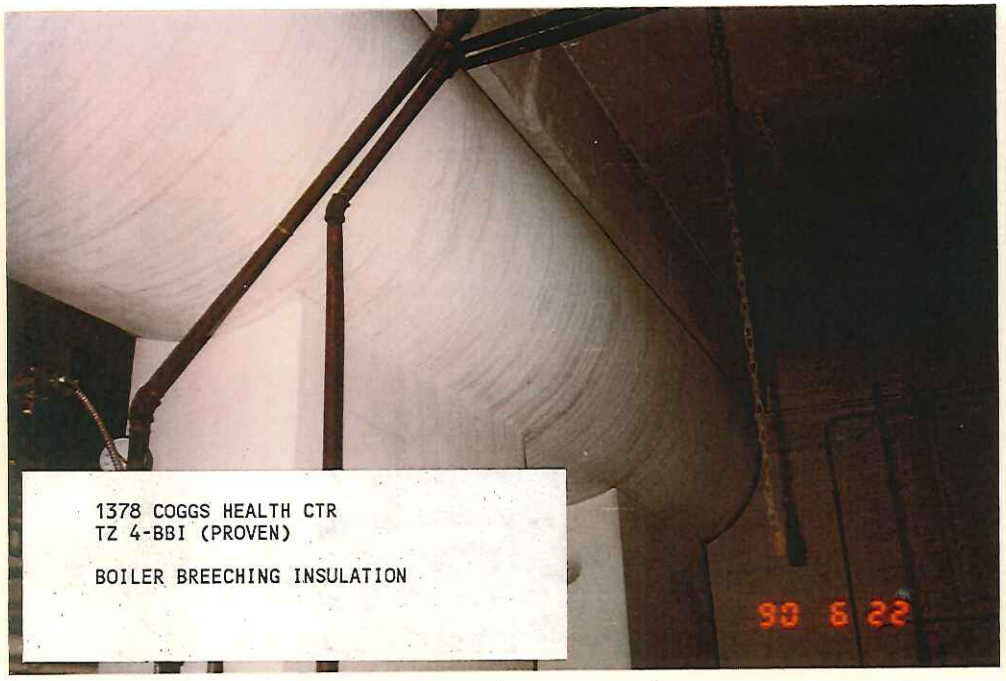
1378 COGGS HEALTH CTR
TZ 4-BBI (PROVEN)

BOILER BREECHING INSULATION

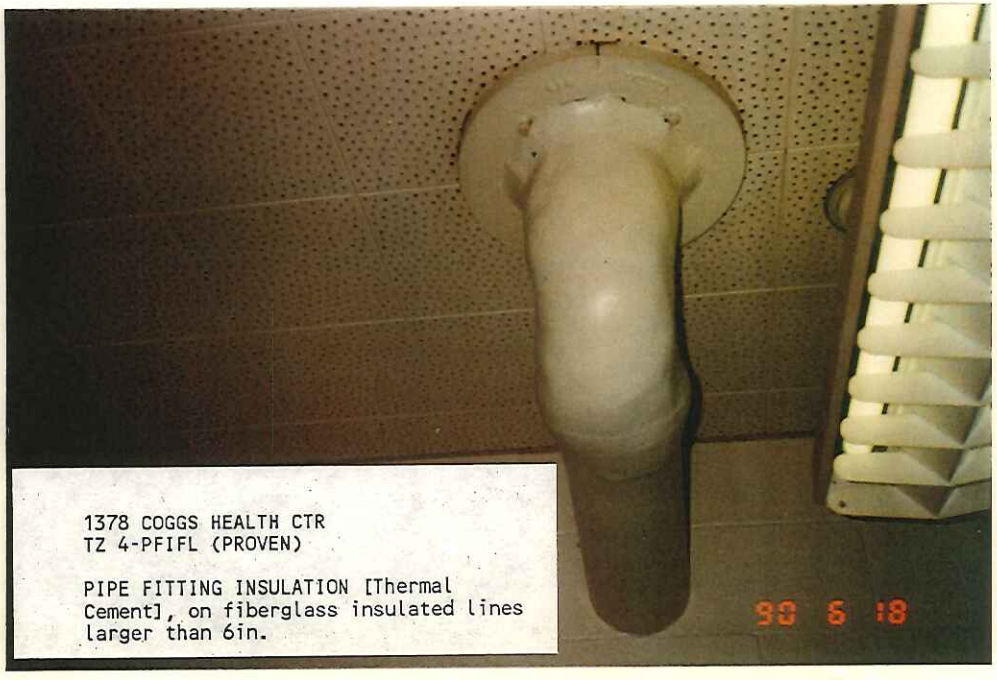
1378 COGGS HEALTH CTR
TZ 4-PFIFL (PROVEN)

PIPE FITTING INSULATION [Thermal Cement], on fiberglass insulated lines larger than 6in.

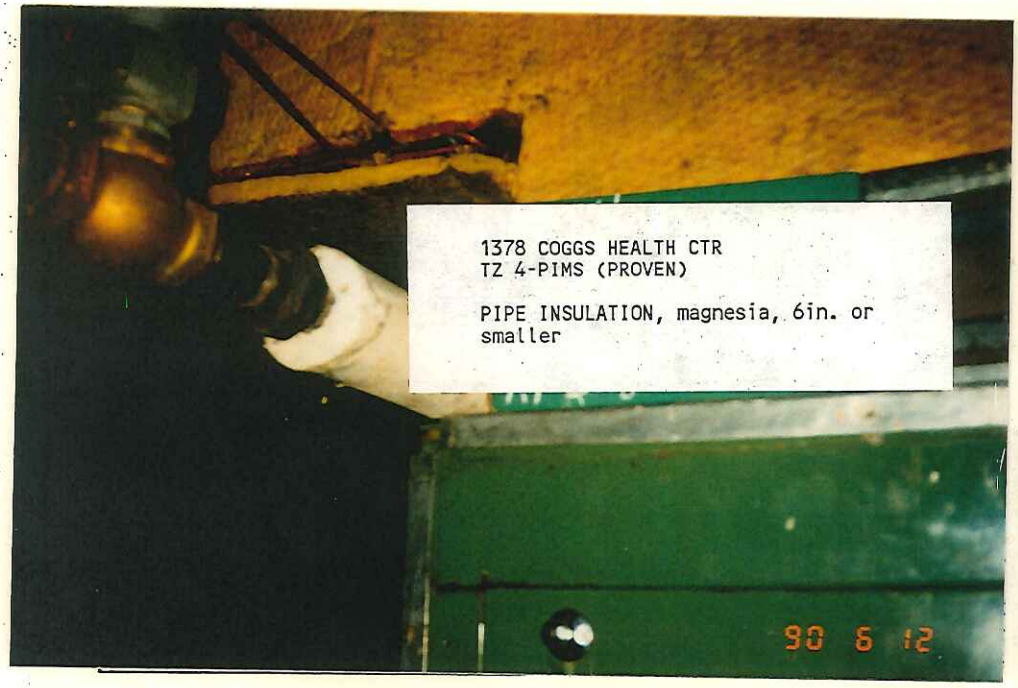
1378 COGGS HEALTH CTR
TZ 4-PIMS (PROVEN)

PIPE INSULATION, magnesia, 6in. or smaller

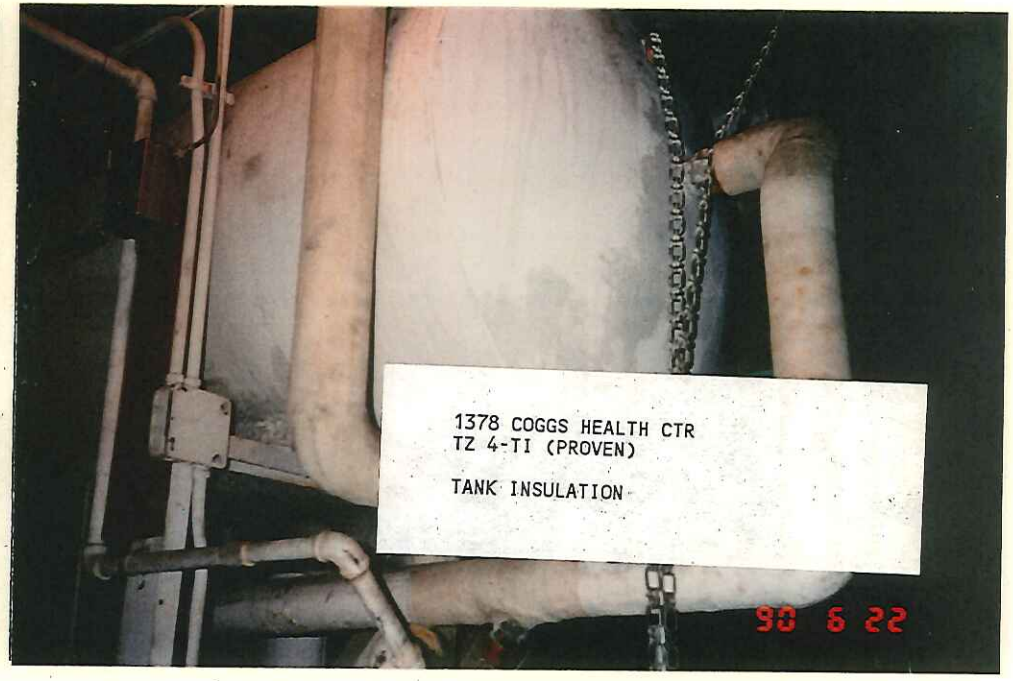
1378 COGGS HEALTH CTR
TZ 4-TI (PROVEN)

TANK INSULATION

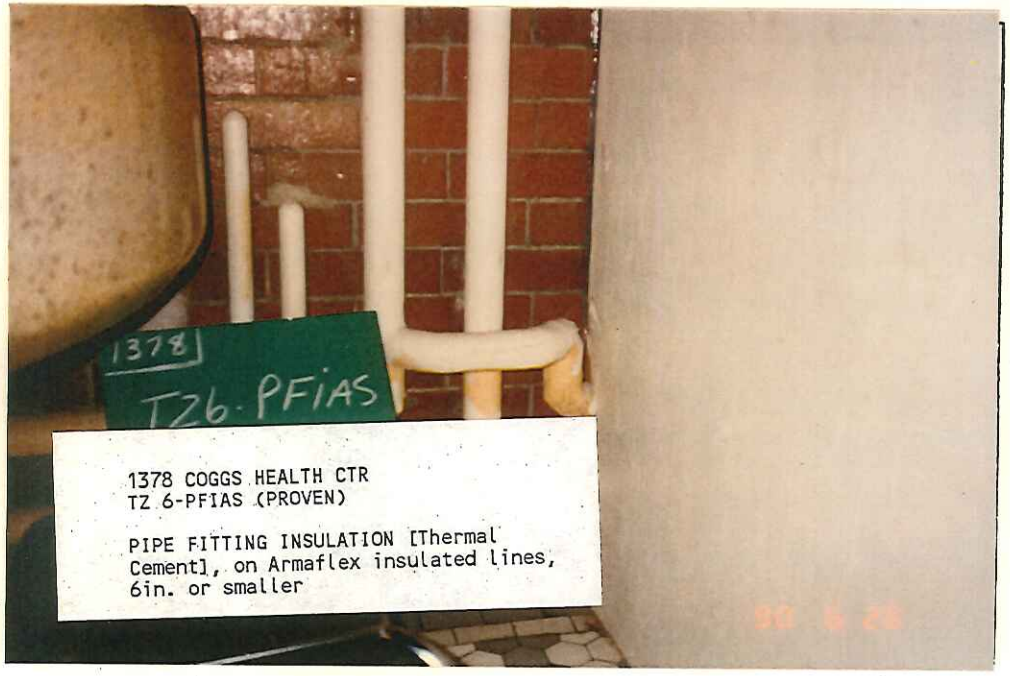
1378 COGGS HEALTH CTR
TZ 6-PFIAS (PROVEN)

PIPE FITTING INSULATION [Thermal Cement], on Armaflex insulated lines, 6in. or smaller
