PRE-DEMOLITION HAZARDOUS MATERIALS ASSESSMENT REPORT
FORMER T.C. ESSER PAINT MANUFACTURING SITE
1542-46 N. 32ND AND 3131 W. GALENA STREETS
MILWAUKEE, WISCONSIN 53208

PROJECT REFERENCE #11525

OCTOBER 2010

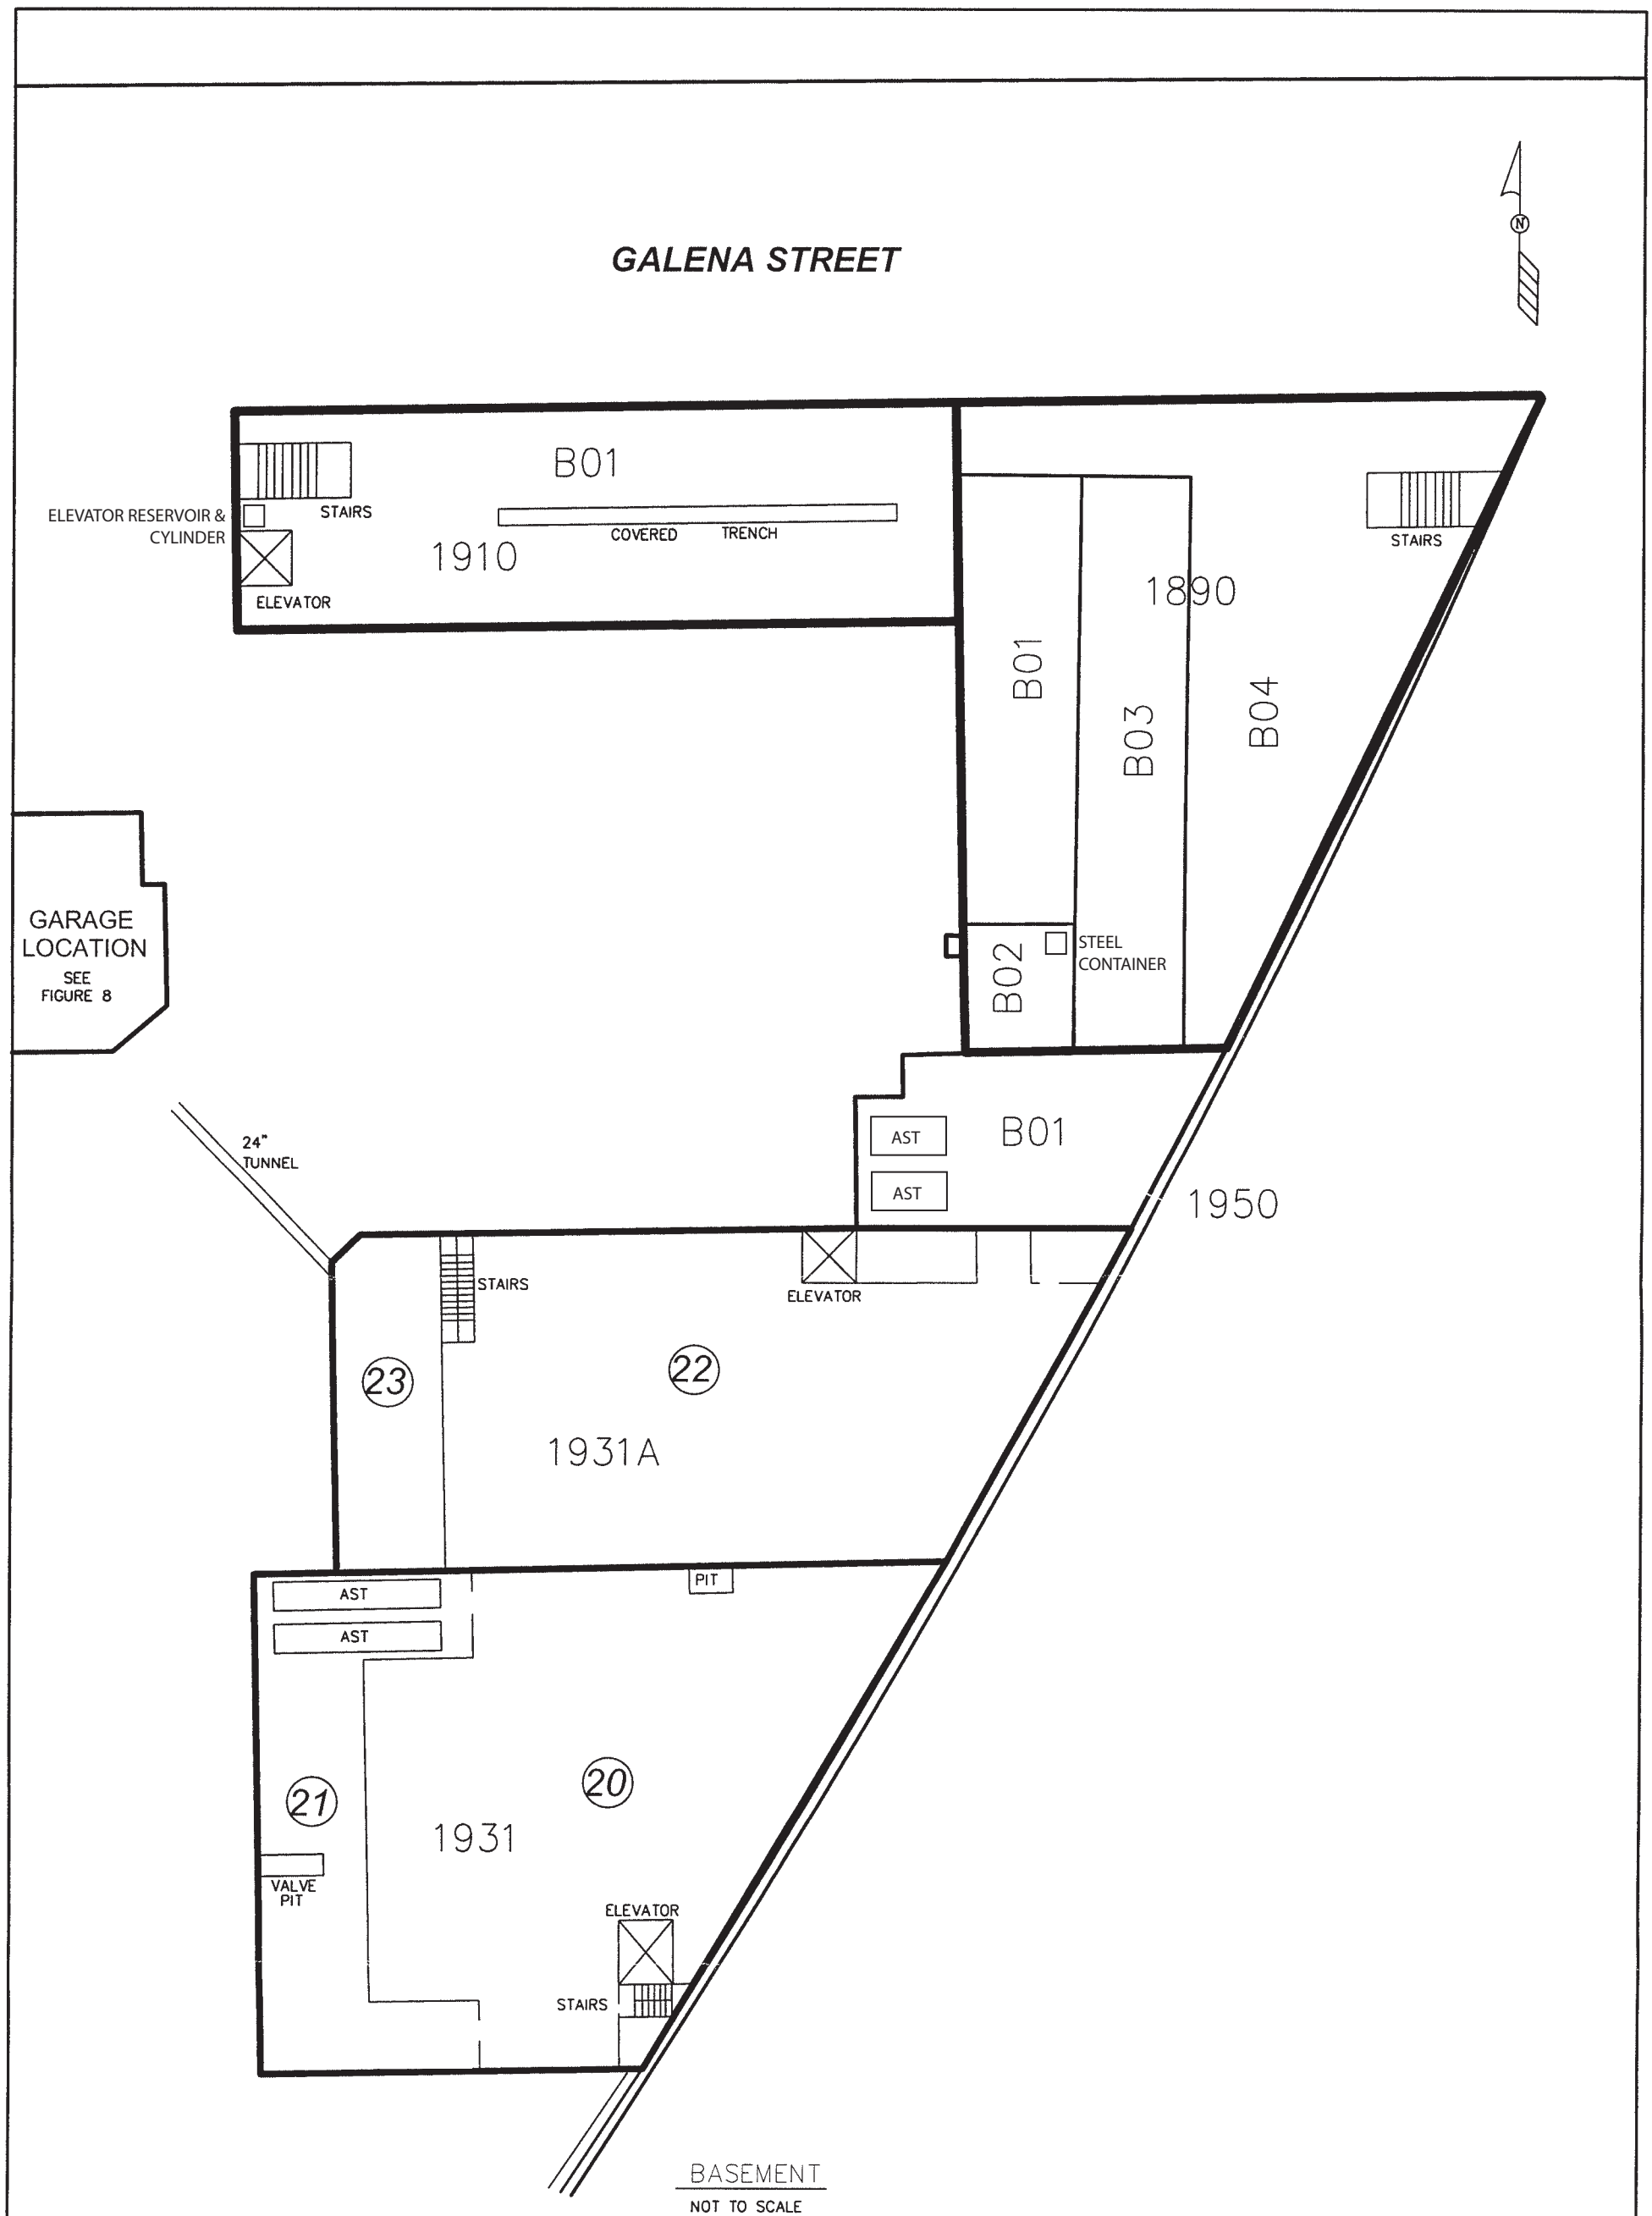
CITY OF MILWAUKEE–GALENA DEVELOPMENT W. GALENA ST. MILWAUKEE, WISCONSIN			SIGMA ENVIRONMENTAL SERVICES INC.
DATE: 2-23-04	DR. BY: BEB	DR.# 8582-003	SCALE: NOT TO SCALE
BASEMENT SAMPLE LOCATION MAP			FIGURE 3

Two ASTs are located in room 21 in the basement of the 1931 Building (refer to **Figure 3**). Residual paint and varnish sludge (0 to 3 inches) are present in these ASTs. It is not practical to clean these ASTs in their current basement location. The selected demolition contractor should include allowances for removing these ASTs from the basements during building demolition and staging them at a remote location on-site for cleaning and disposal by others.

Findings: Sigma observed pits/sumps in rooms 20 and 21 in the basement of the 1931 Building and room B01 of the 1910 Building. Another pit/sump is present in the floor of the garage building; approximately 6-inches of oil/oily water is present in the bottom of this sump that will require proper handling and disposal. Any plumbing associated with the pits/sumps shall also be properly abandoned in accordance with state, county, and local plumbing codes.

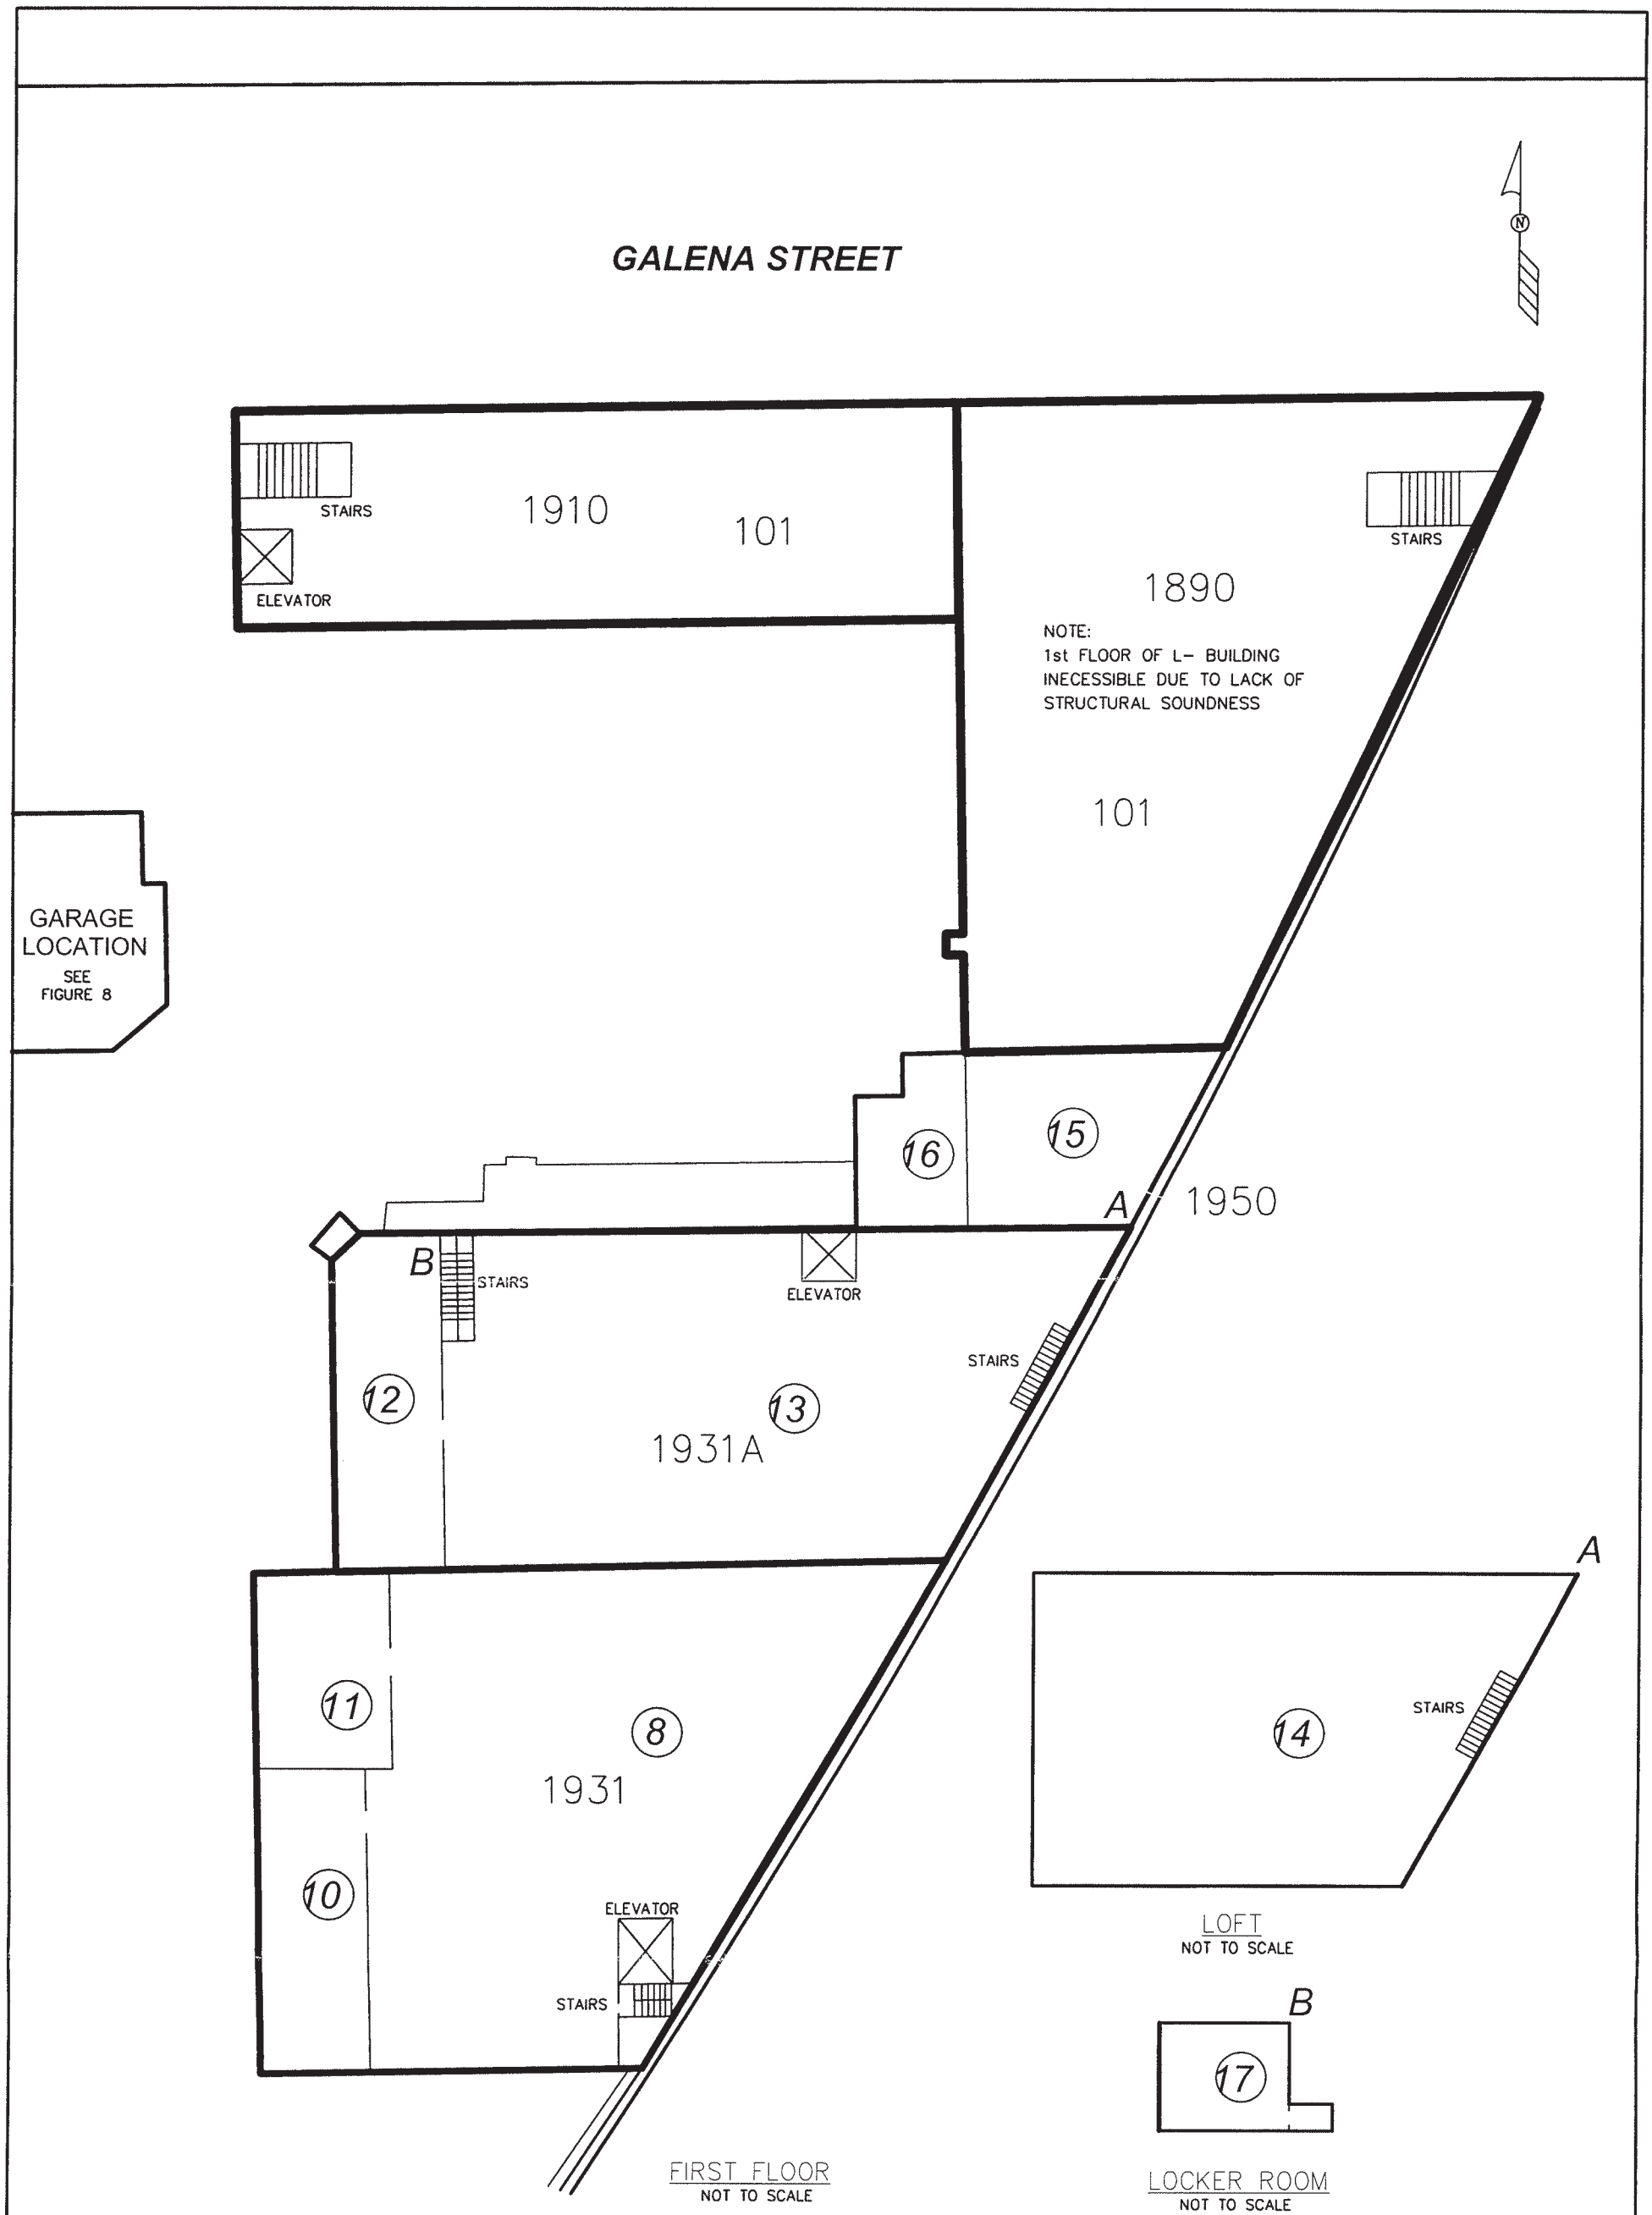
CITY OF MILWAUKEE-GALENA DEVELOPMENT W. GALENA ST. MILWAUKEE, WISCONSIN			SIGMA ENVIRONMENTAL SERVICES INC.
DATE: 2-23-04	DR. BY: BEB	DR.# 8582-003	SCALE: NOT TO SCALE
FIRST FLOOR SAMPLE LOCATION MAP			FIGURE 4

USTs located in the south tank farm (south of the 1931 building), central tank farm (south of the Garage), and north tank farm (west of the 1890 building) and one additional AST located in room 8 on the first floor of the 1931 building (refer to **Figure 4**) were removed under the direction of Sigma in September through November 2009. Documentation regarding the tank removal, soil sampling, and waste disposal activities will be prepared by Sigma.
