Historical Land Use Investigation
3020-26 West Fond du Lac Avenue
Milwaukee, Wisconsin

File: 309-15

Department of City Development

November 22, 2013

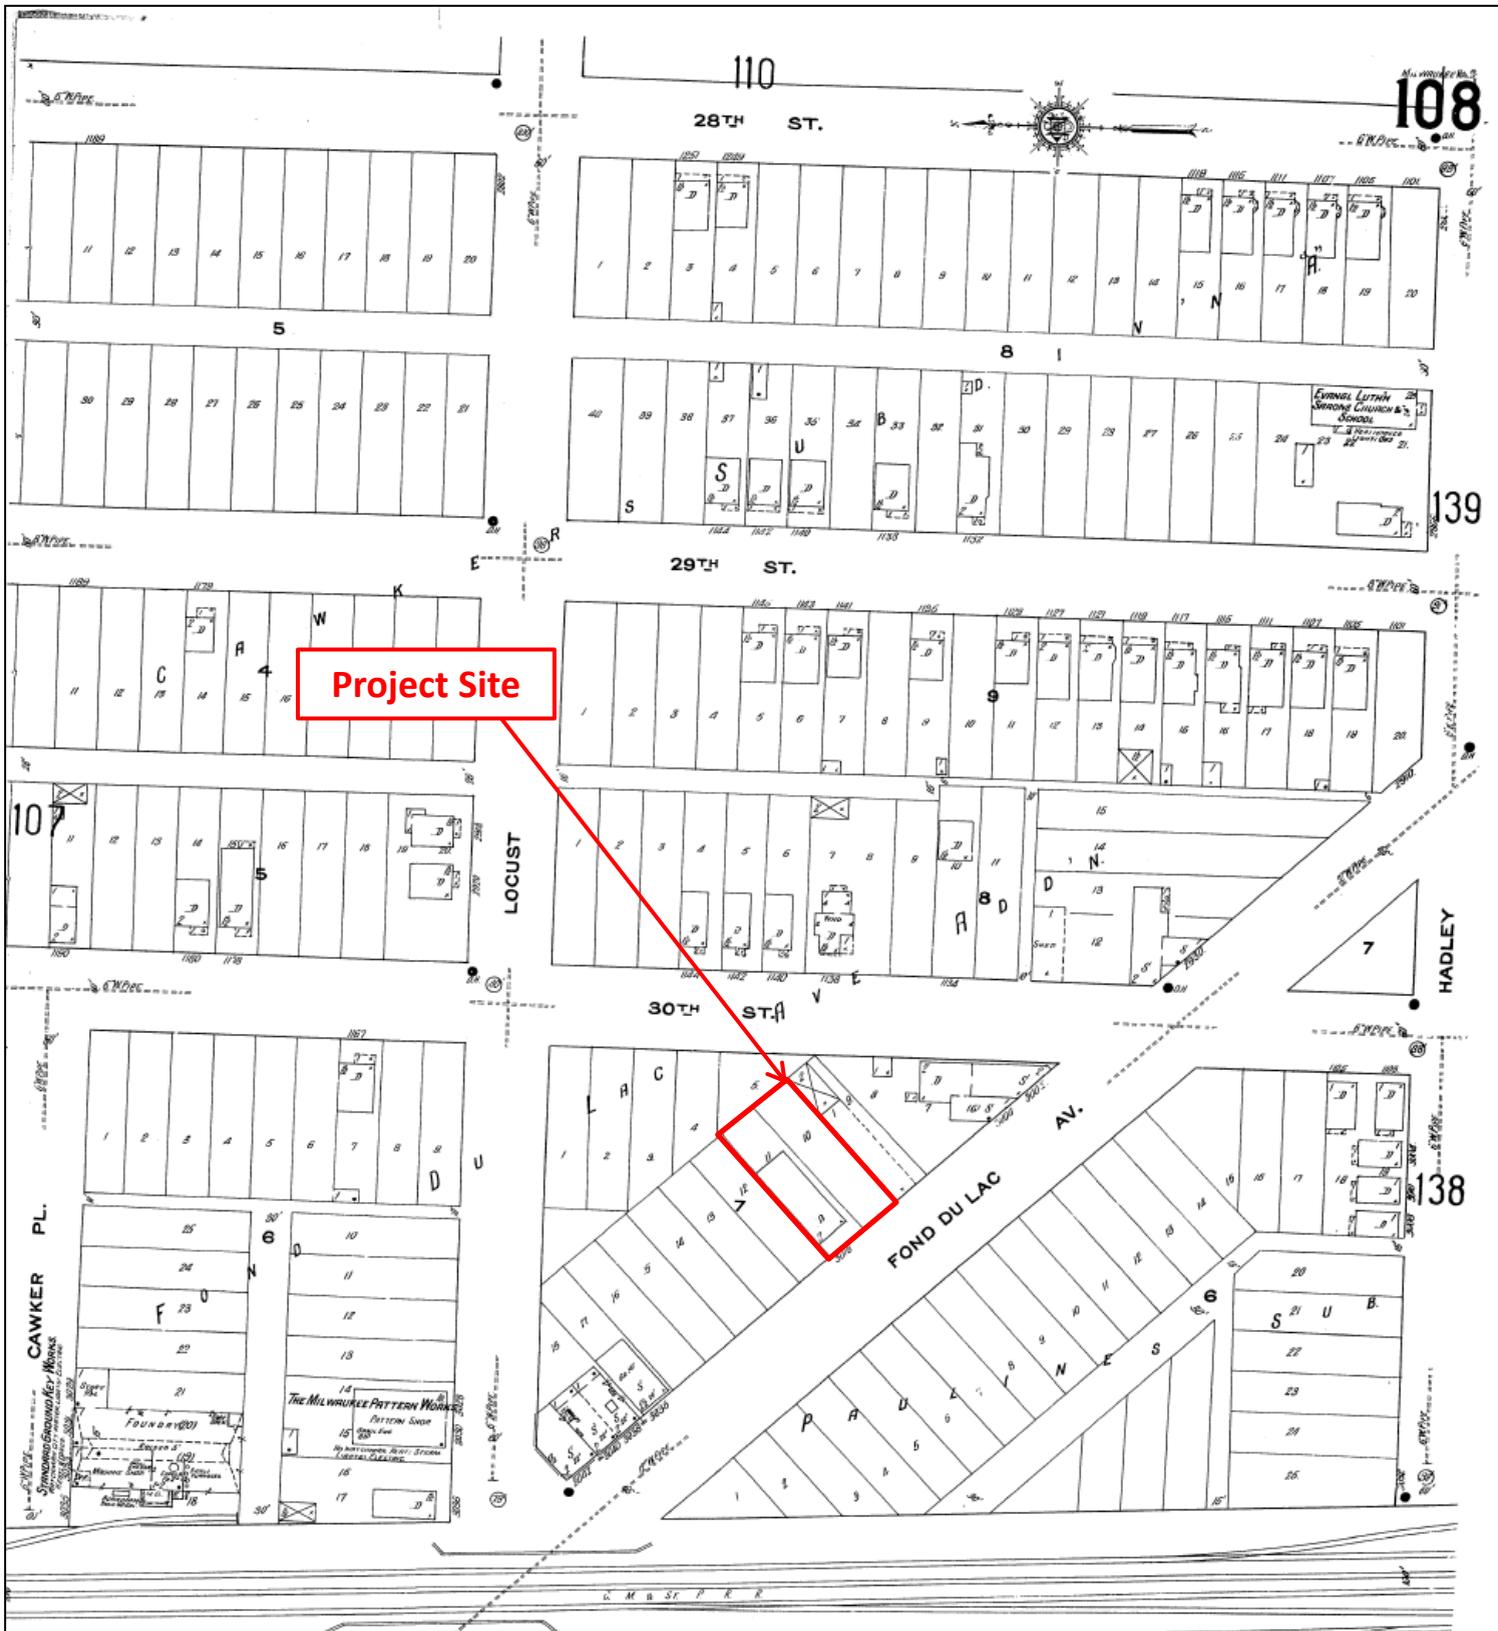
FIGURE 4

The surrounding area has only scattered development. The rail line is shown one block west, bordered by industry including Standard Ground Key Works foundry, Milwaukee Pattern Works, and several unlabeled stores. Several other unlabeled stores are shown to the east of the project site, along West Fond du Lac Avenue. Most other development in the area is residential. **(Figure 4)**

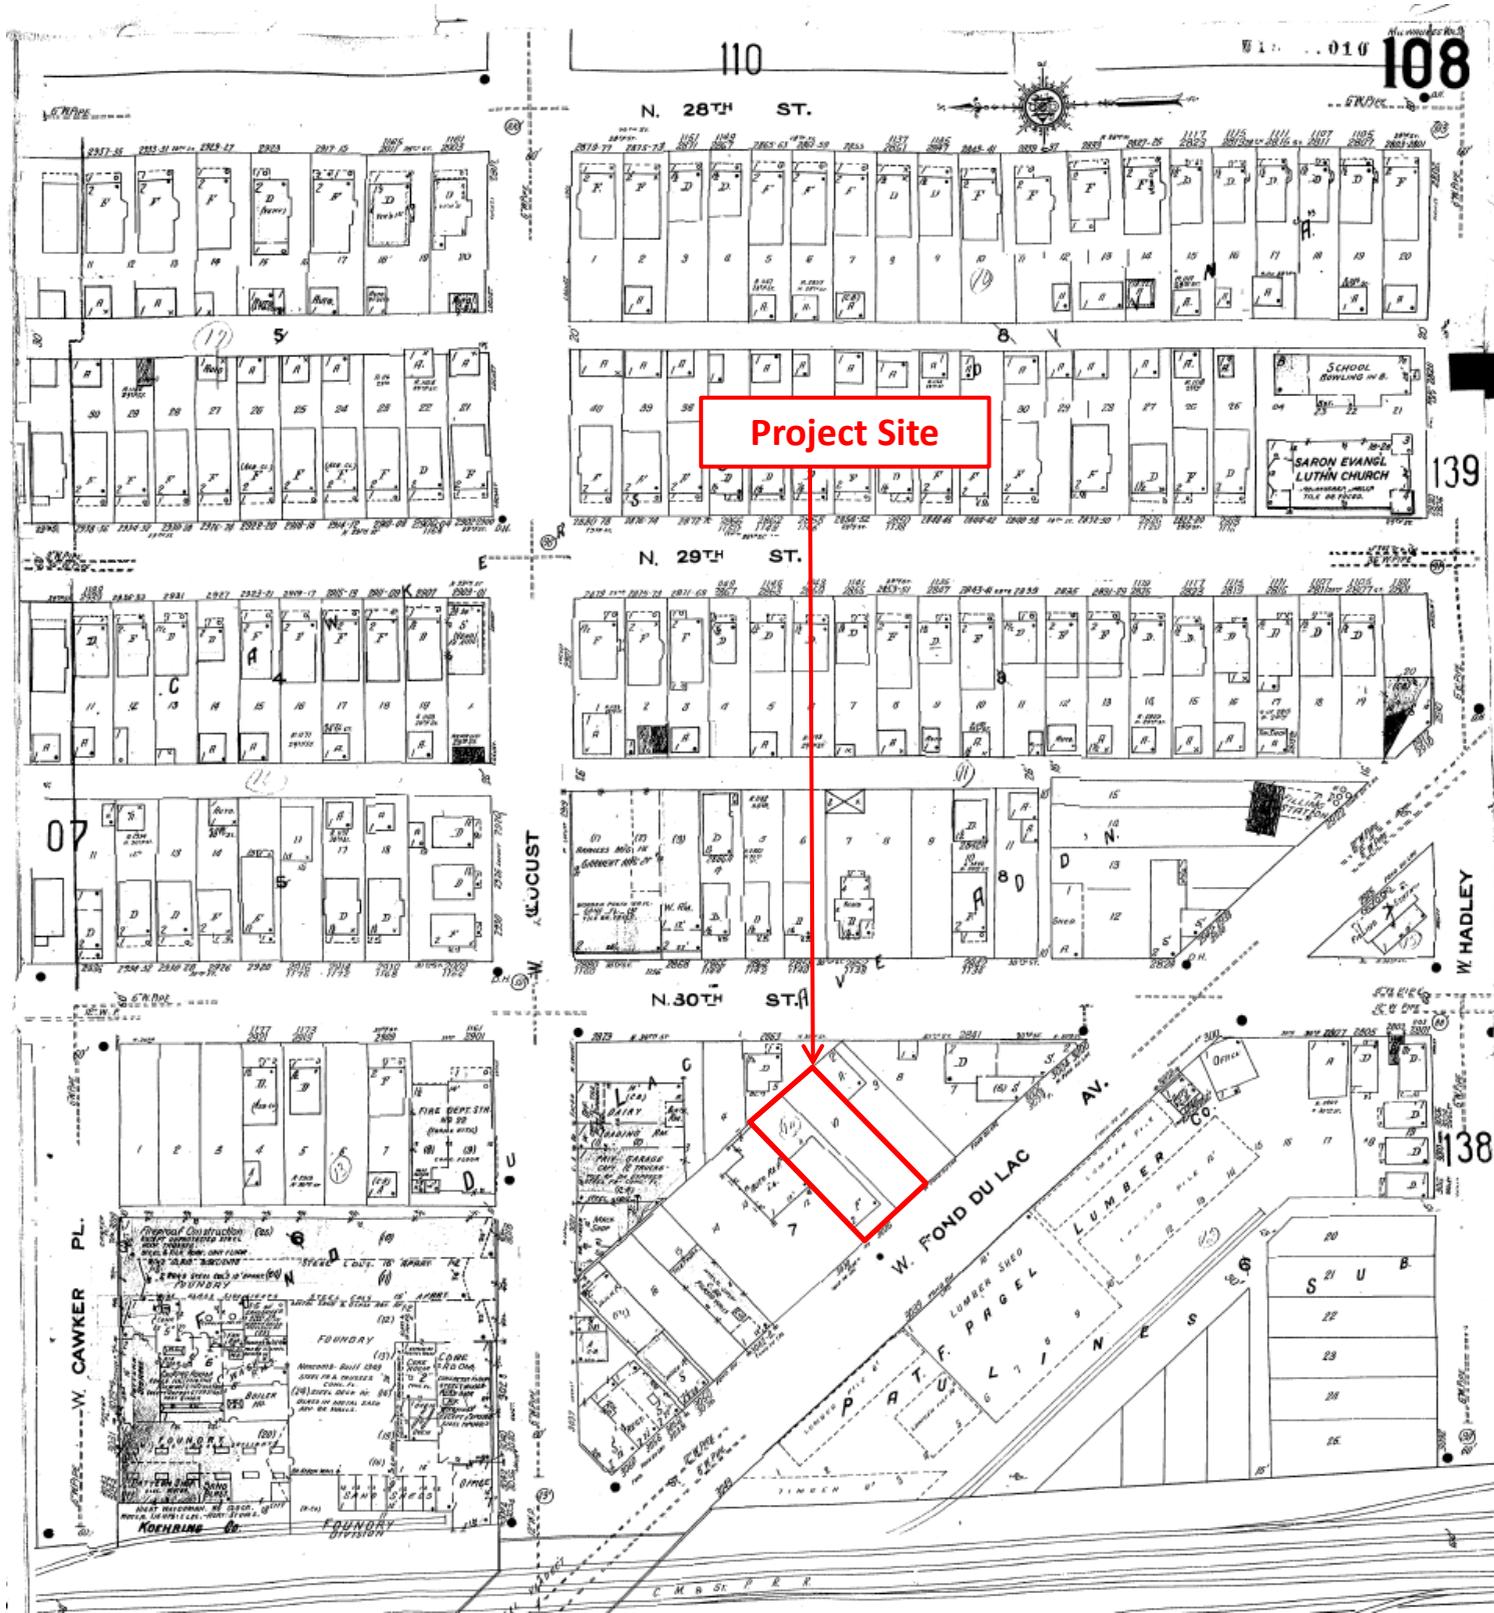
FIGURE 5
1910 SANBORN FIRE INSURANCE MAP
(WITH UPDATES THROUGH 1951)
3020-26 West Fond du Lac Avenue, Milwaukee, WI

- b. A 1910 (*with updates through 1951*) Sanborn Fire Insurance Map shows the project site occupied by the same two-story dwelling on the western portion of the project site. The eastern portion of the project site is again shown to be undeveloped. The site immediately west of the project site, undeveloped in the previous map, is now developed with a one-story structure labeled “auto repair”. This structure is located along the project site property line.

other industrial and commercial uses are also shown in surrounding area, including machine shops, garment manufacturing, a dairy, garage, fire station, and unlabeled store buildings. One block north of the project site, two filling stations are shown, each with four to five gas tanks. Beyond the industrial and commercial corridors of West Fond du Lac Ave. and the rail line, the area has been developed by mostly single-family homes and flats. **(Figure 5)**

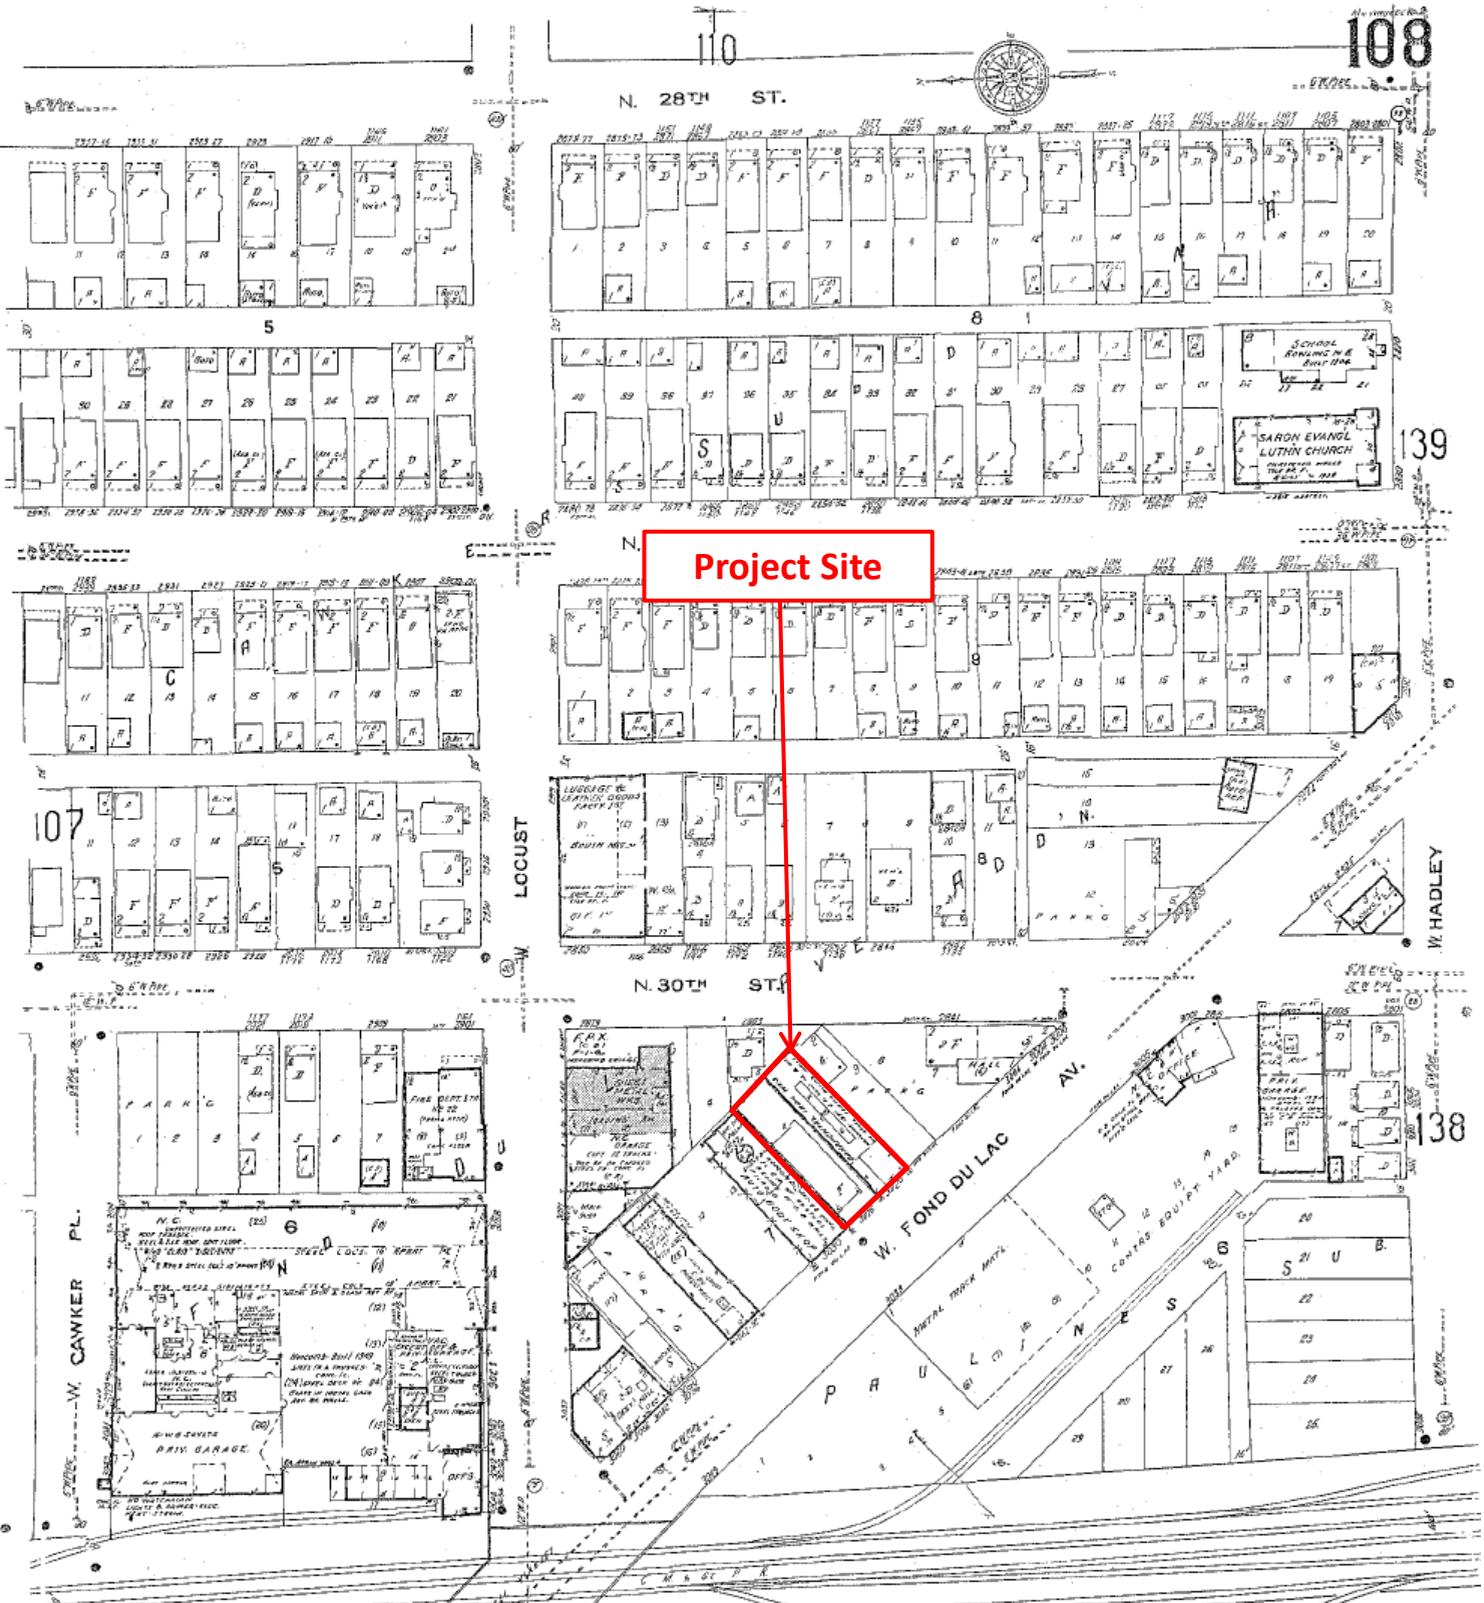
FIGURE 6
1910 SANBORN FIRE INSURANCE MAP
(WITH UPDATES THROUGH 1951)
3020-26 West Fond du Lac Avenue, Milwaukee, WI

The surrounding area appears substantially the same as in the previous map. Changes include that the former lumber yard directly across West Fond du Lac Ave. from the project site is now labeled as a “contr’s equipt. yard”. A parcel at the rear of the project site block is now “sheet metal wks” rather than a dairy. The two filling stations with gas tanks to the north of the project site are no longer shown; one is now labeled “auto rep” while the other is unlabeled. **(Figure 6)**
