Historical Land Use Investigation
4828 West Lisbon Avenue
Milwaukee, Wisconsin

File: 328-22

Department of City Development

November 11, 2013

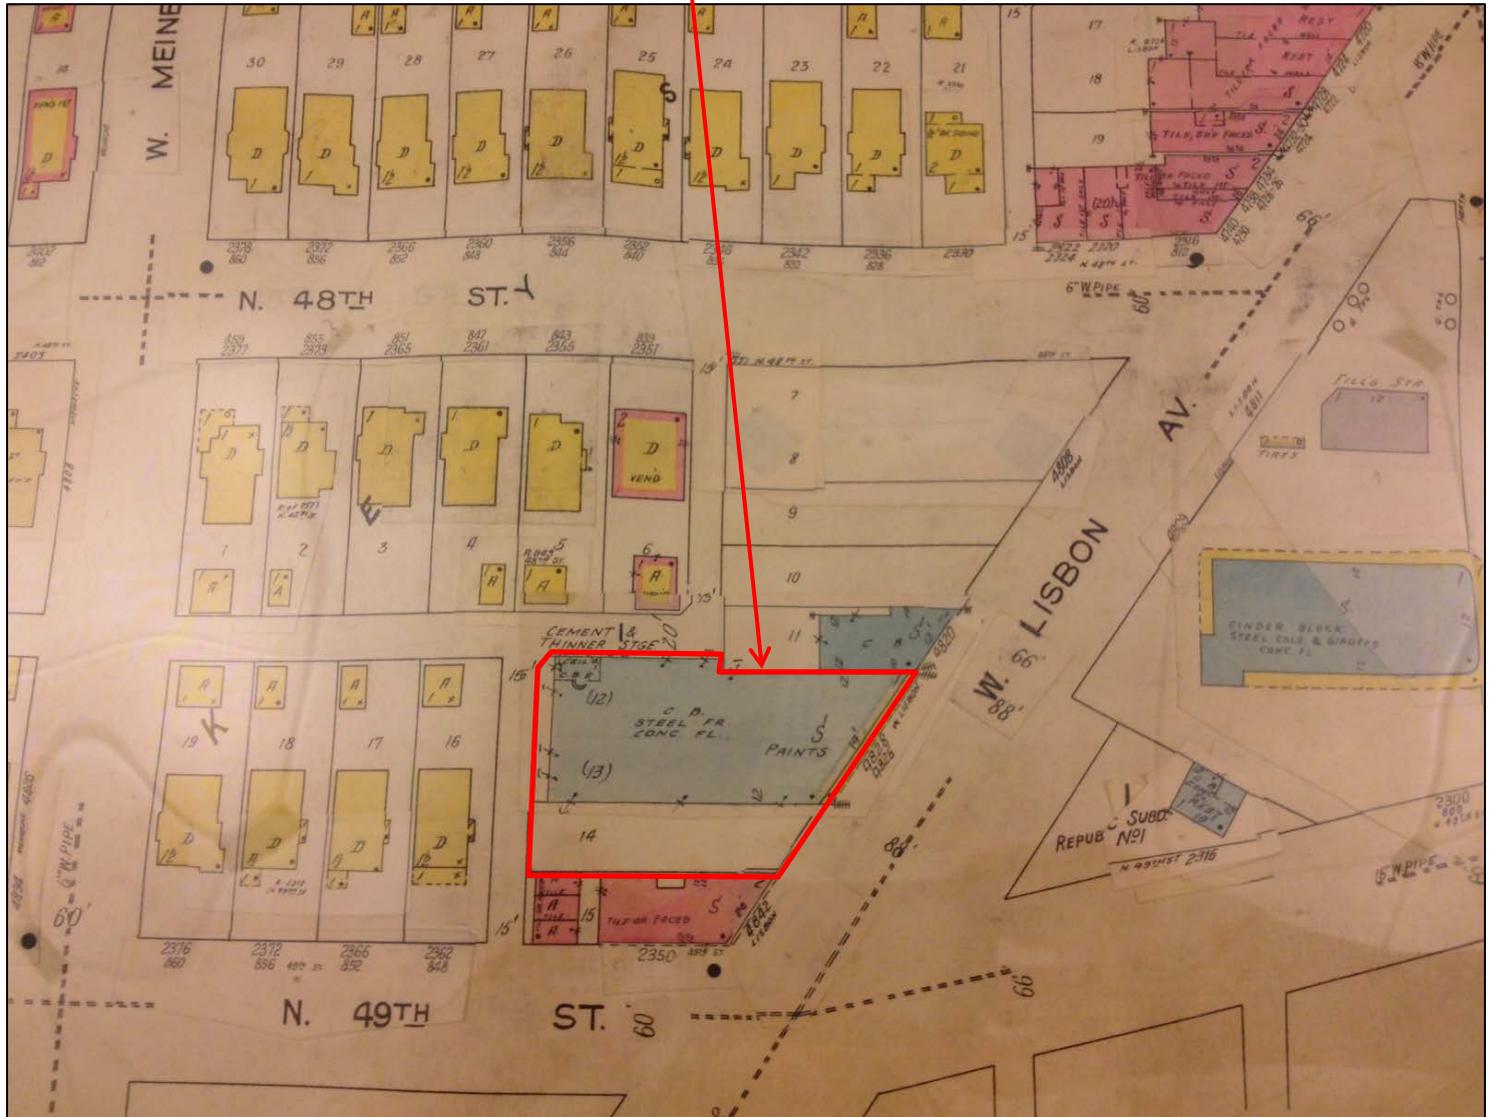
ATTACHMENT A
SITE PHOTOGRAPHS
4828 West Lisbon Avenue, Milwaukee, WI

View of project site exterior, looking north from W. Lisbon Ave. (DCD file photo)
