Historical Land Use Investigation
5128-30 West Center Street
Milwaukee, Wisconsin

File: 306-04

January 8, 2013

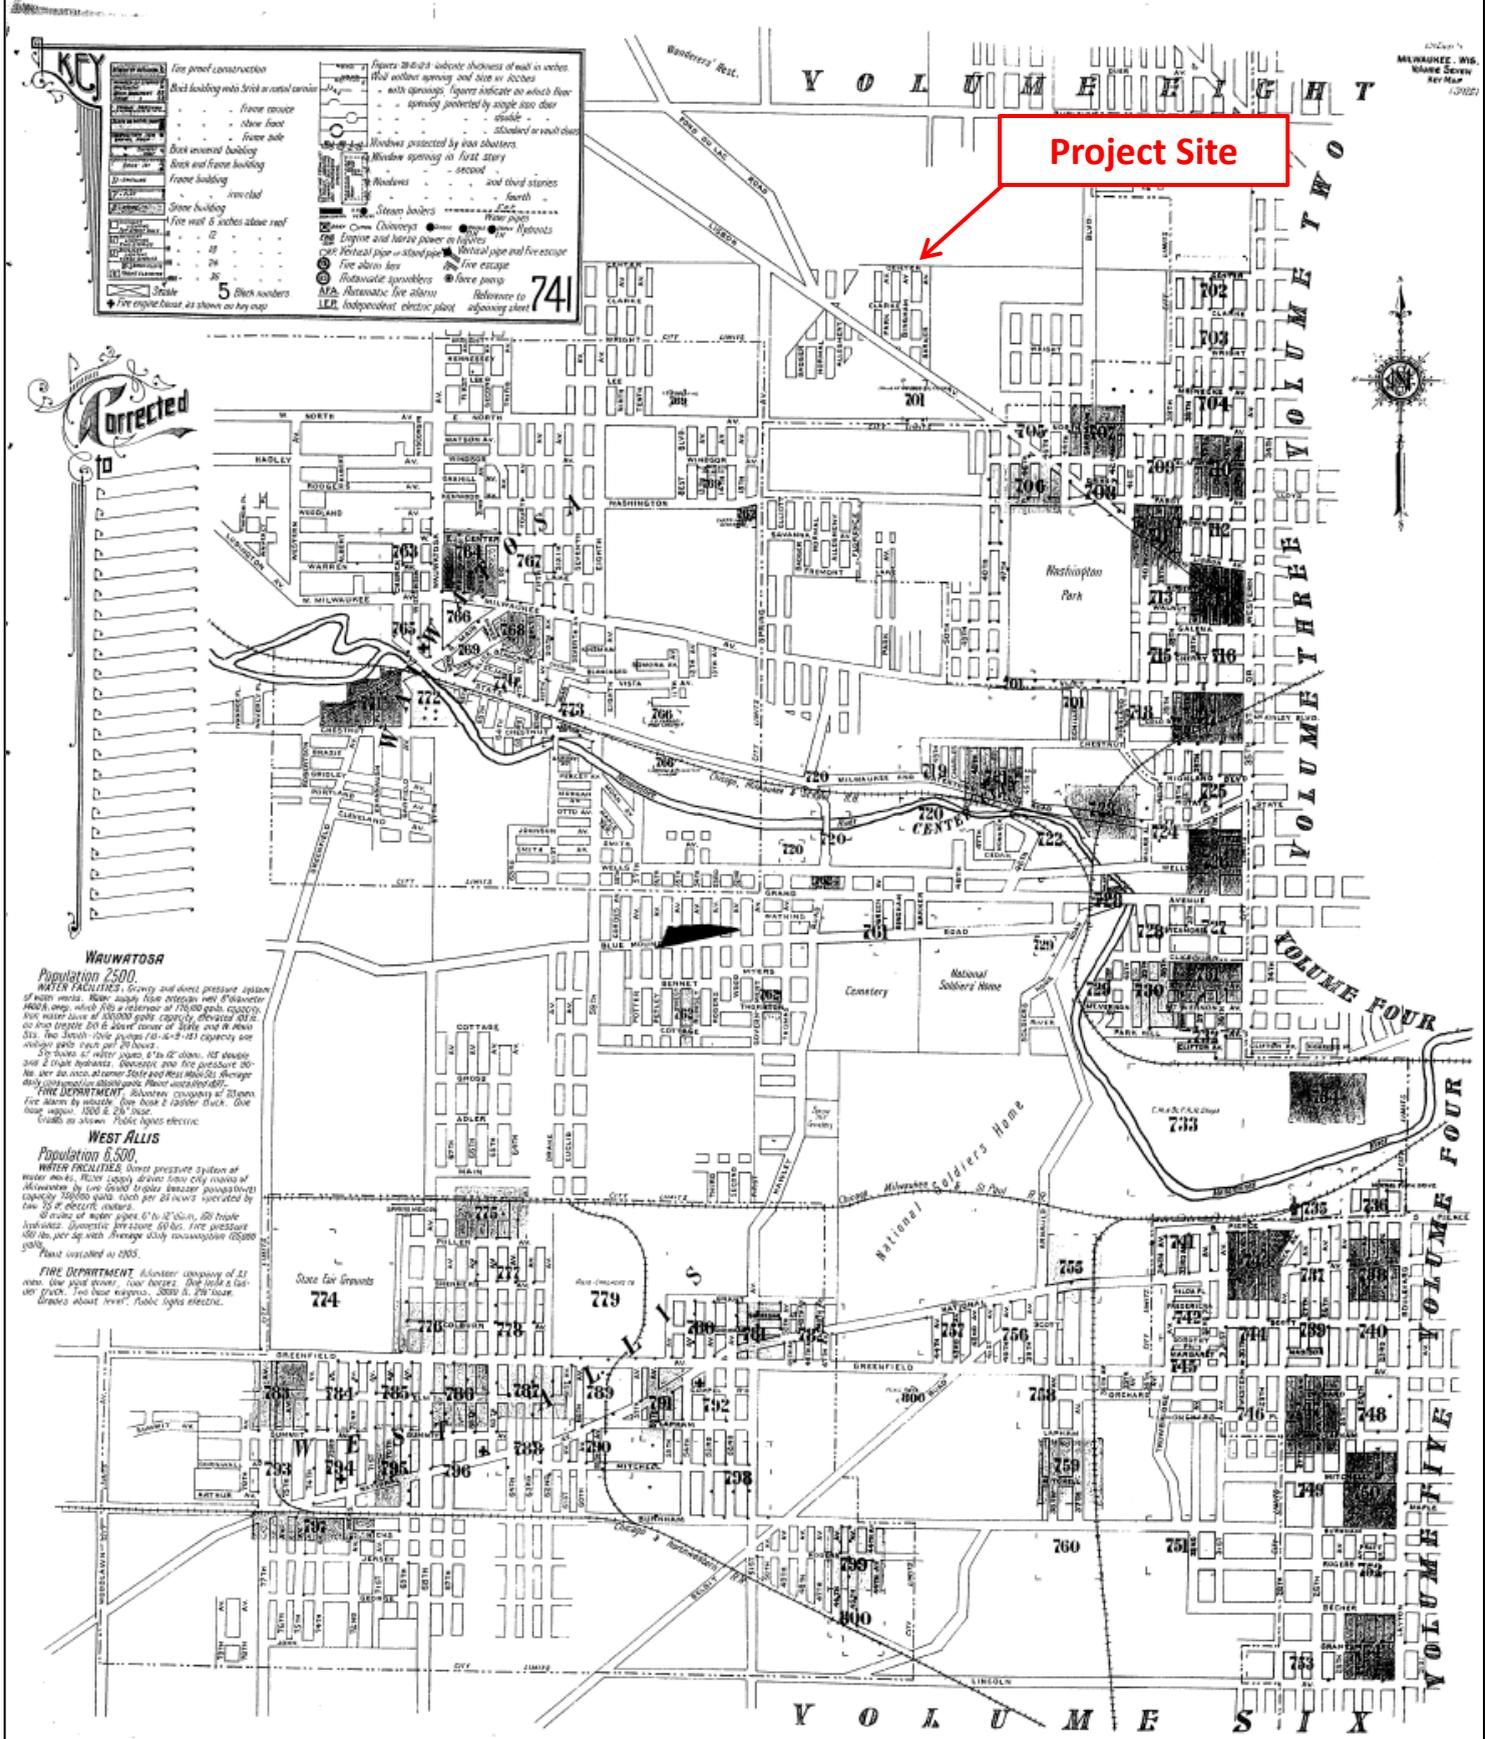
FIGURE 5
1910 SANBORN FIRE INSURANCE MAP
(WITH UPDATES THROUGH 1951)
5128-30 West Center Street, Milwaukee, WI

- a. A 1910 (*with updates through 1937*) Sanborn Fire Insurance Map is not available. A Sanborn Map of the surrounding area indicates that the project site was located outside the City limits and was unoccupied. **(Figure 4)**
- b. A 1910 (*with updates through 1951*) Sanborn Fire Insurance Map shows the project site occupied by a two-story building consisting of two store spaces fronting W. Center St. and

one store space located in the rear of the building, fronting N. 52nd St. The project site also includes a detached auto garage, located along the rear alley, fronting N. 52nd St. The surrounding area includes a commercial corridor developing along W. Center St., with residential neighborhoods to the north and south. Directly across W. Center St. from the project site is St. Catherine's Church and School. Filling stations with gasoline tanks are indicated in the surrounding area, including one station with three tanks directly across N. 52nd St. from the project site. Other filling stations with tanks are also indicated at the corners of W. Center St. and N. 51st St., W. Center St. and N. 50th St., and W. Center St. and N. 53rd St. **(Figure 5).**

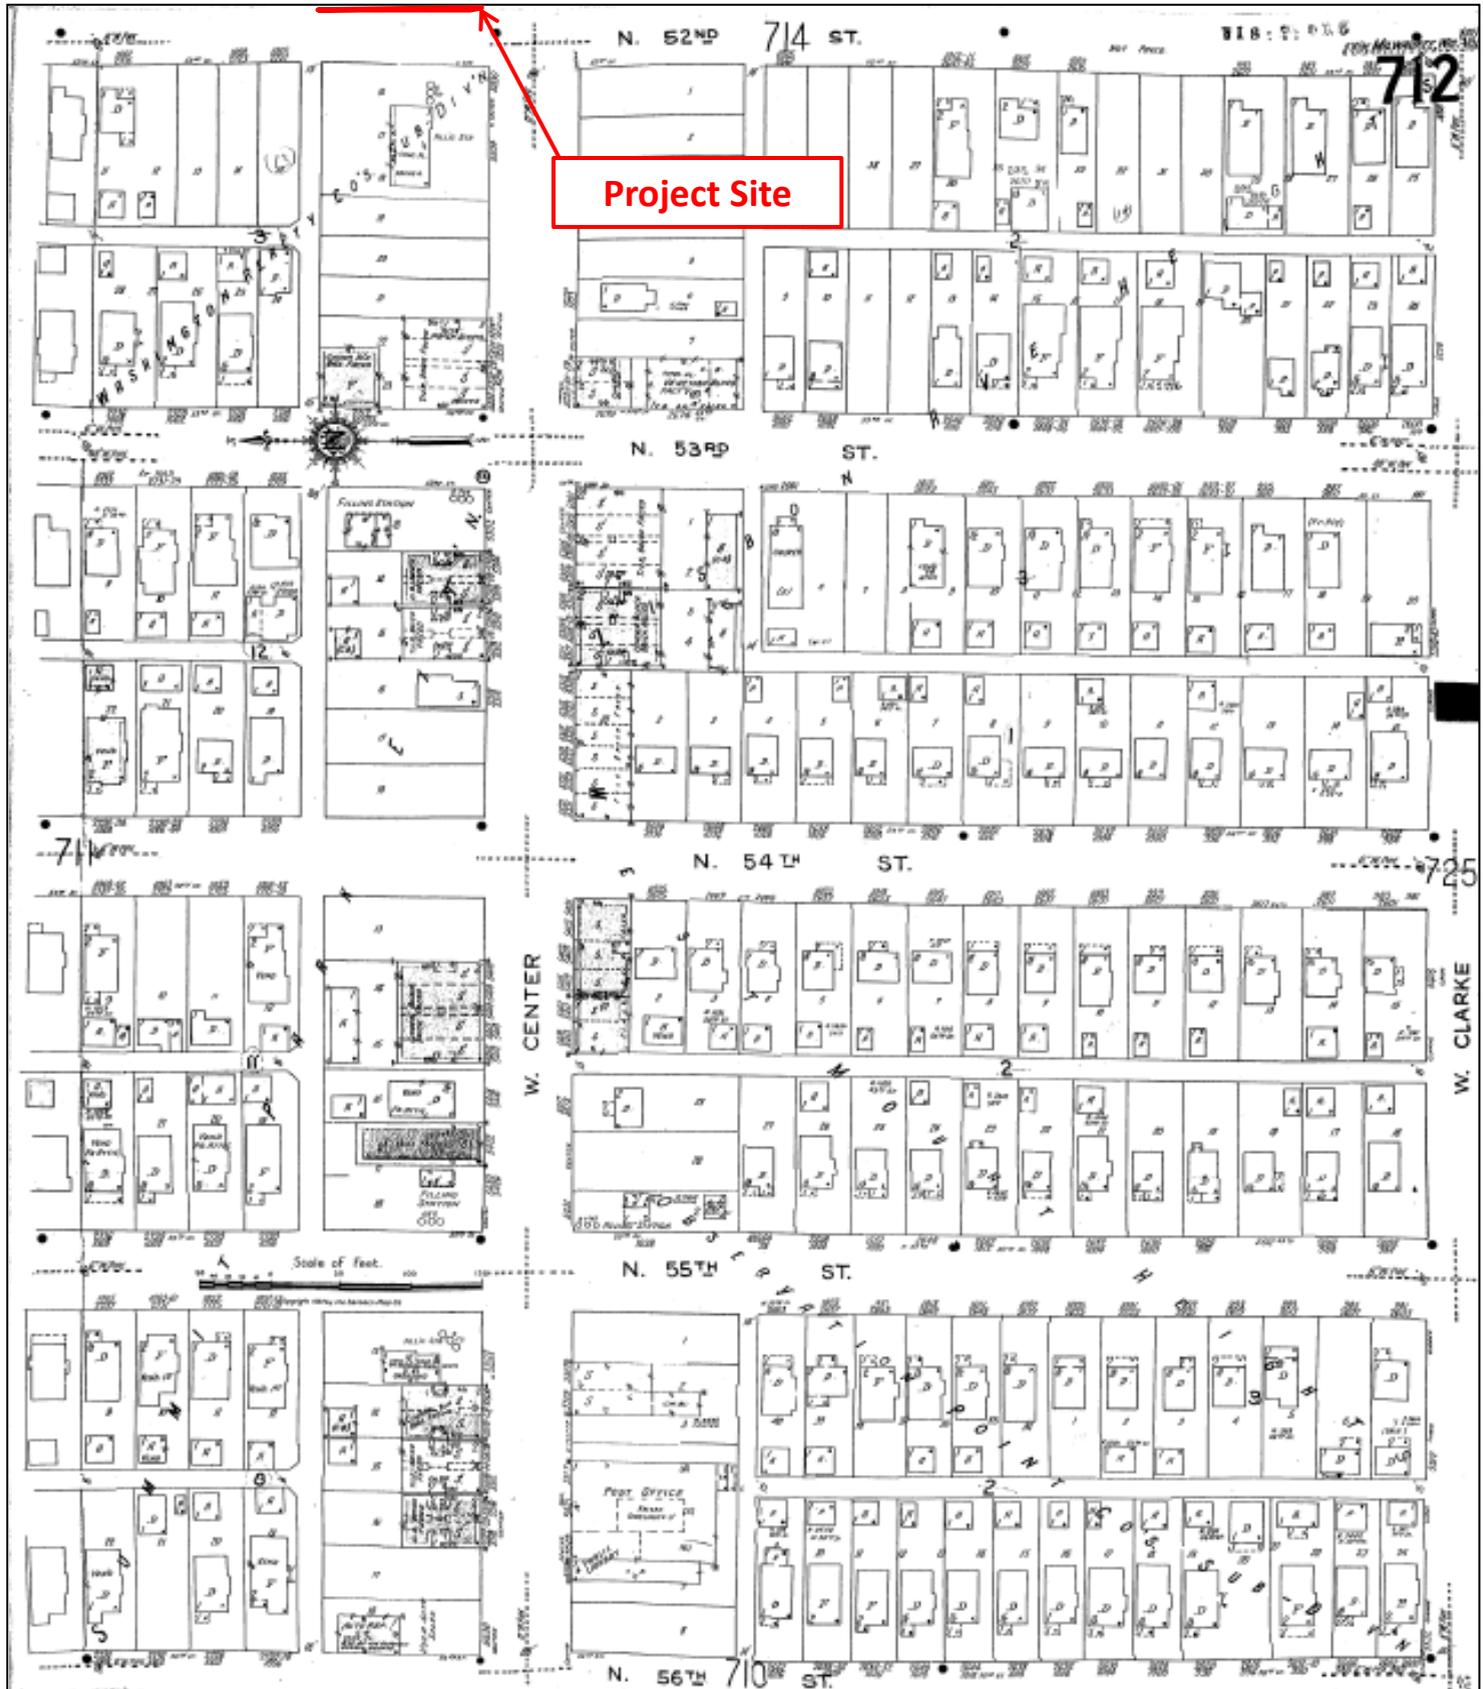
FIGURE 7
1910 SANBORN FIRE INSURANCE MAP
(WITH UPDATES THROUGH 1969)
5128-30 West Center Street, Milwaukee, WI

- c. A 1910 (*with updates through 1969*) Sanborn Fire Insurance Map shows the project site occupied by the same two-story building and detached garage. The surrounding area has been more fully developed according to the neighborhood development pattern noted above. Filling stations with gasoline tanks are again indicated on surrounding blocks, including the station with three tanks located directly across N. 52nd St. from the project site. **(Figure 7).**
