North Point Tower Restoration Project July 18, 2017 Update

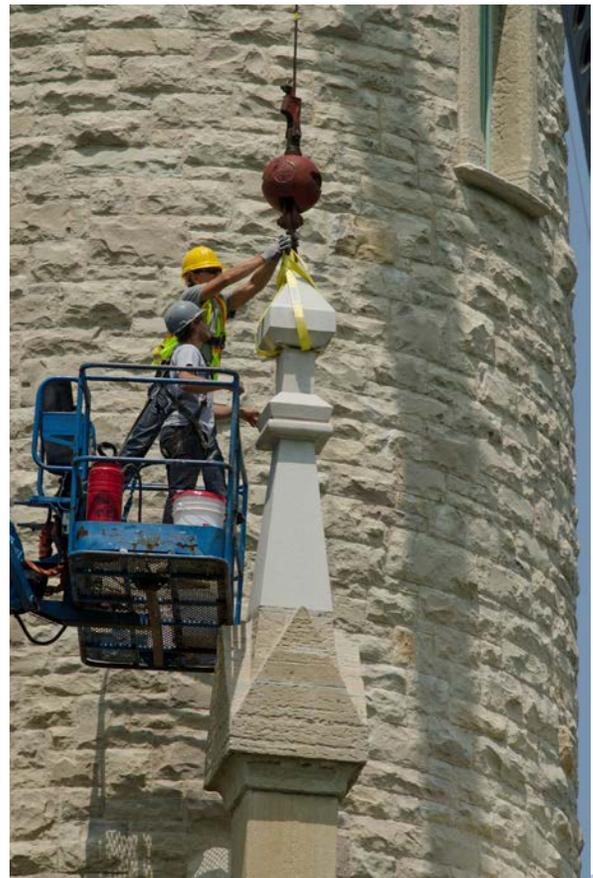
Masonry work on ornate stone façade on the south, west and north sides of the upper portion of the tower is complete. Repairs included removal of organic debris, replacement of damaged stone, tuck pointing of mortar and crack repairs. The east side of the tower was found to require the most repair and additional stone replacement.

The wood windows were repaired, painted and sealed. Some of the glass was replaced. The work was intended to prevent water infiltration that previously degraded the masonry.

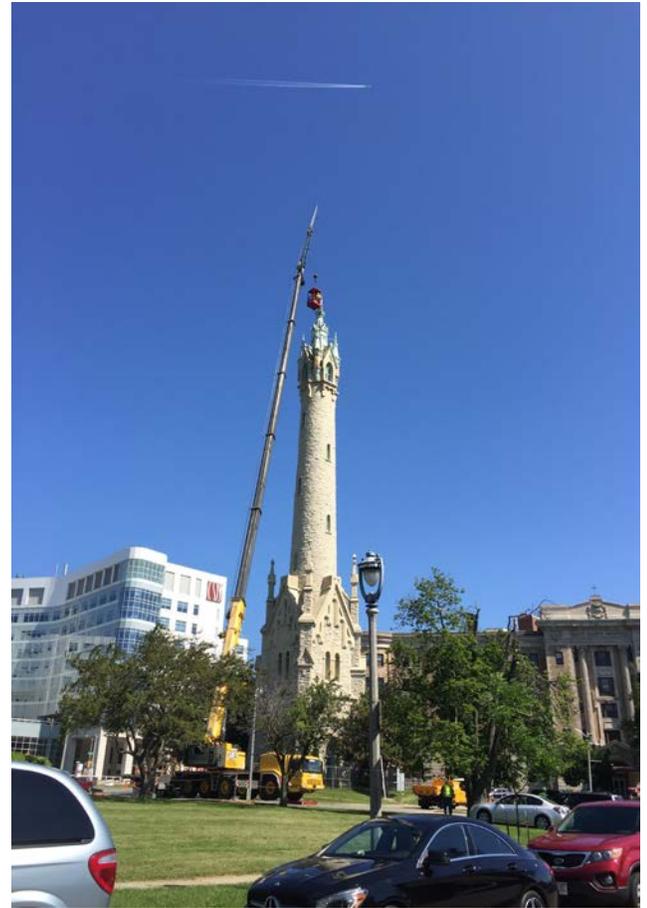
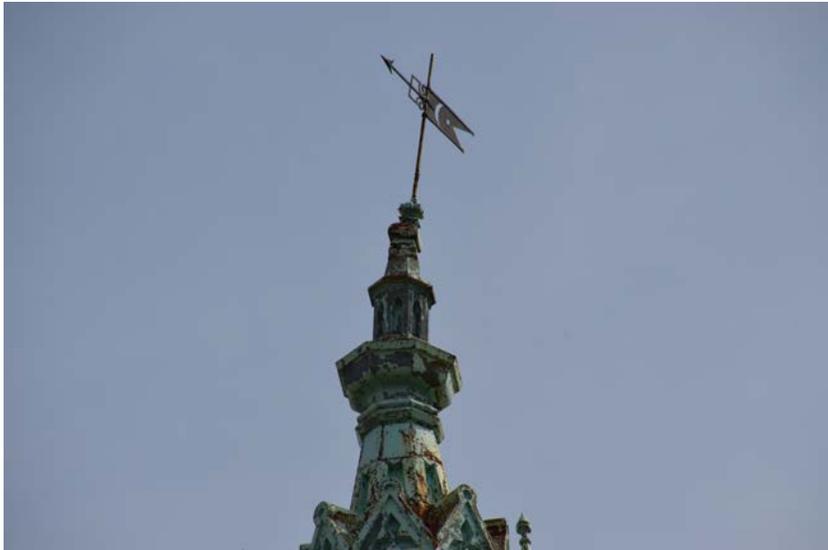
The weather vane had recently taken on a decided lean to the side. Project coordinators suspect a severe, early spring storm exacerbated an existing but hidden deteriorated and weakened condition. Although the roof is in good shape, there is rusting visible in the interior of the peak. The ornamental sheet metal above the peak hid three or more feet of the rod holding the weather vane upright, and the cause of the leaning was not readily apparent. Because the cause of the deterioration appears to be within the structure of the roof, a permanent fix was not possible at this time.

Project coordinators determined the weather vane could fall and pose a safety hazard. On June 27, a crane was used to allow the contractor to reach the weather vane and lift it and the steel pole on which it swung from the peak of the roof.

The repair of the roof structure will be included in the scope of roofing and repainting work proposed for the Department of Public Works 2018 capital budget.

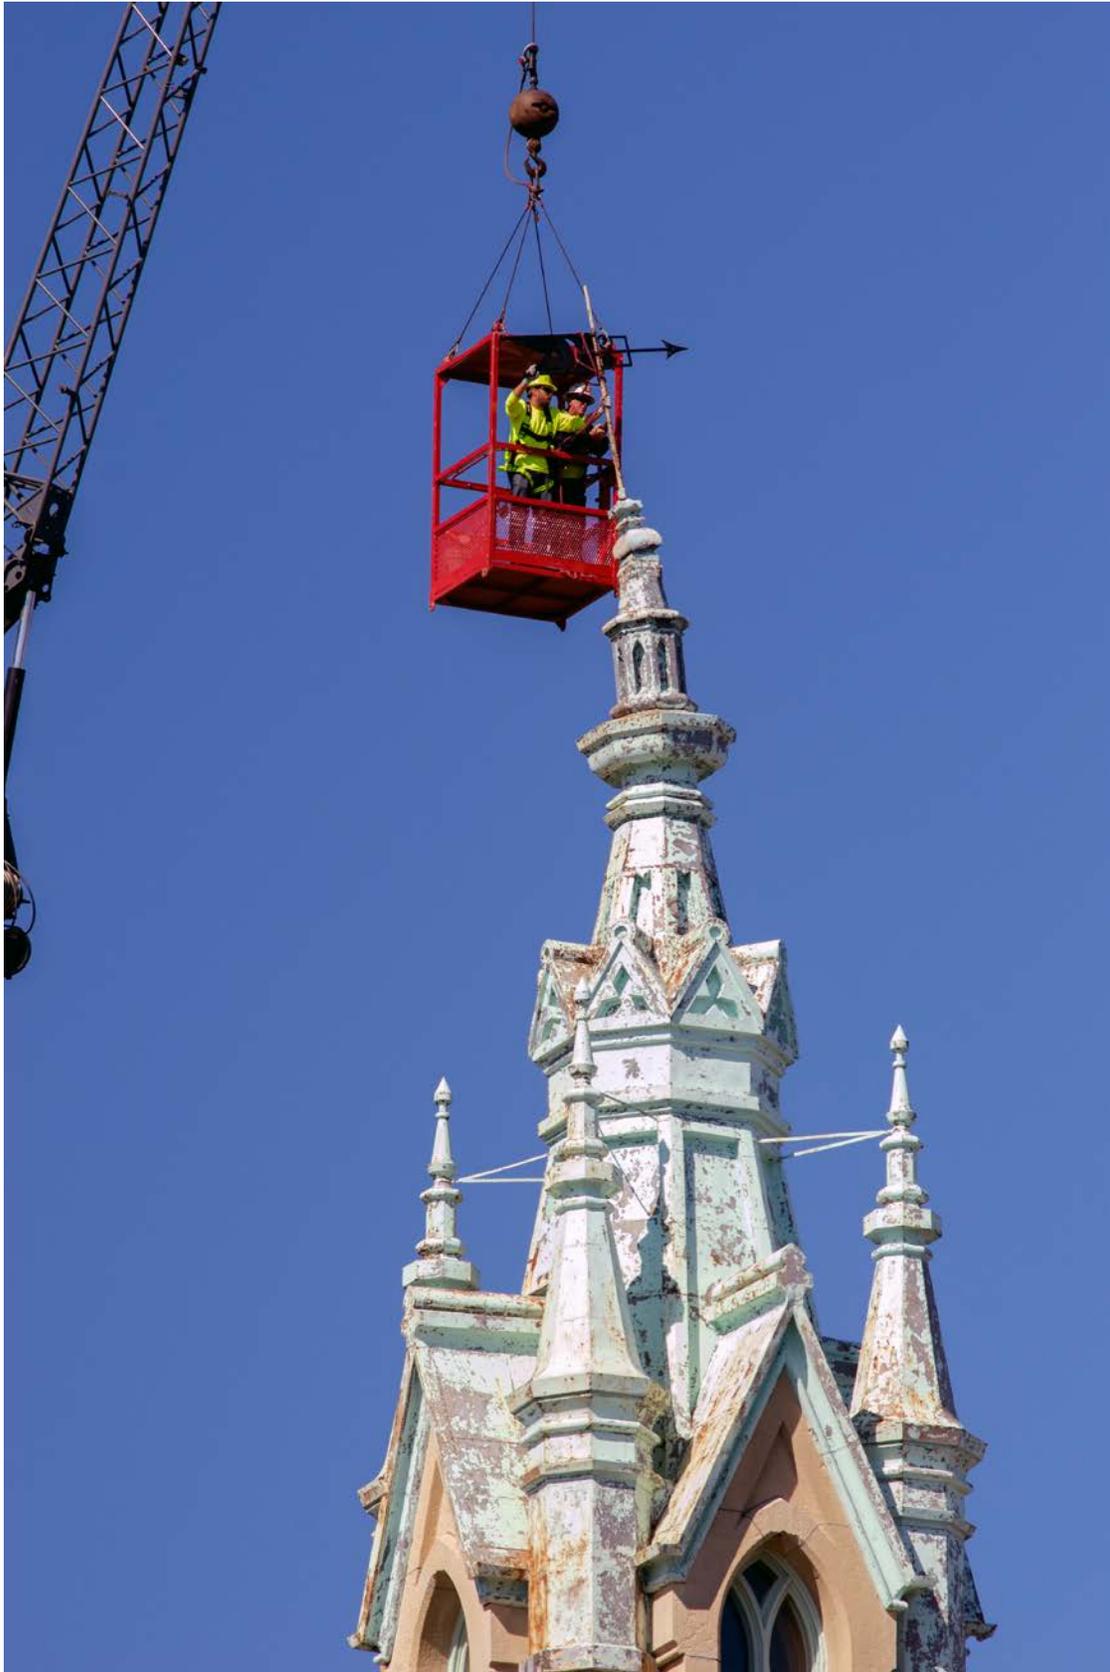
The interior of the peak of the roof and the area that held the steel rod on which the weather vane rested.

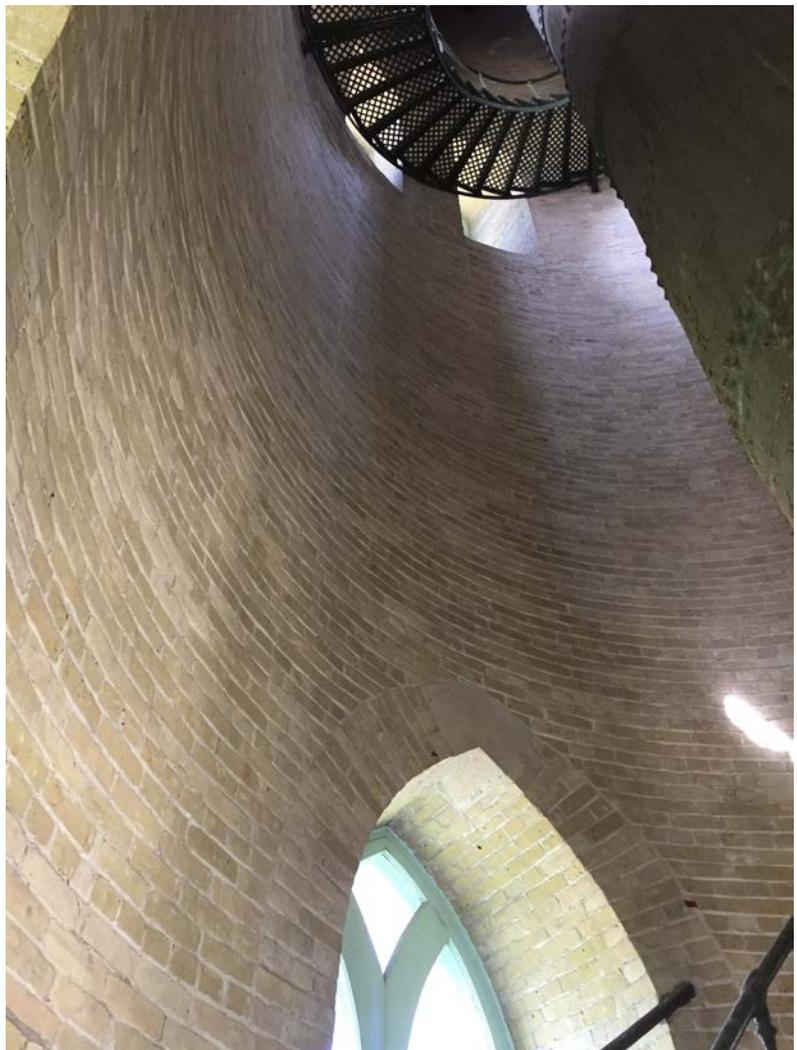
The contractor replaced the original cast iron floor plates with galvanized plates, and made interim repairs to selective cast iron stair treads and partial repairs to the stringers which support the treads and risers.

The 142-year-old staircase is not sound enough for public traffic, and for liability reasons, only City of Milwaukee employees preparing to perform maintenance at the tower are allowed to climb the stairs.
