Historical Land Use Investigation

827-29 E. Brady Street
Milwaukee, Wisconsin

File: 360-13

March 18, 2013

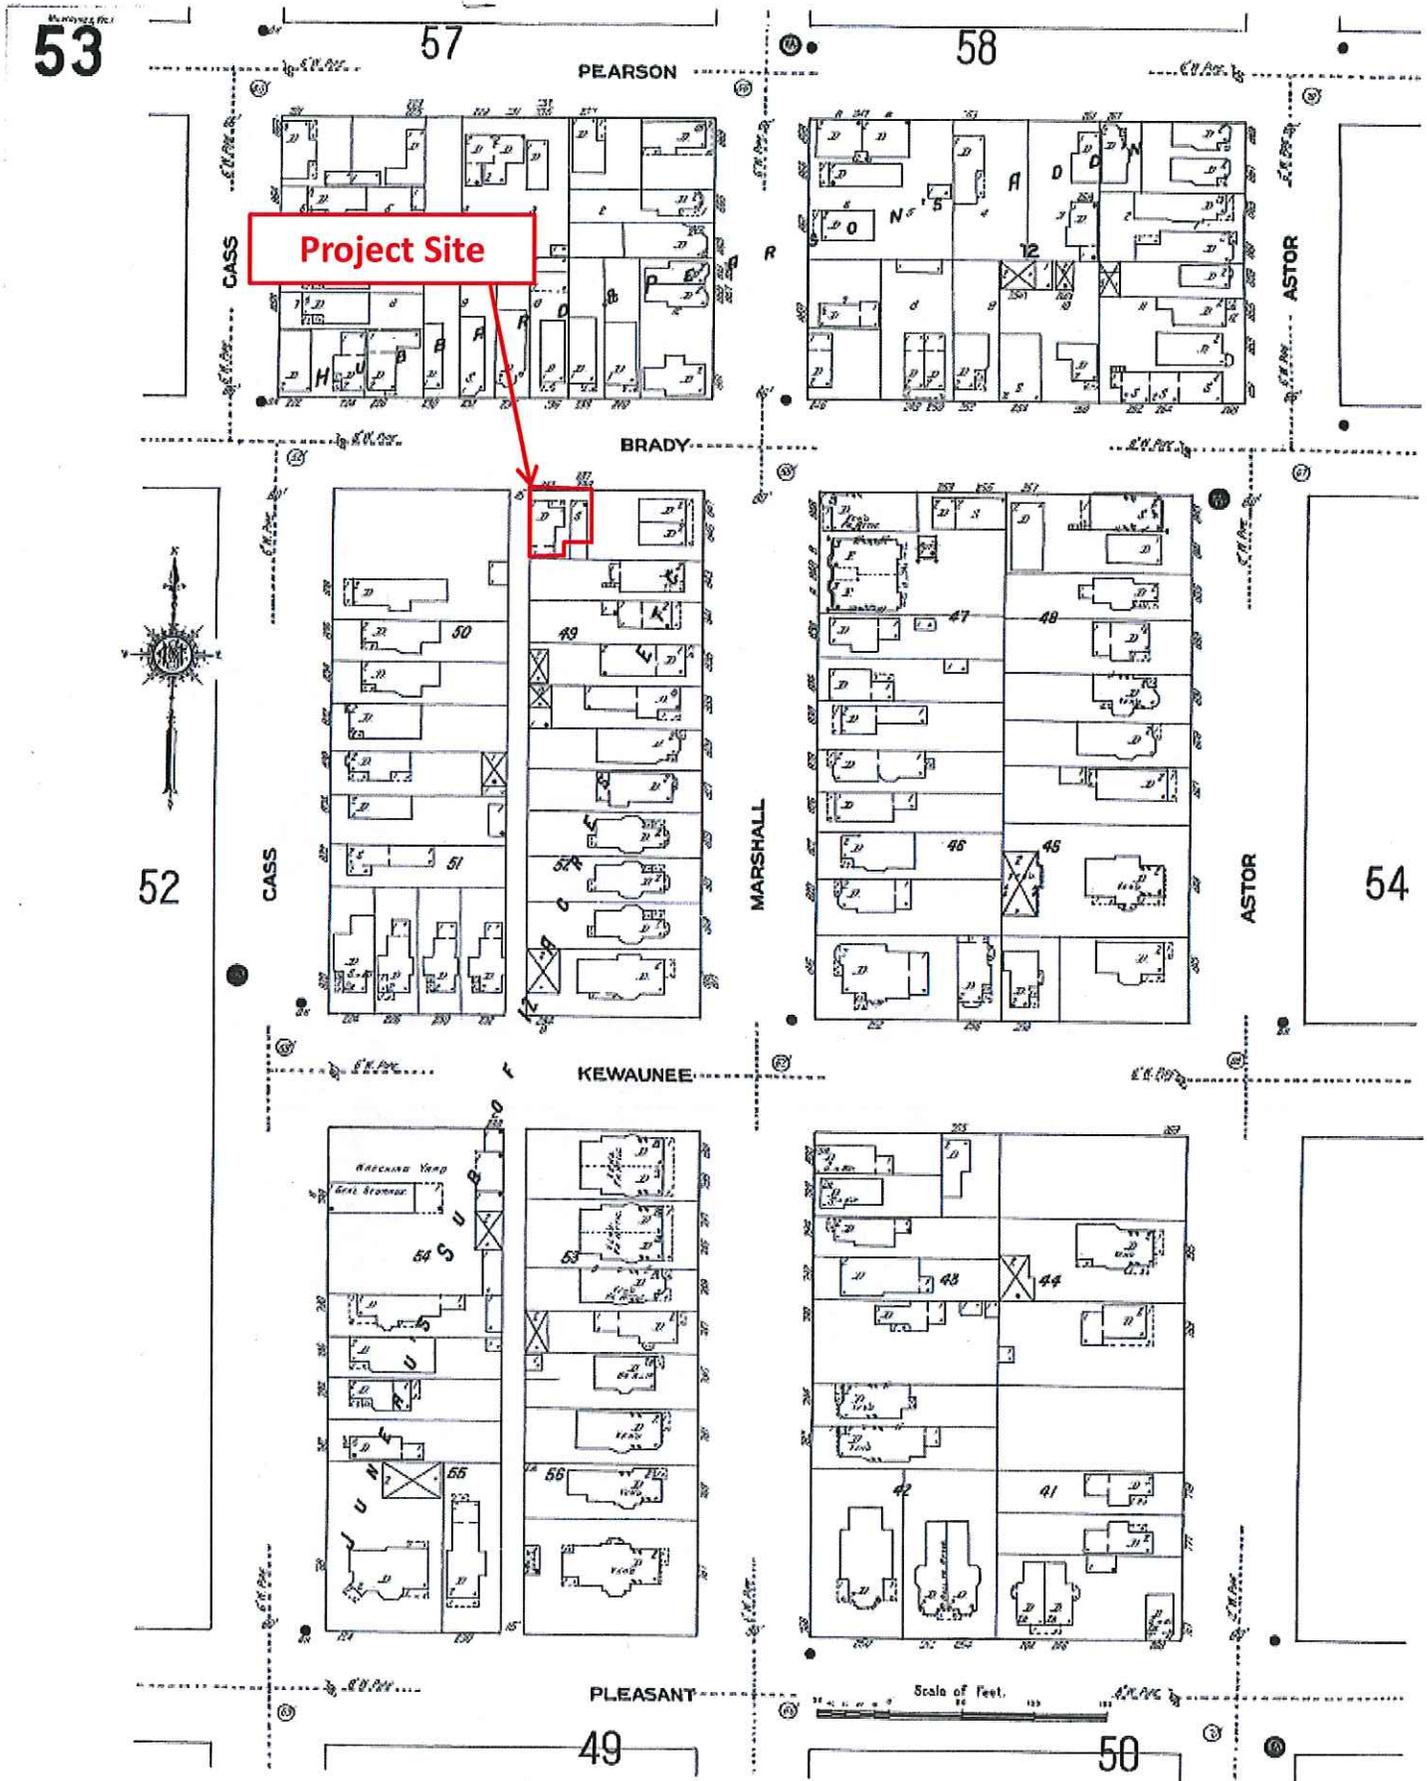
FIGURE 4

Development in the area immediately surrounding the project site consists primarily of single-family residences, as well as with other store buildings along E. Brady St. **(Figure 4)**

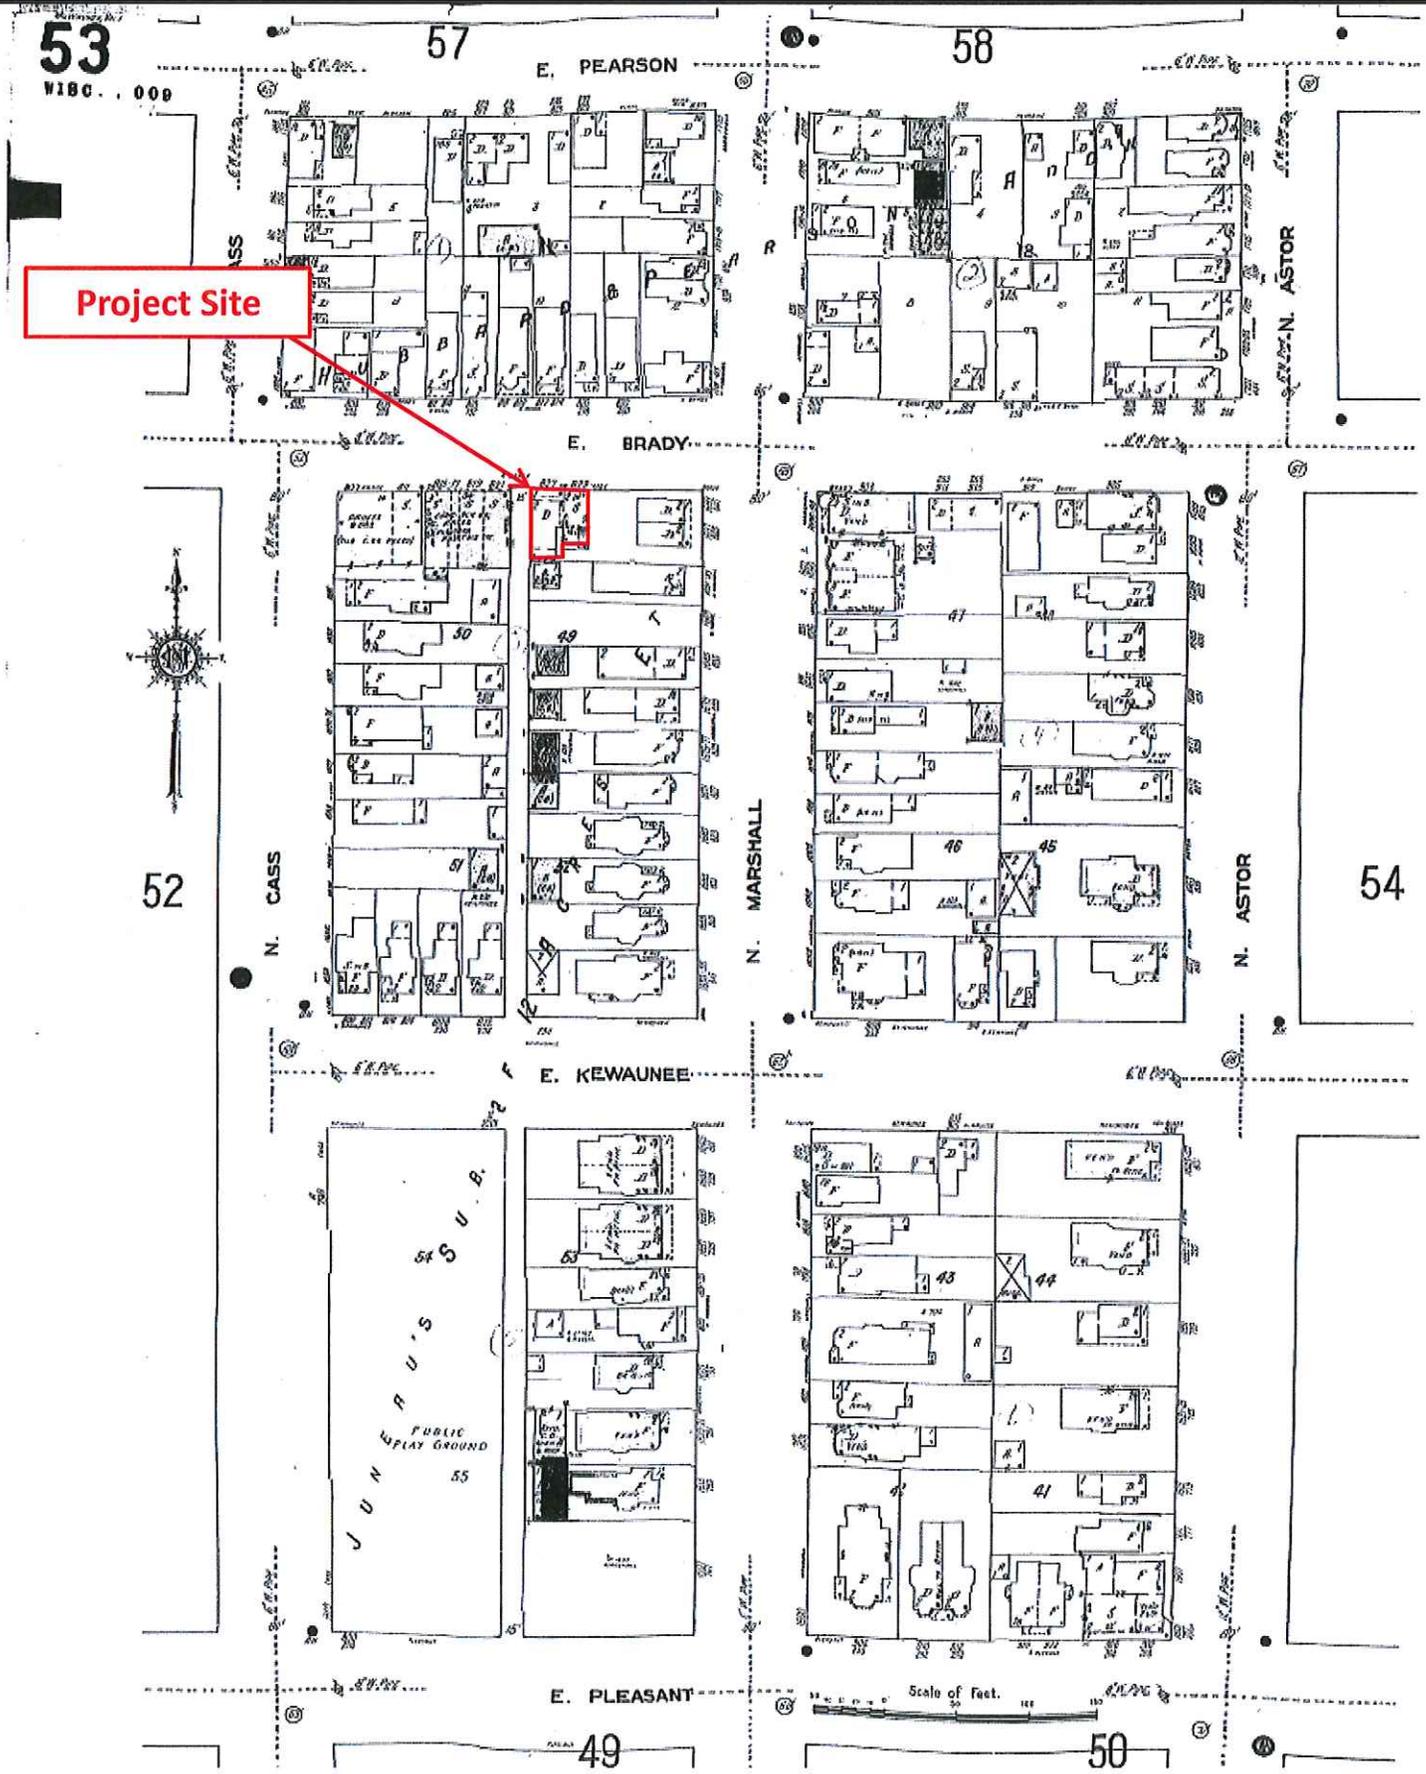
FIGURE 5
1910 SANBORN FIRE INSURANCE MAP
(WITH UPDATES THROUGH 1951)
827-29 East Brady Street, Milwaukee, WI

Development in the area immediately surrounding the project site continues to consist primarily of single-family residences, with additional store development along E. Brady St. The area also now includes apartment buildings, both new development and conversions of single-family structures. One nearby building, on the corner of E. Brady St. & N. Cass St., is a store labeled “paints and oils”. **(Figure 5)**

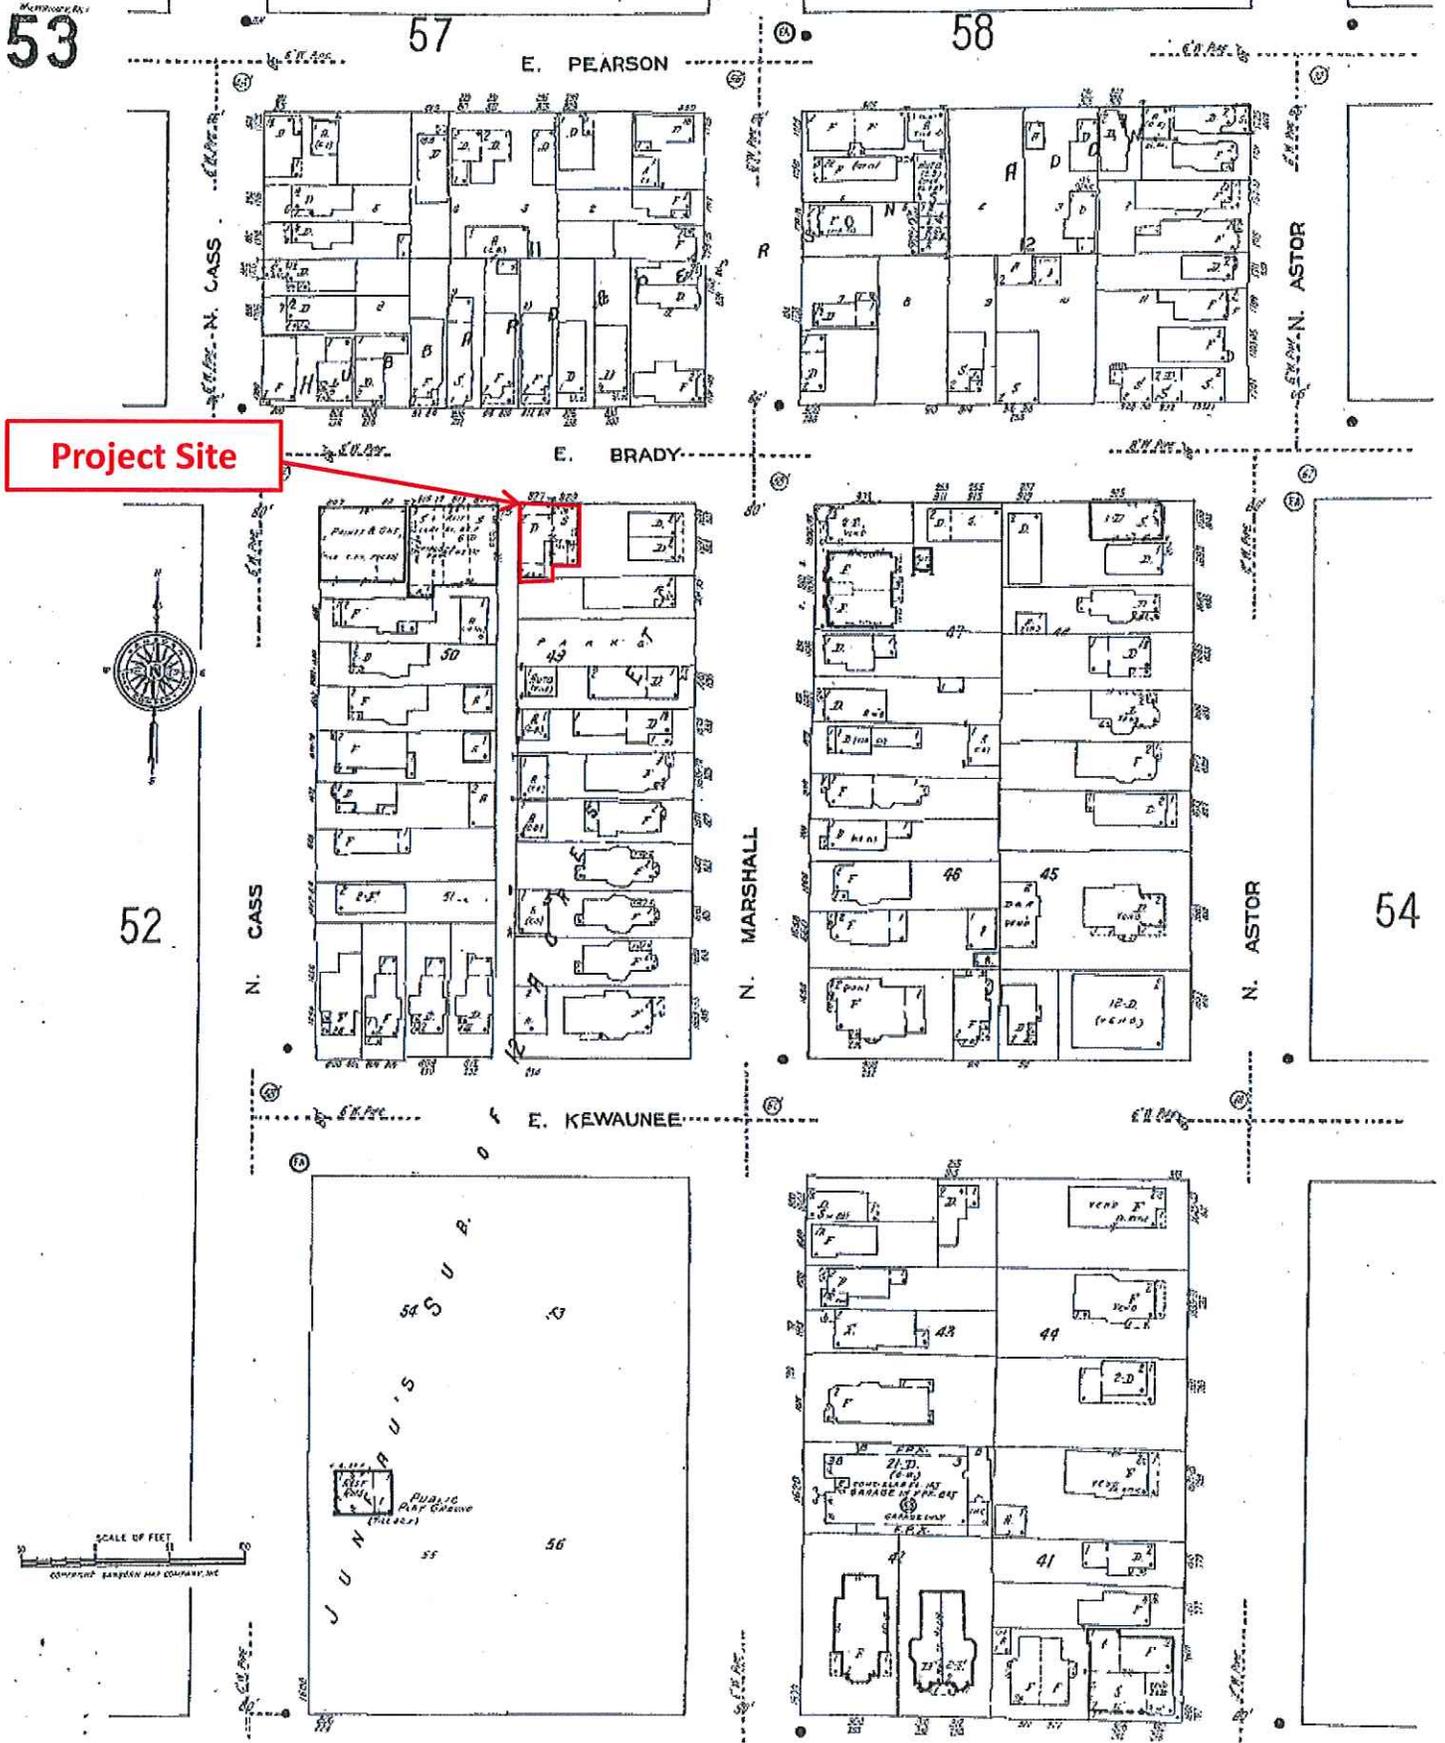
FIGURE 6

Development in the area immediately surrounding the project site has not changed significantly since the earlier Sanborn. **(Figure 6)**
