OFFICIAL NOTICE

INVITATION FOR BIDS FOR MECHANICAL DEMOLITION PROJECT OPENING 04-22-2024

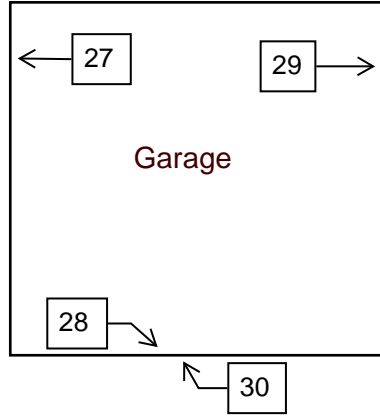
1st Floor Plan

One Family Dwelling & Garage
5066 North 24th Place
Milwaukee, Wisconsin
