Project Reference #18779

SUBJECT: Summary of Completed Remediation Activities
1132-1164 E. North Avenue
Milwaukee, Wisconsin

The Sigma Group, Inc. (Sigma) submits this summary of our knowledge of the completed environmental remediation activities at the site and current site status. The site is currently tracked as an open Environmental Repair Program (ERP) site (BRRTS #02-41-557602) by the Wisconsin Department of Natural Resources (WDNR).

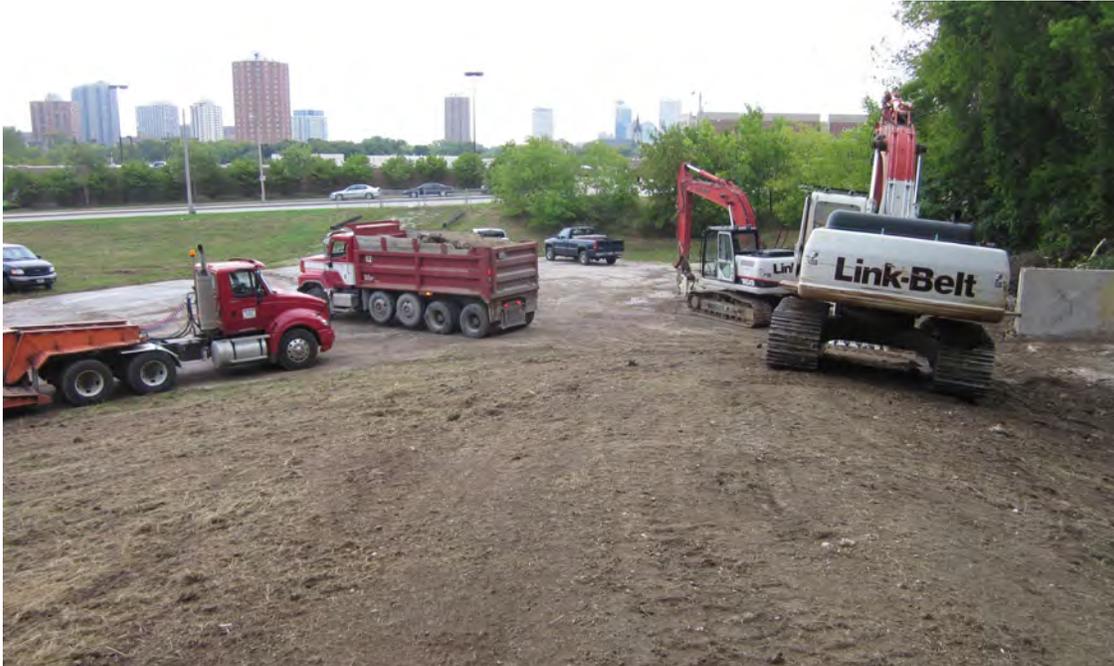
Photo 1: Site following building demo. View to southwest; photograph taken on September 7, 2012.

Following asbestos abatement, the former site building was demolished in September 2012. Existing on-site soil from high areas in the north central area and southwest site corner were graded appropriately to as part of the redevelopment-specific grading plan.

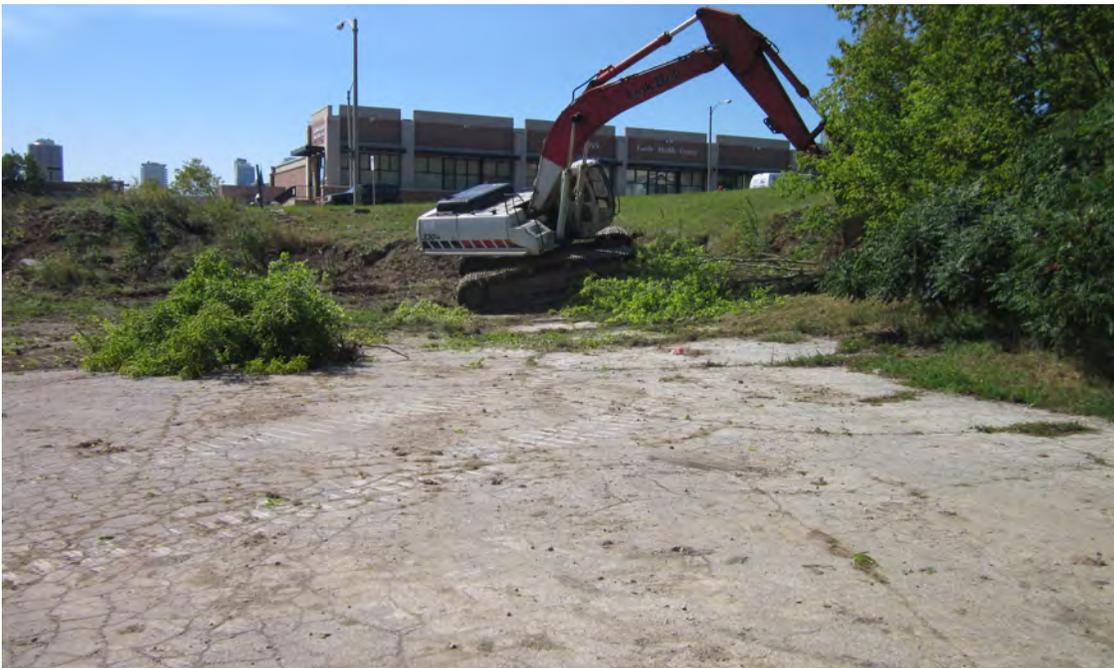
Photo 2: Removing vegetation from west side of site. View to south, photograph taken on September 11, 2012.

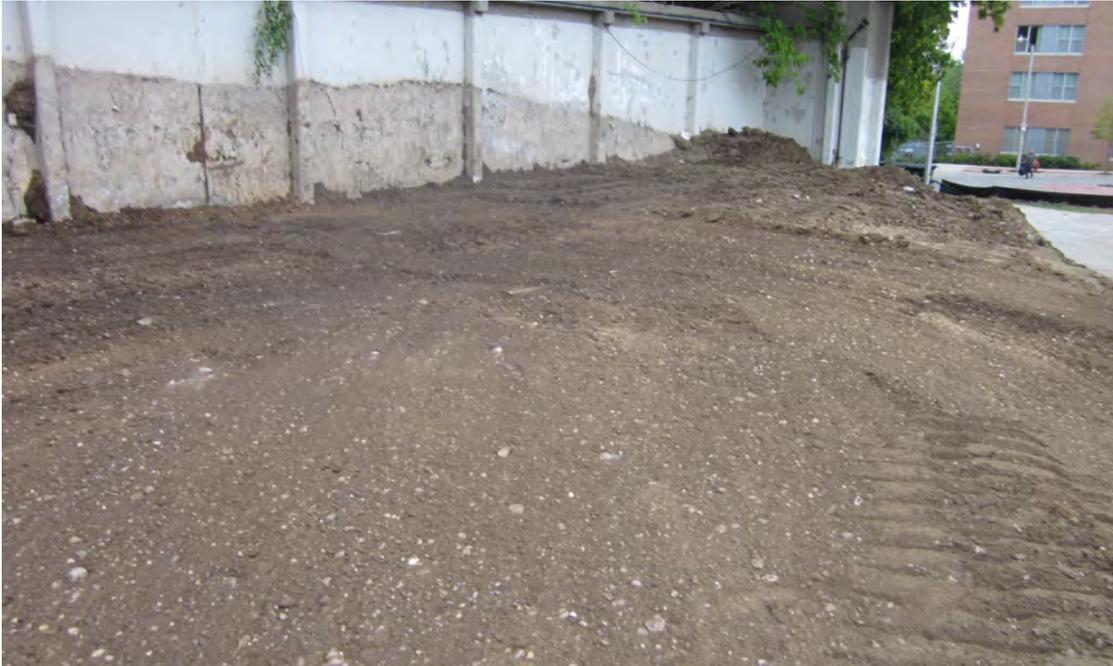
Photo 3: On-site soil re-use. View to northeast, photo taken September 13, 2012.

Following re-grading of the on-site soils, select grab samples were collected and submitted for laboratory analysis of PAHs and lead. The purpose of the additional soil sampling was to document post-management conditions as part of a future case closure submittal. Results of the post-grading samples are summarized in **Table 1**.

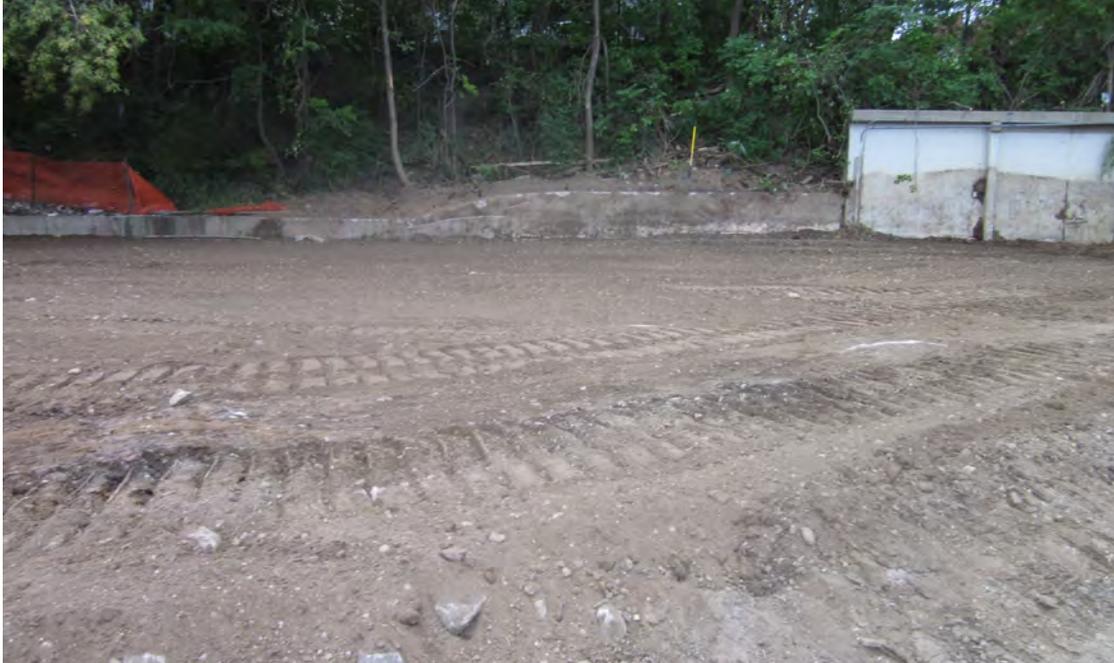
Photo 4: On-site soil re-use. View to north, photo taken September 13, 2012.

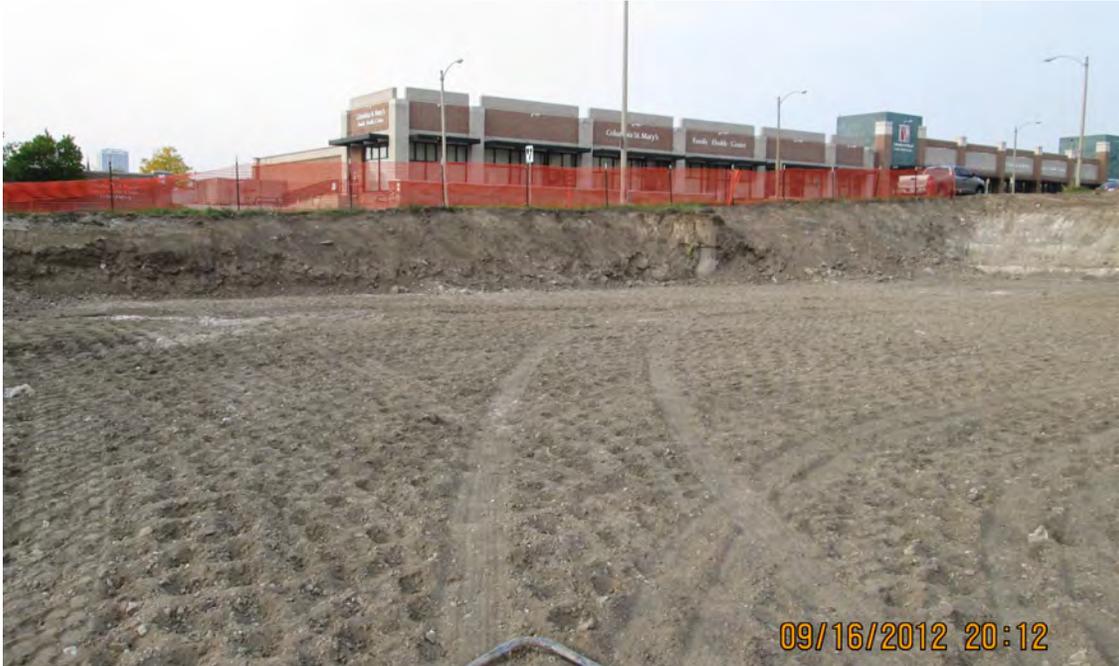
Photo 5: Site following placement of on-site soil for re-use. View to south/southwest, photo taken September 17, 2012.

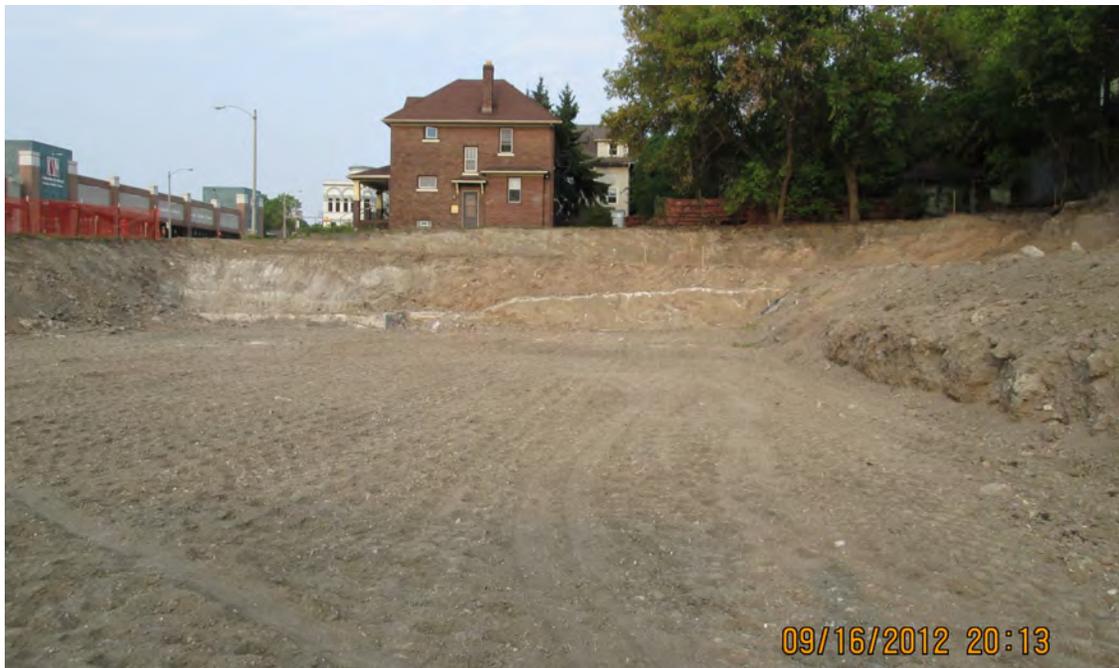
Photo 6: Site following placement of on-site soil for re-use. View to west photo taken September 17, 2012.

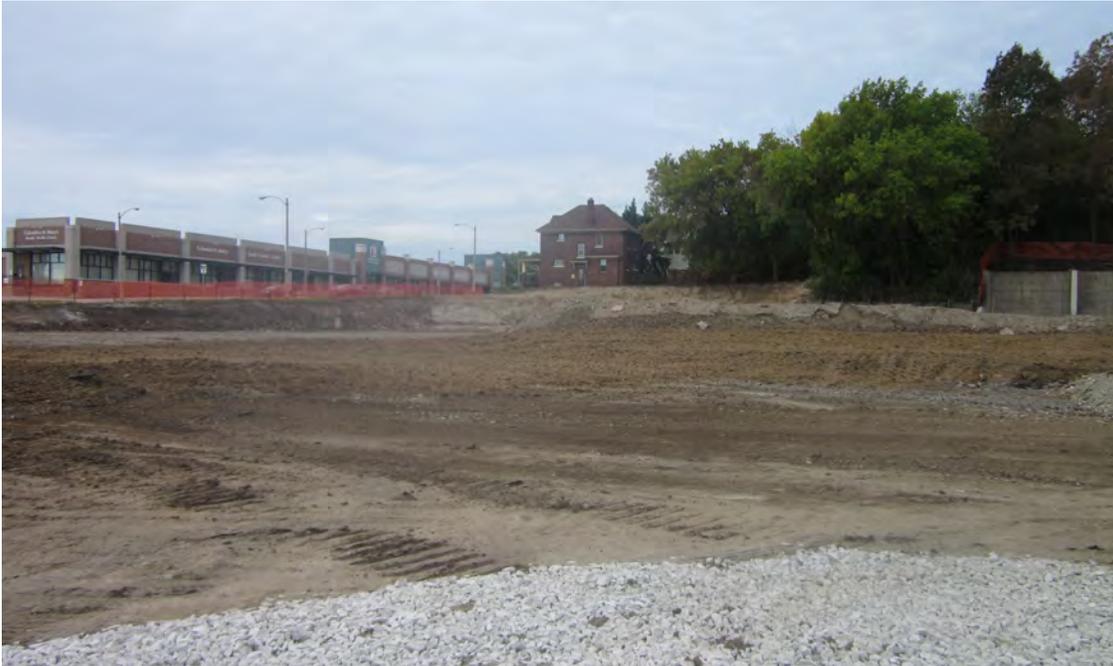
Photo 7: Site during placement of imported clean fill. View to southwest, photo taken September 18, 2012.

Once on-site soils were graded, clean fill material was imported and placed to meet required grades associated with the proposed redevelopment. Fill material consisted of excess soil generated from new residential construction projects located at 4850 Lake Drive, Whitefish Bay and 4375 Bradley Road, Milwaukee.

Fill material was primarily placed in locations outside the proposed building footprint requiring elevation gain as part of the proposed redevelopment.

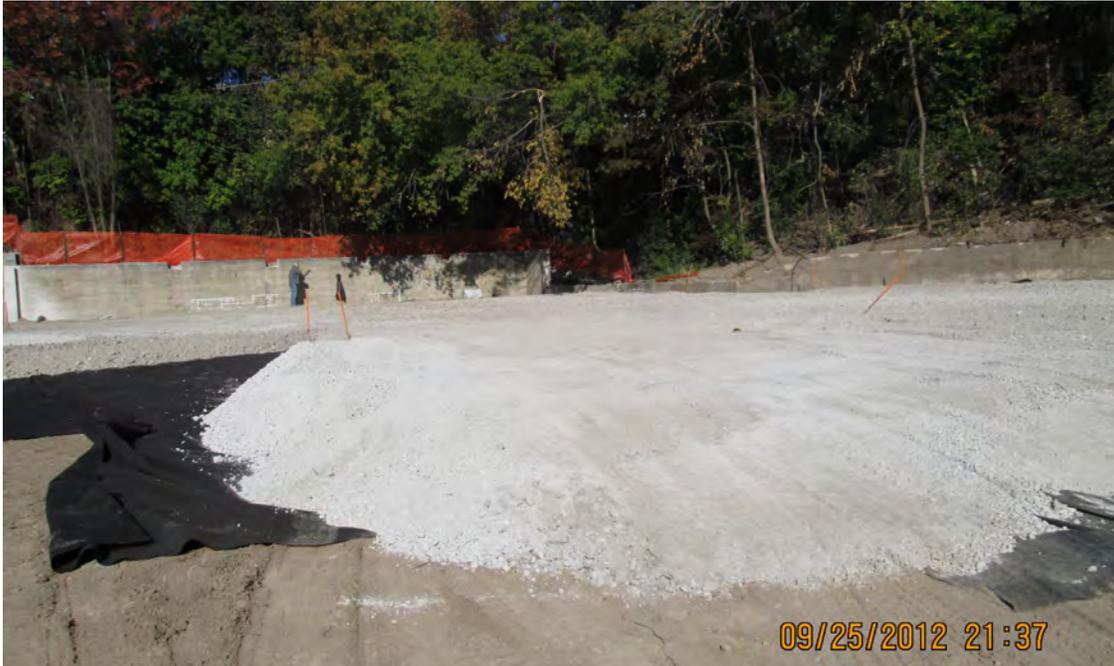
Photo 9: Proposed parking area during placement of geotextile and traffic bond. View to west/northwest, photo taken September 26, 2012.

Following placement of the imported fill, a layer of nonwoven geotextile fabric was placed beneath the area of the site outside the building footprint to provide separation between the underlying soil and traffic bond to be placed beneath the proposed parking lot/drive area. A layer of traffic bond stone was subsequently imported and placed over the geotextile fabric.

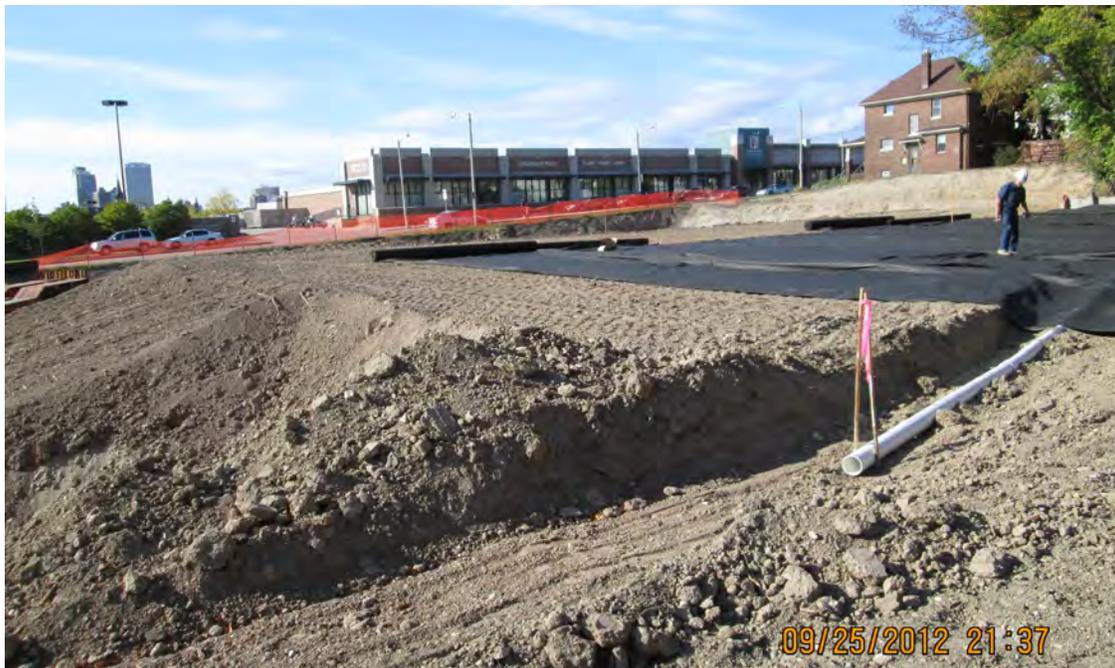
Photo 10: Proposed parking area during placement of geotextile and traffic bond. View to southwest photo taken September 26, 2012.
